SOUTHERN SHORES VOLUNTEER FIRE STATION: EXISTING FACILITY ASSESSMENTS & PROGRAM NEEDS

South Station Located at 15 S. Dogwood Trail, Kitty Hawk, NC 27949

East Station Located at 28 E. Dogwood Trail, Kitty Hawk, NC 27949

3 Jan. 2017

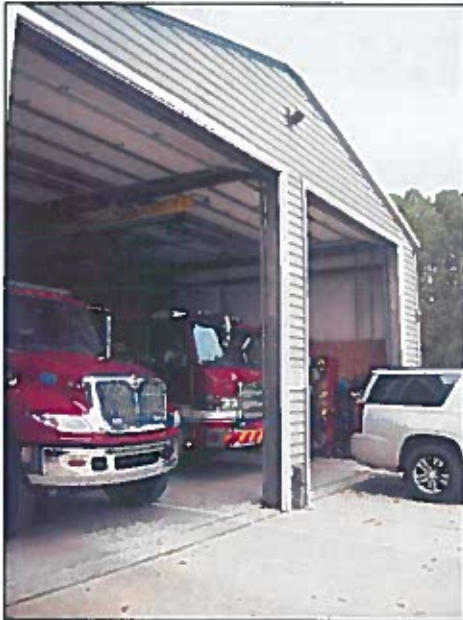
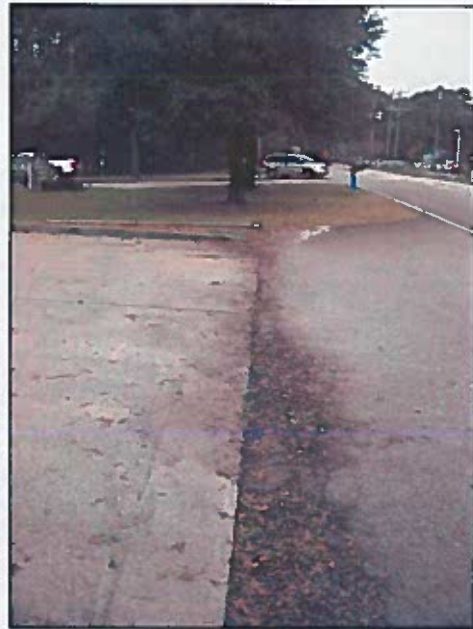
East Elevation – The east elevation fronts South Dogwood Trail, and is where the (2) Apparatus Bays exit for street access, as well as main public entry, are located. The apron in front of the bays, while adequate in length, is in relatively poor condition. While the aprons may have been sufficient for the apparatus and equipment in service in 1982, the increasing size, capacity, and weight of fire response vehicles may require replacement of the concrete aprons in the future.

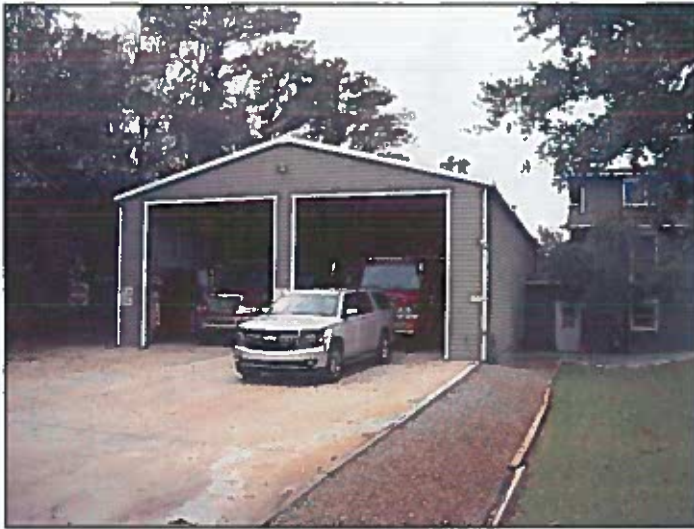
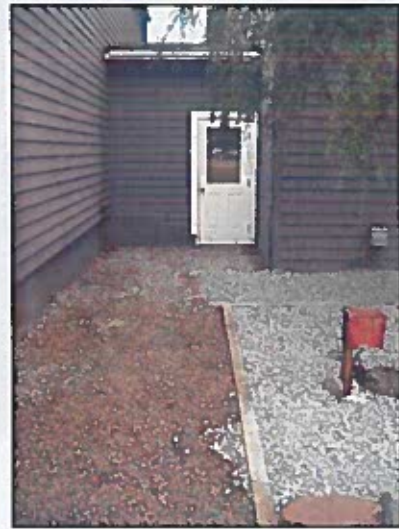
It seems upon visual observation, that the railroad ties framing out the gravel walkway to the north of apron have been rubbed with tires from apparatus' turning. This may be due to the inadequate apron cut to street access. The overhead doors are insulated metal panel doors with a double vision panel and are in good condition. No complaints about the operation of the doors were stated at the time of the assessment. The overhead doors are 14'Wx14'H. These opening sizes are adequate for the current apparatus.

The bollard protection at the overhead doors is inadequate. There are no bollards at front of bays. The typical new construction standard is a free-standing pipe bollard at least 4'-0" tall located at least 2' forward of the building surface. This will protect the building from backing the vehicles up into the walls, and damaging door tracks. Since this is a 'back-in' only facility, bollard protection is even more necessary.

The design of S. Dogwood Trail causes the street to drain onto the property, and pools in low spots to the north of the drive apron, and in front of the man-door shown in image above. Here, an undersized drainage structure depends on a sump pump to remove rain water. The drainage on-site is inadequate for the additional amounts, and during major storms, water damage occurs in the basement in the form of flooding (see Interior Building notes) There remains serious concern for current and future mold contamination.

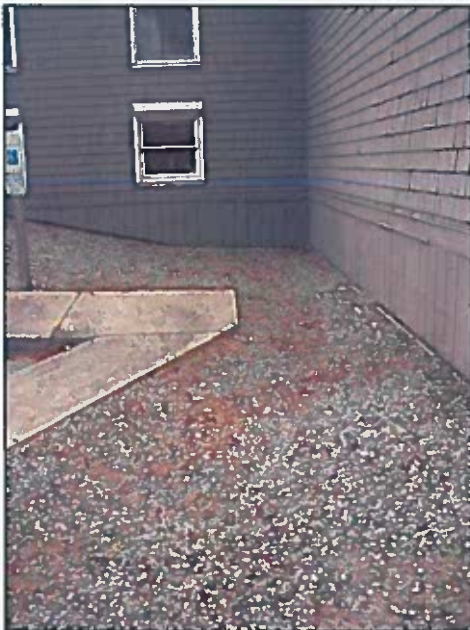
Exterior doors and windows provide daylight and ample access to facility, but they look to be residential and not commercial quality. They have storm shutter boxes above openings due to the location along the coast. No complaints about the shutters were stated at the time of the assessment.

Gravel landscaping provides less maintenance problems with xeriscaping, but it does present potential hazards to the disabled visitor/ staff, of unstable ground surfaces when not cleared off of path of travel.

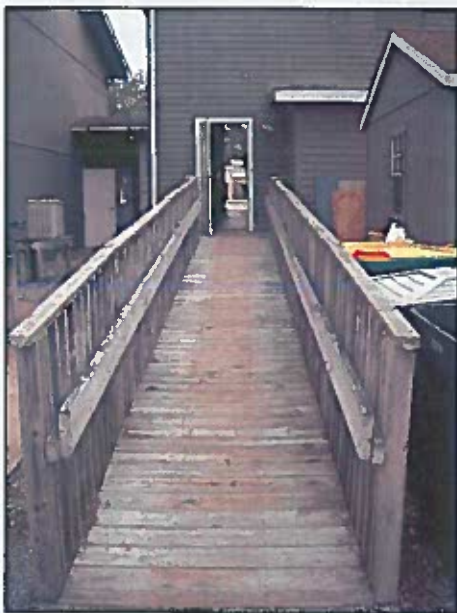
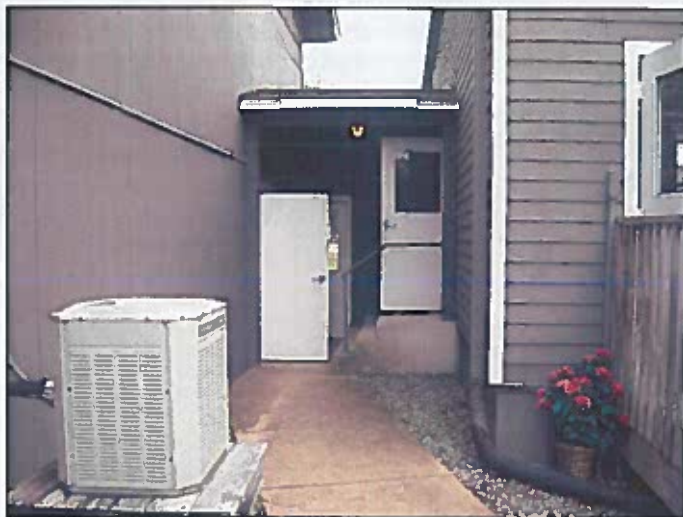
There are security challenges at the connector element, including blind spots and poor lighting.

The west elevation has an egress door, an access door to the apparatus bay, (via 3 steps), a passage way door to east elevation, and a handicap ramp to apparatus bay. The ramp is weathered wood and regular replacement will be required. There also seems to be a lip at the door threshold that may be exceeding ADA standards of $\frac{3}{4}$ ".

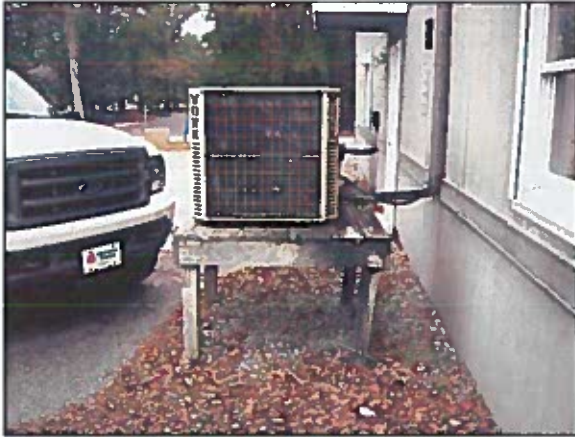
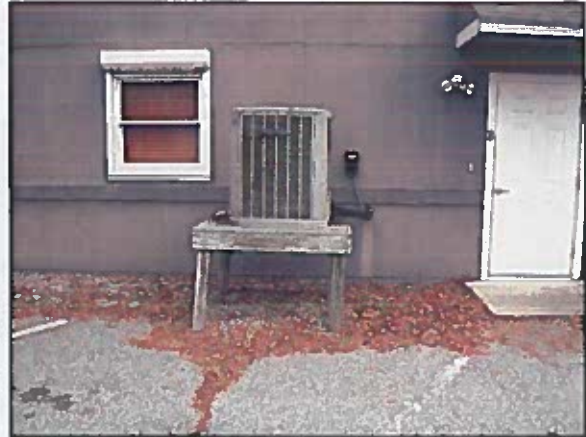
There are two condensing HVAC units on wooden stands which seem to be extremely weathered and need of repair.

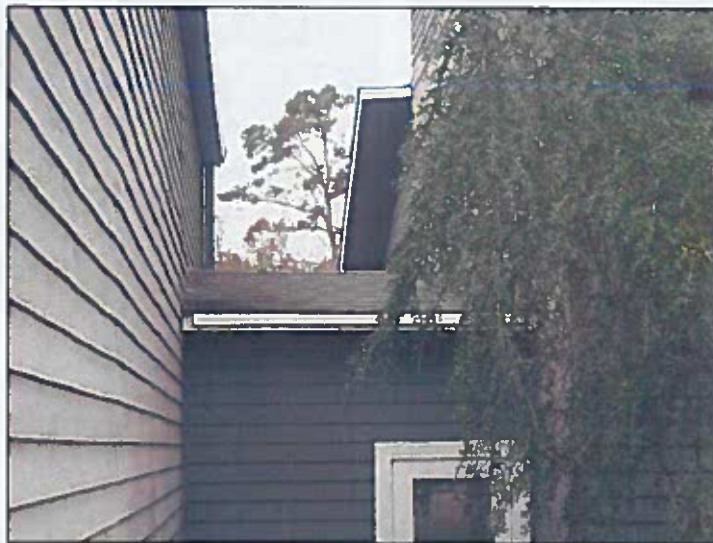
Roofing – Looking at the roof from ground level, it appears that the integrity of the roof structure is sound, although weathered by time and elements from coastal atmosphere. The asphalt shingles seem to have had their share of patchwork and replacement over time. There is a stack of unused shingles beside the shed on western elevation, with roles of tar paper.

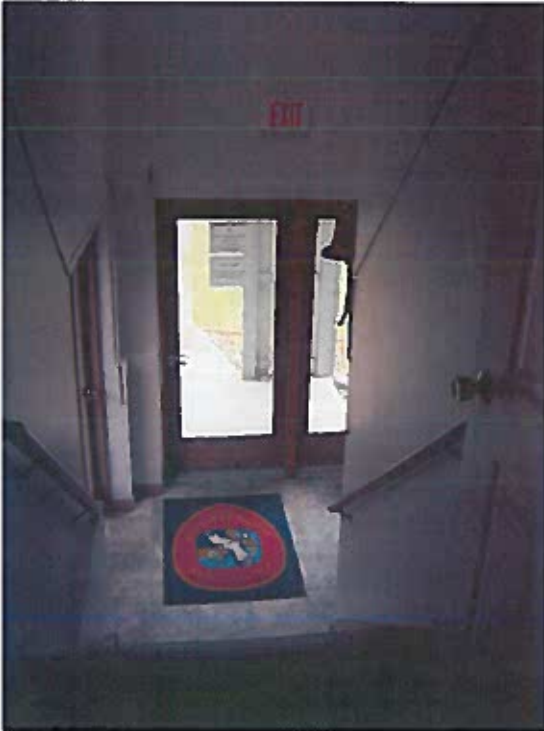
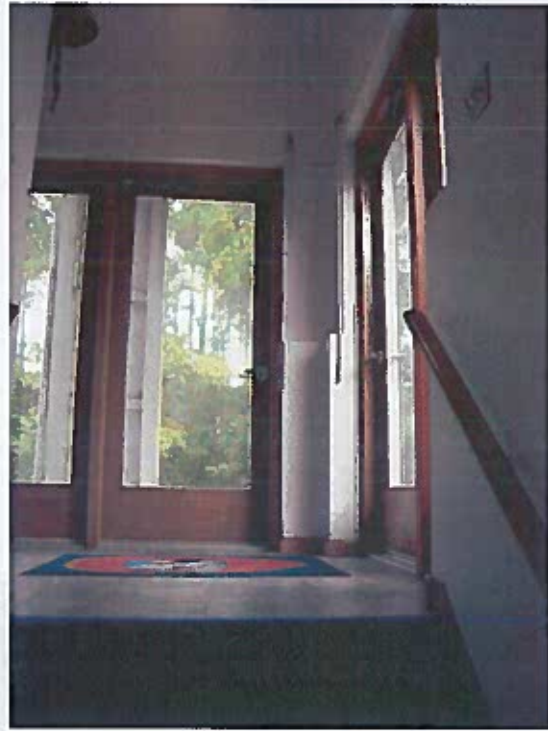
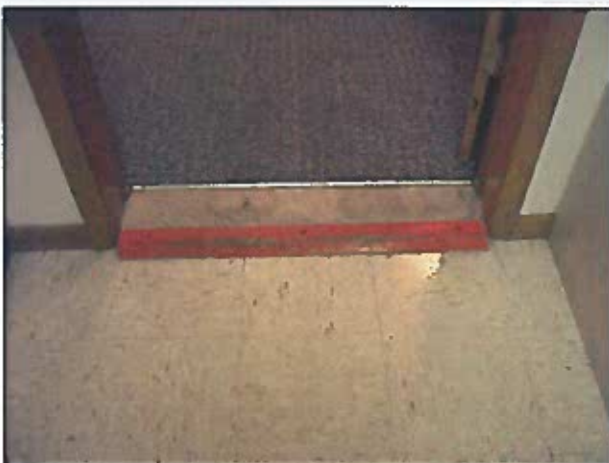
General Accessibility – The interior spaces of Station present an accessibility problem since there are multiple levels at the main entrance, with no accommodations for the disabled.

There are many conditions inside the facility which were not required to meet today's handicap standards when initially constructed. Renovation of these areas will require that items such as door hardware, door swing clearances, thresholds, toilet fixture clearances, kitchen sink accessibility, and casework storage accessibility will all need to comply with current standards. The knob style cylindrical hardware will all need to be replaced with lever style. Any areas open to the public needs to be fully accessible.

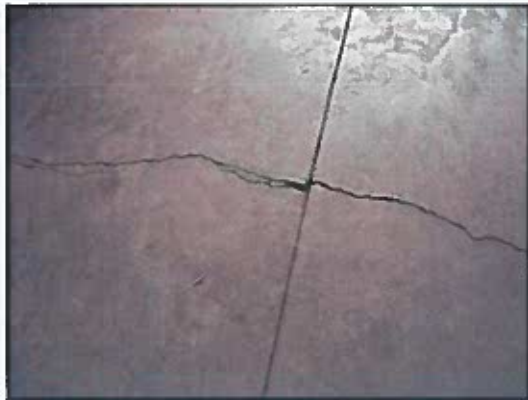
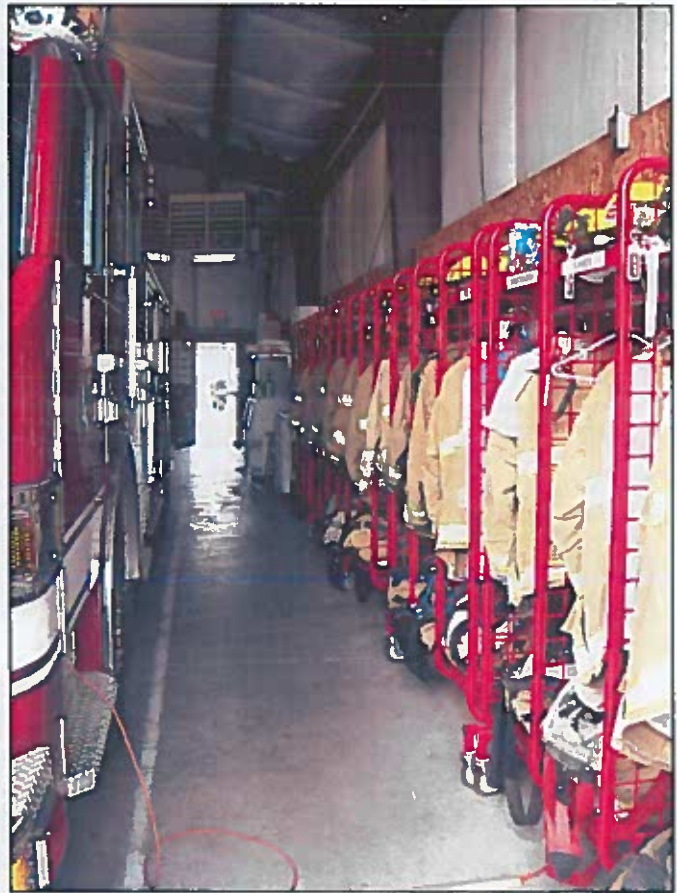
Apparatus Bays – The Apparatus Bays are in generally good condition but it does not appear as though the initial construction of the floor slab provided adequate control joints for controlled cracking of the surface. As a result of the cracking and possible settlement, water used to clean the apparatus bay floor, or deposited by the apparatus, will not travel fully into the exterior (there are no drains) and presents a potential slip hazard in the bay area.

Personal Protection Equipment (PPE) is stored in the open Apparatus Bays, which does not meet current guidelines for protecting the PPE from UV degradation and vehicle exhaust contamination, or protecting building occupants from carcinogen off-gassing from the PPE.

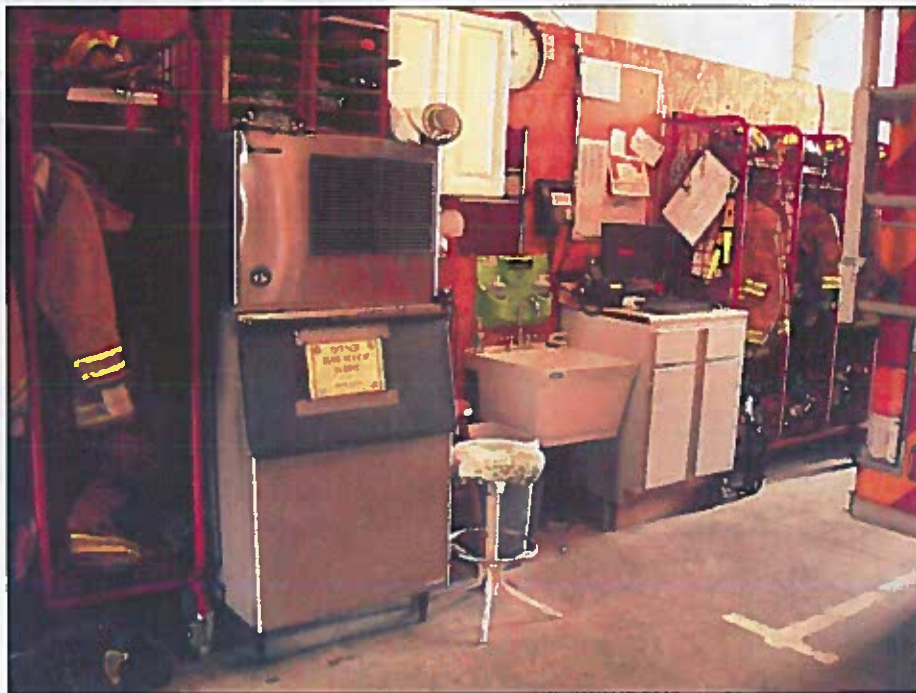
The existing ice machine is currently housed in the rear corner of the apparatus bay. There is a small decontamination area with a decon sink next to the ice machine. The typical standard in a new construction is to have a separate decontamination room where this equipment can be housed out of the bay area. Typical new construction would also have a large decontamination sink with sideboards for washdown of larger items in addition to an emergency shower/eyewash station for safety. Per OSHA recommendations, the ice machine should be moved into a room not subject to exhaust fumes, particulate contaminants, etc.

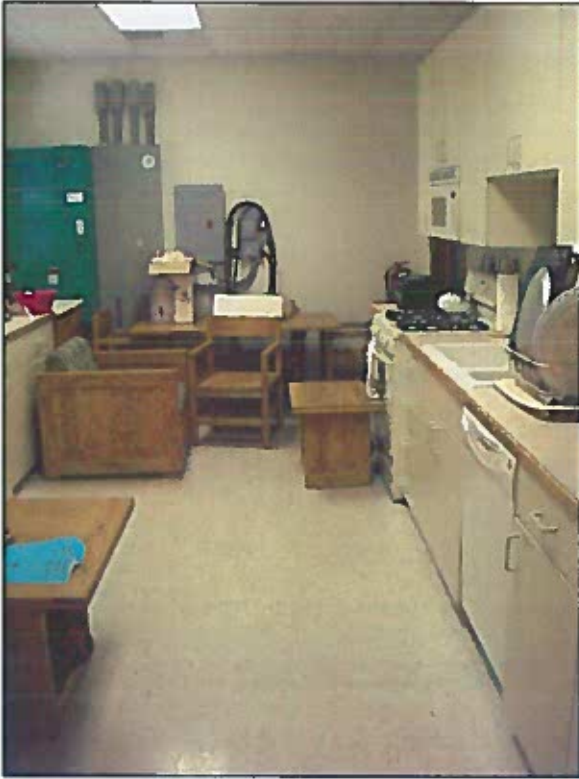
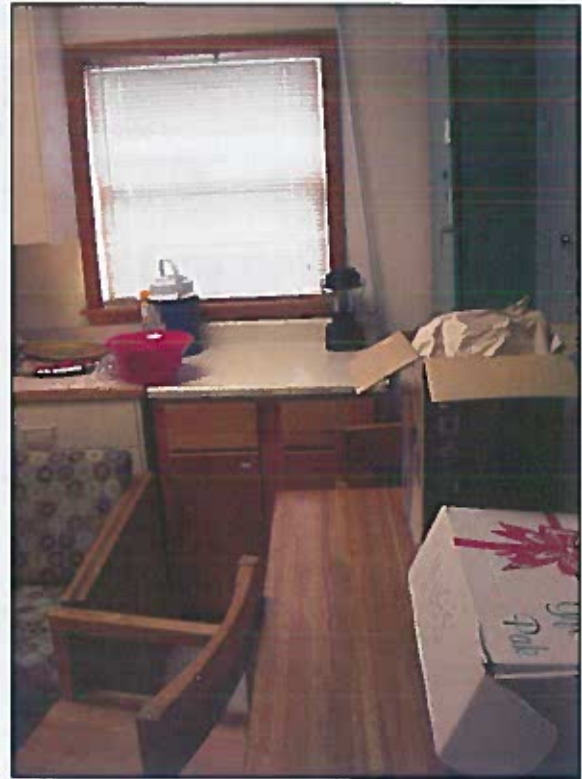
Kitchen- The kitchen for the station shows its age. The casework in the kitchen is lighter duty residential grade casework than would typically be recommended in new construction for a fire station. The kitchen sink height, hardware and base cabinet configuration will not meet current accessibility standards. The VCT flooring shows cracking. The dining area is congested around the main breaker boxes & ATS, and blocks access to the Fire Extinguisher.

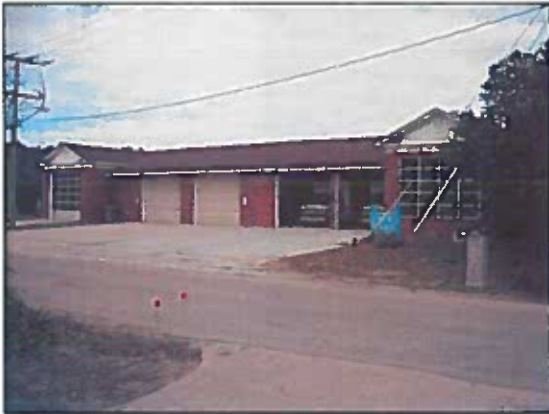
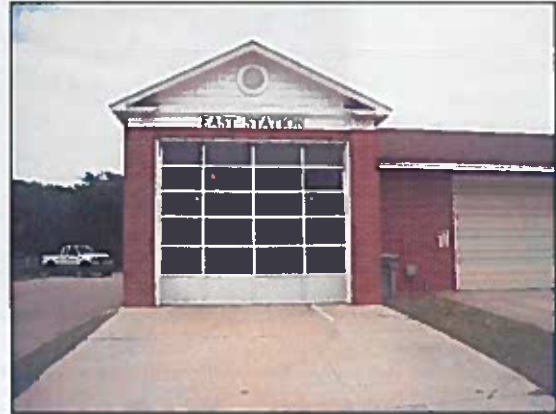
Upon visual inspection the overall exterior of the building, the building envelope appears to be in fair to poor condition, with extensive weathering of materials and access paths. The facility is a 45 year old structure, of a combination residential/ commercial construction materials. There is noticeable aging of the building, due to proximity to the Atlantic Coastline and Currituck/ Albemarle Sounds. The elements have faded the roof and exterior doors and window frames. Upon visual inspection, there does not seem to be an ADA accessible entry meeting building codes, as there are step thresholds in case of flooding. There are numerous OSHA violations throughout the facility. The roof conditions are fair, but aged.

South Elevation- The south elevation fronts to East Dogwood Trail, and is the main emergency apparatus ingress/ egress side. The main engine bay overhead door is all glass panels (un-insulated) with lower panel blanked out aluminum. The other 4 doors have been replaced w/ non-insulated opaque plastic paneled doors which allow transmitting of ambient light into bays. These doors should be replaced w/ proper insulated doors, and all OH door seals need replacing.

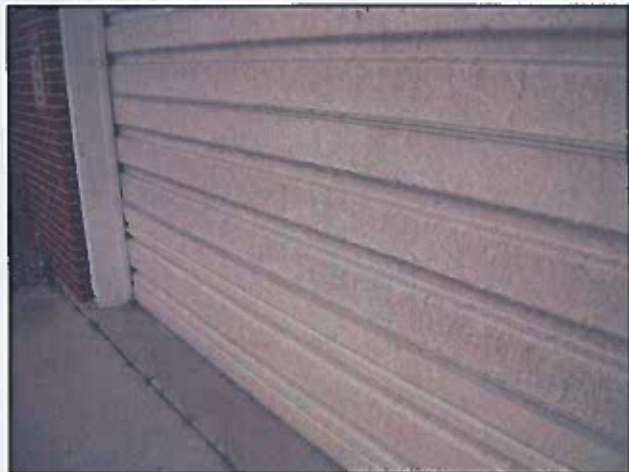
The apron shows many cracks, indicating poor subsurface conditions and settling. At the expansion joint at overhead door, the interior slab is pronounced about an inch.

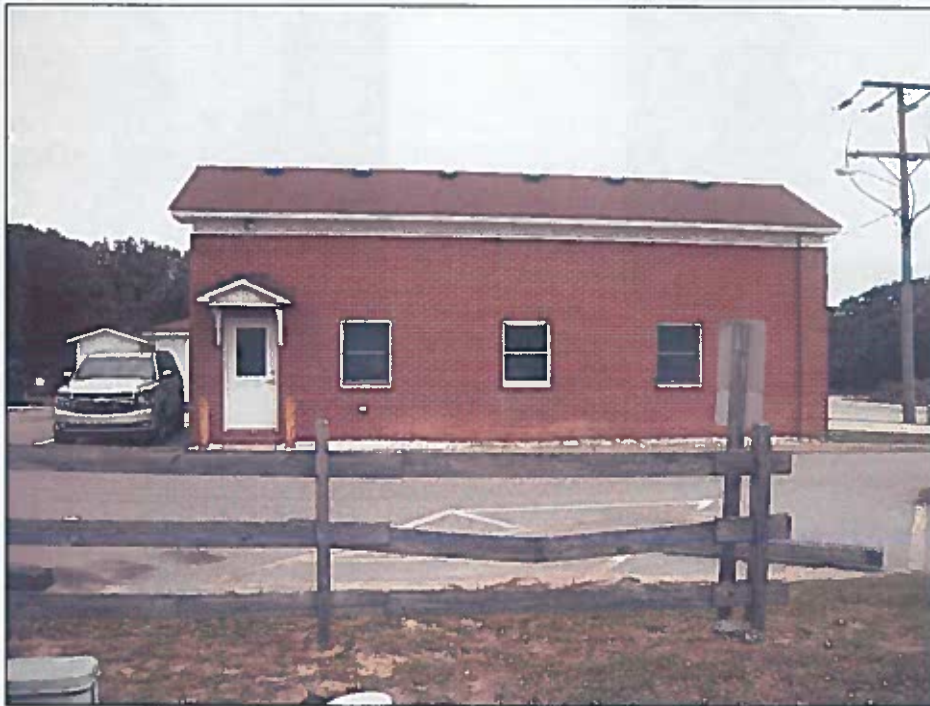
West elevation- The west elevation shows the 3 windows and entry door to main bay through the brick and mortar exterior wall. The only concrete bollards on the property are located at the door to bay on this elevation. Again, this door, as every other exterior door, does not meet ADA standards (although this one does have a lever handle) for either an ingress or egress door due to the stepped threshold.

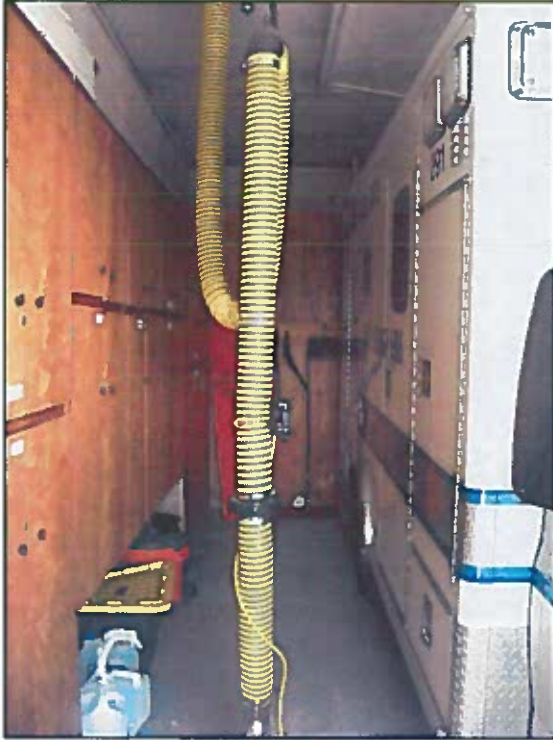
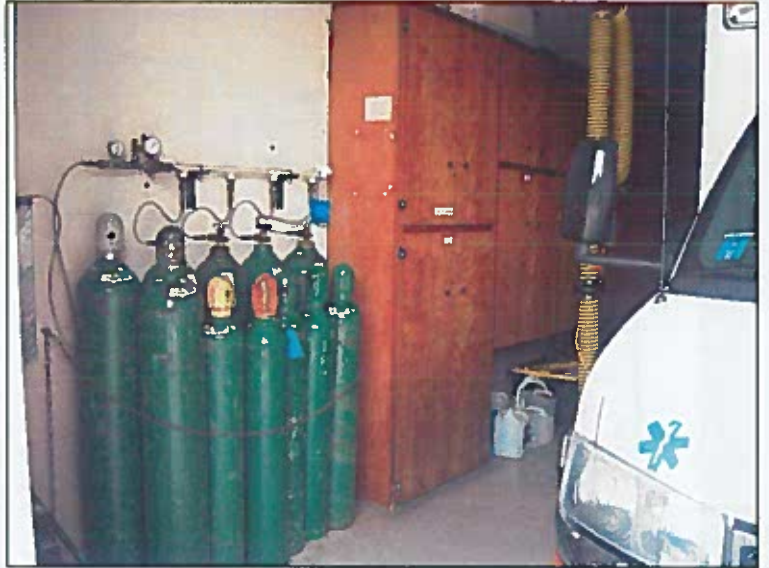
Apparatus Bays- Storage of Oxygen bottles in EMS bay, with only a small chain for fall protection will not pass code. Concrete filled bollards, with a top and bottom chain, are needed for proper protection.

Exhaust system hoses left hanging down in access routes can be hazards in an emergency egress situation.

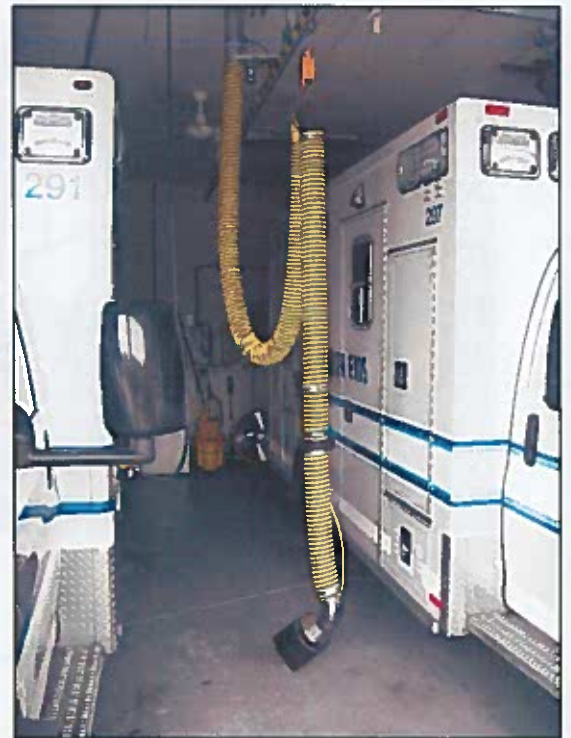
In an already confined space, necessary exhaust system hoses take up precious real-estate.

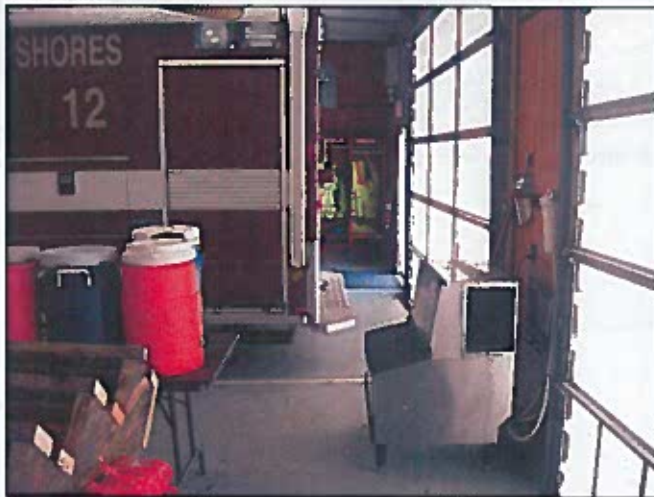
The existing ice machine is currently housed in the front of the apparatus bay. Per OSHA recommendations, the ice machine should be moved into a room not subject to exhaust fumes, particulate contaminants, etc.

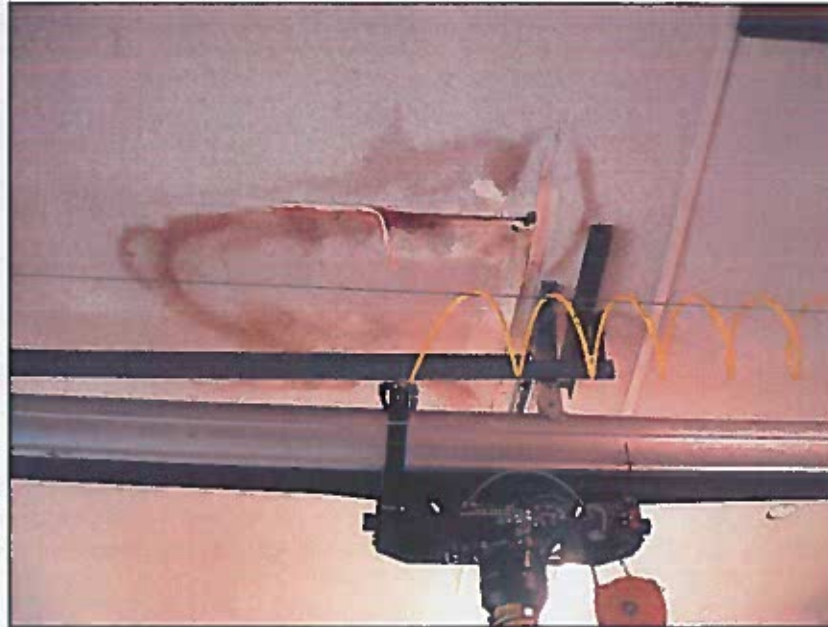
There is water damage in bay ceiling from attic space above.

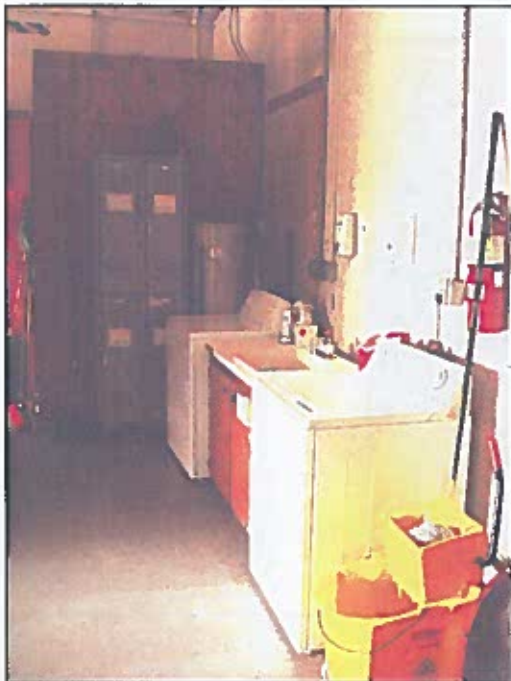
Residential Washer and Dryer are located in rear of EMS bays. There is a small decontamination area in-between washer and dryer. The typical standard in a new construction is to have a separate decontamination room where this equipment can be housed out of the bay area. Typical new construction would also have a large decontamination sink with sideboards for washdown of larger items in addition to an emergency shower/eyewash station for safety.

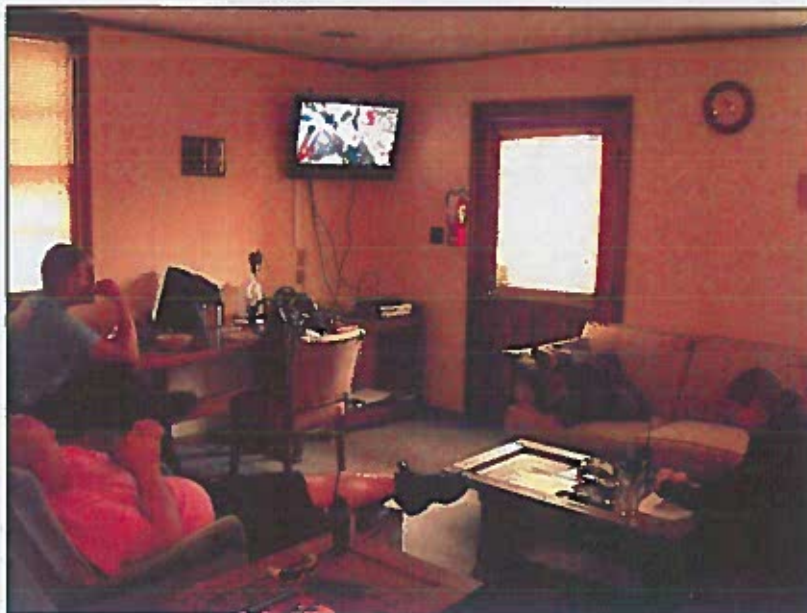
Day Room/ Kitchen- The dayroom is an open plan configuration containing the areas for seating and dining with the kitchen. The Kitchen has Plastic Laminate counter tops, and residential style fixtures.

The casework in the kitchen is light duty residential grade and would not be recommended in new construction for a fire station. The kitchen sink height and base cabinet configuration will not meet current accessibility standards.

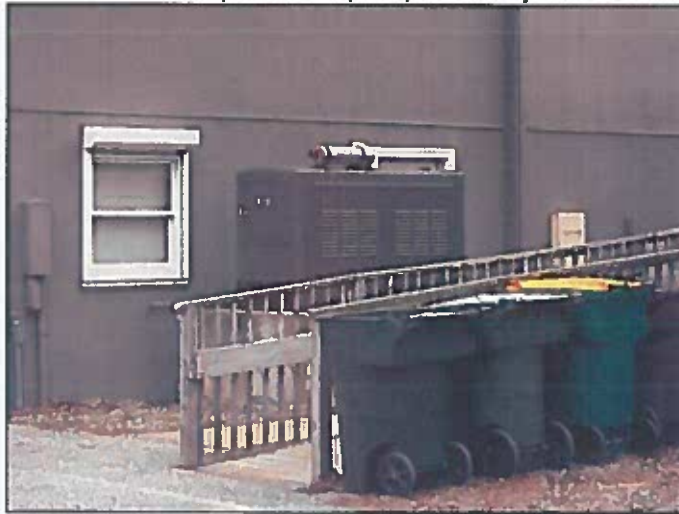
4. The Emergency input of the ATS is supplied by a generator located outside at the South side of the facility. The generator is an Onan Model 45EM. The generator is fueled by LP gas and is rated 120/240 Volts, 45 kW, 45 kVA. The output of the generator is supplied through a 175 Amp circuit breaker located on the exterior of the building adjacent to the generator. The generator is installed on a concrete pad approximately 2' above grade, presumably to aide in preventing issues due to high water levels. A staff member indicated that the generator has always backed up the facility adequately exhibiting no apparent issues with regard to its capacity.

5. The generator steel enclosure shows signs of past rusting with small holes observed through the metal. It is difficult to keep steel enclosures in acceptable condition in an environment with close proximity to the coast. Obvious painting maintenance efforts are ongoing as the paint currently appears to be in reasonable condition.

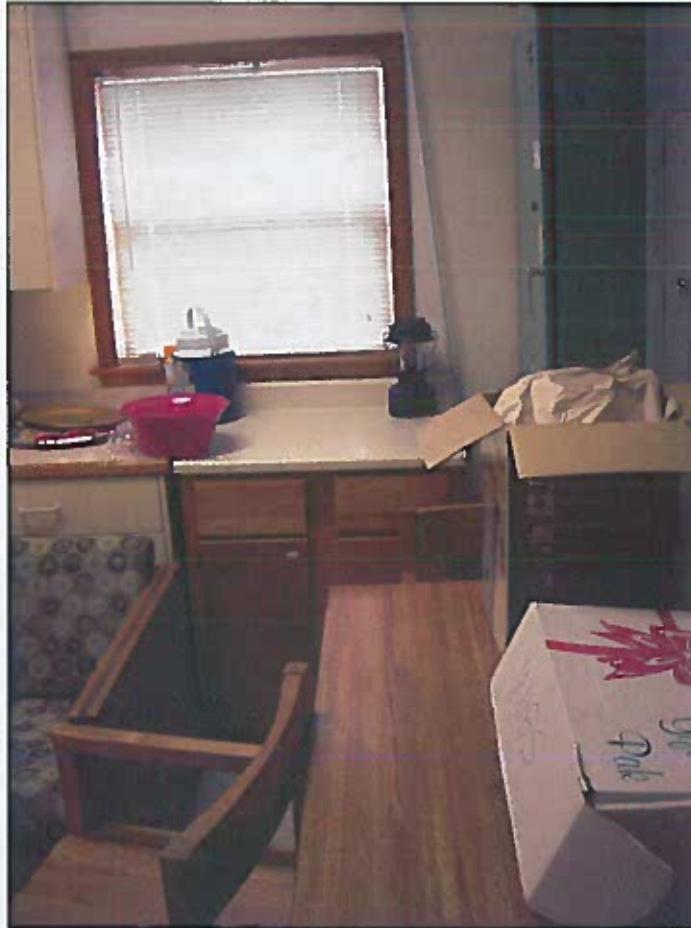
12. Kitchen: There is a counter in front of the ATS that is in the code required clearance in front of the ATS, and that also prevents fully opening the ATS door. Upon further examination, the counter is not fixed in place and can be moved to provide access as required.

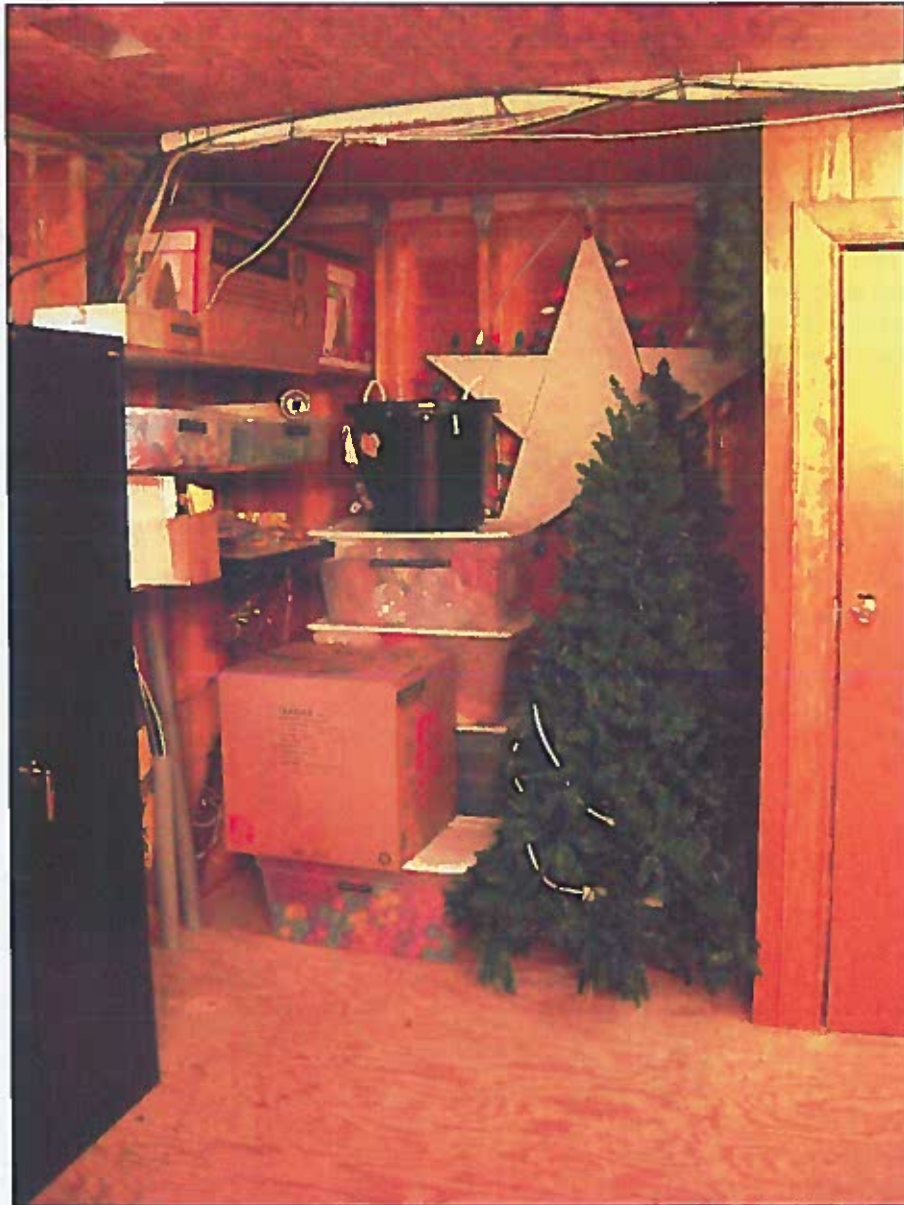
18. Upper Level Storage: Exposed nonmetallic-sheathed cable was observed, exposed both in wall framing and surface mounted to the ceiling. Nonmetallic-sheathed cable is only permitted by code where concealed in walls, floors, or ceilings that provide a thermal barrier of material that has at least a 15-minute finish rating as identified in listings of fire-rated assemblies.

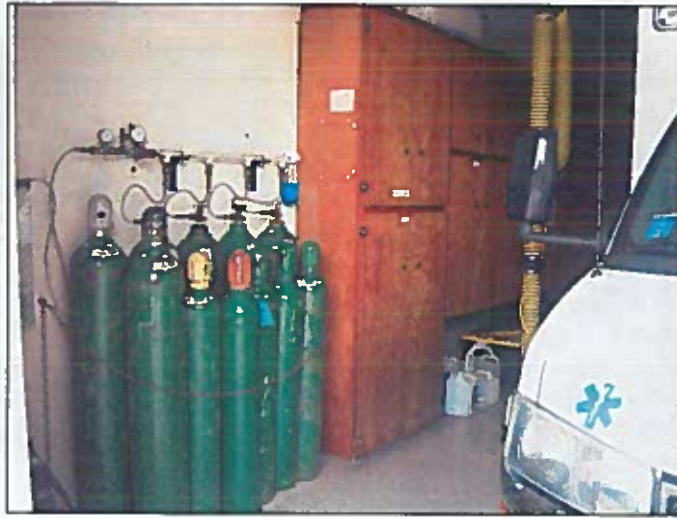
13. Multiple cylinders of oxygen are stored in the EMS truck bay, with no protective bollards. This is not only very hazardous, but a code violation.

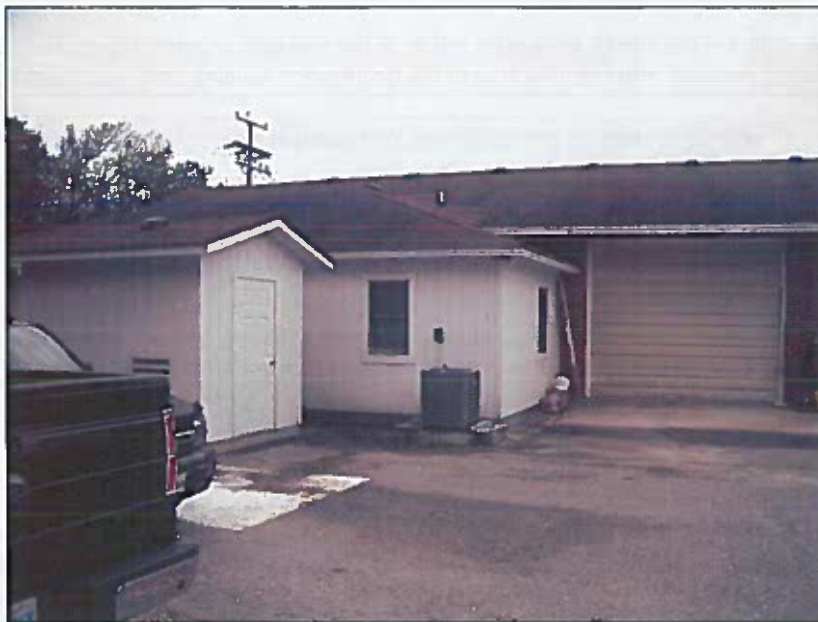
3. The Goodman 1-1/2 ton heat pump system should be replaced due to its service life and that it uses phased out R-22 refrigerant.
4. Split systems' indoor air handling unit sections are not in locations conducive to maintenance, they are located above a ceiling and in a closet.
5. Two ceiling diffusers have residue which could be dirt or mold. Without being sampled and tested by a certified industrial hygienist, we would be speculating what it is.

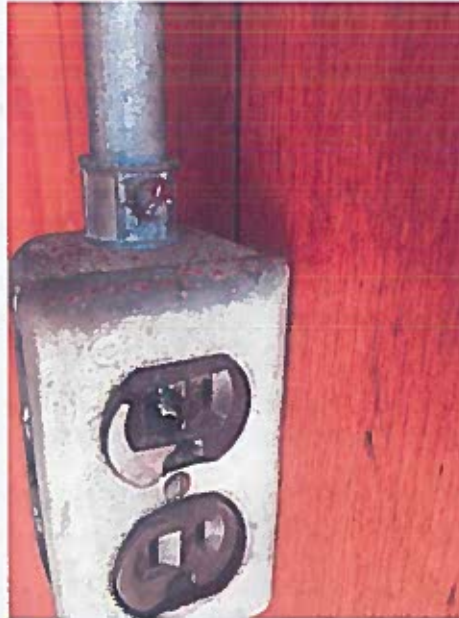
14. No convenience outlets were observed within 25' of exterior HVAC equipment.
15. There is a broken plug which needs replacement on wood panel wall, between the Apparatus bay and living quarters.
