# Structure Safety Report

## 2 Year Complete Topside and Underwater Element Inspection

DIVISION: 1 COUNTY: DARE STRUCTURE NUMBER: 270051 FREQUENCY: 24 MONTHS

SUPERSTRUCTURE: SINGLE 25'X11' ALUM. BOX CULVERT; 41'-6" ALONG CENTERLINE OF CULVERT

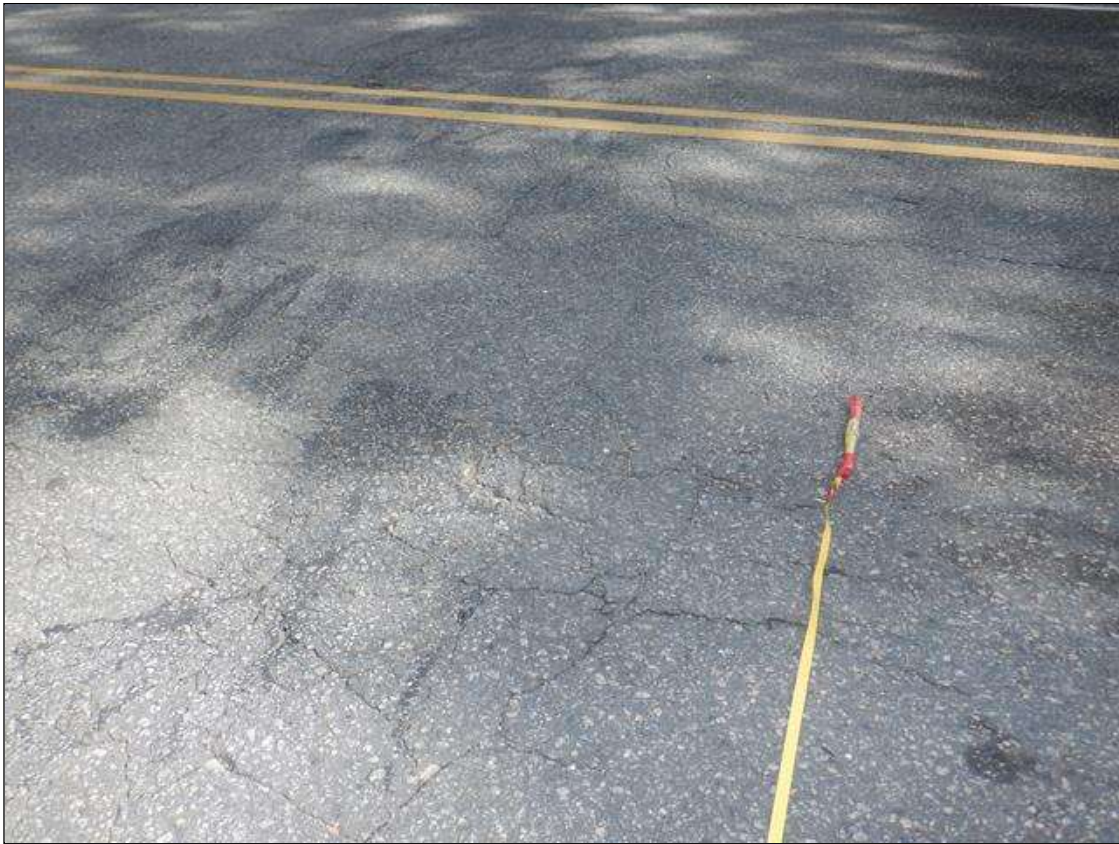
AWS - CRACKED TO 1/8" AND SETTLED TO 1"

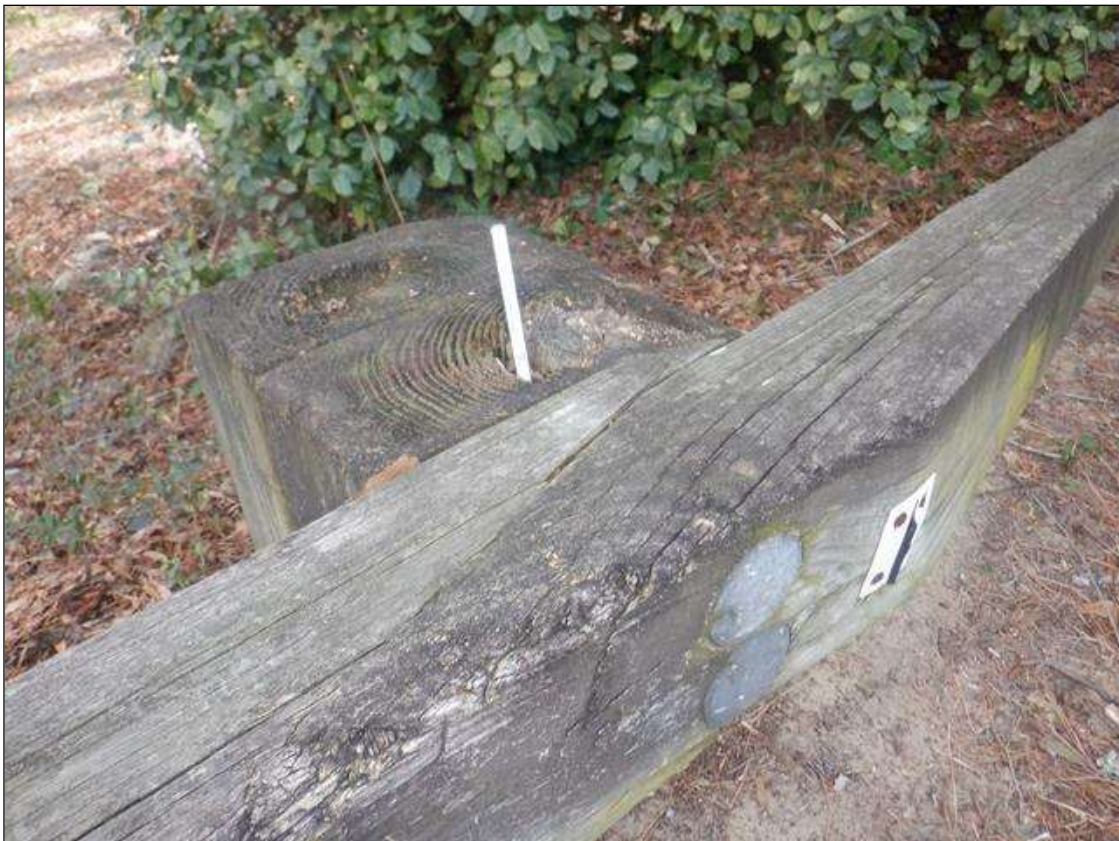
RAILING POSTS HAVE END DECAY TO 1" DEEP.

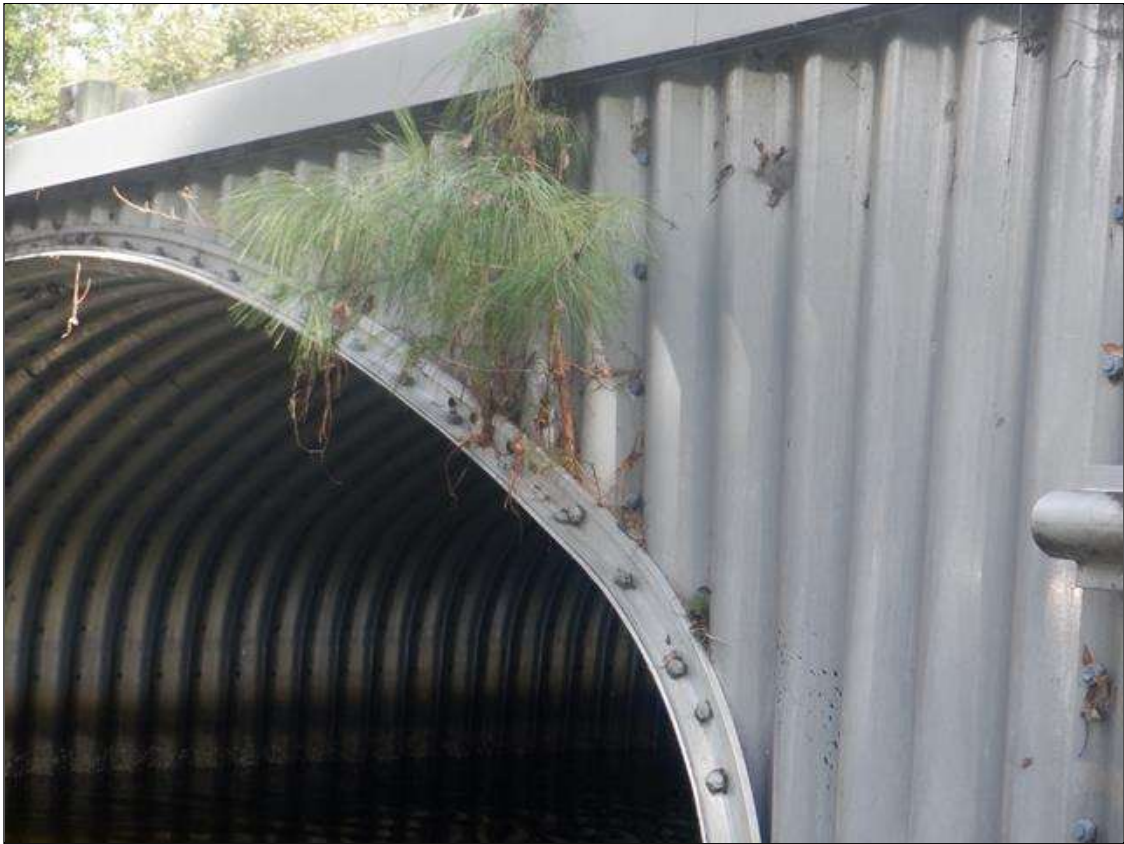
VEGETATION GROWING AROUND BOLT RING

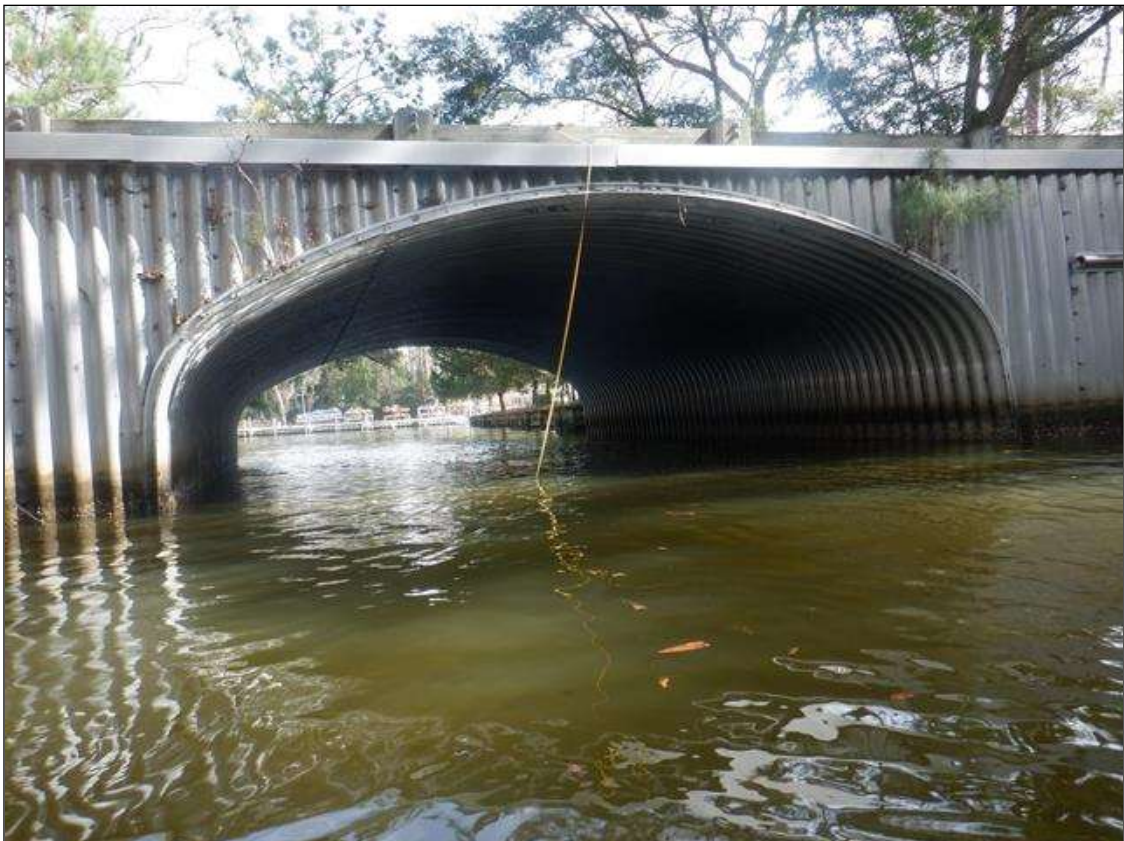
Element Number	Defect Type	Defect Description	CS	CS Qty	Maint Qty
243	Scour	PRIORITY ACTION REQUESTED - 2' VERTICAL EXPOSURE OF TOEWALL ON WEST END	3	1	1 Feet
243	Connection	SURFACE RUST ON CONNECTION HARDWARE FROM HIGH WATERMARK TO MUDLINE	2	41	41 Feet

Span 1 Culvert Section 1: PRIORITY ACTION REQUESTED - 2' VERTICAL EXPOSURE OF TOEWALL ON WEST END

3370	Maintenance and Repair of NBIS Pipes and Culverts	LF	1	Span 1 Culvert Section 1: PRIORITY ACTION REQUESTED - 2' VERTICAL EXPOSURE OF TOEWALL ON WEST END

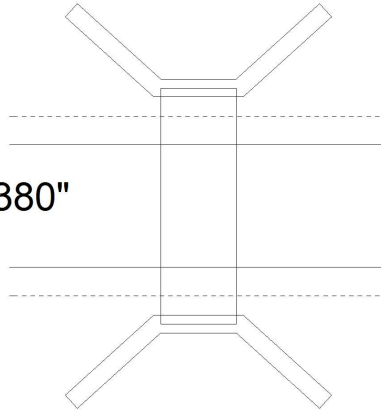
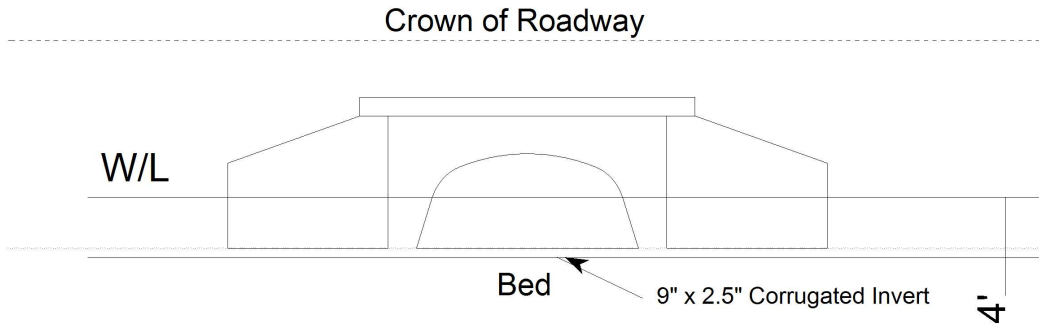
Barrel #	Width	Height	Distance From Scour at Inlet Previous Pipe	Scour at Outlet	Type
1	24.67ft	10.5ft	0	<b>2'</b>	Metal Box Culvert (Structural Plate)
