# JUNIPER/TRINITIE TRAIL CULVERT STRUCTURAL INSPECTION

September 2, 2014

Re: Juniper/Trinitie Trail Culvert

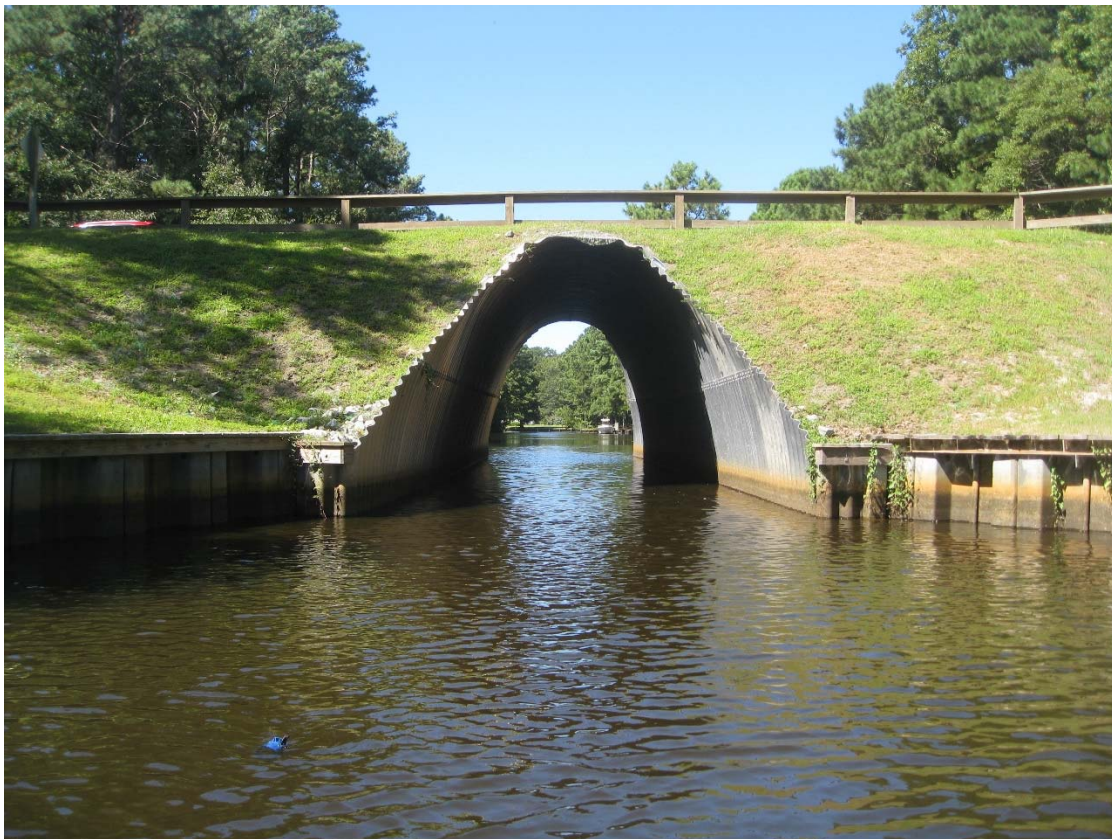
Photo 1  
Juniper/Trinitie Trail Culvert looking West

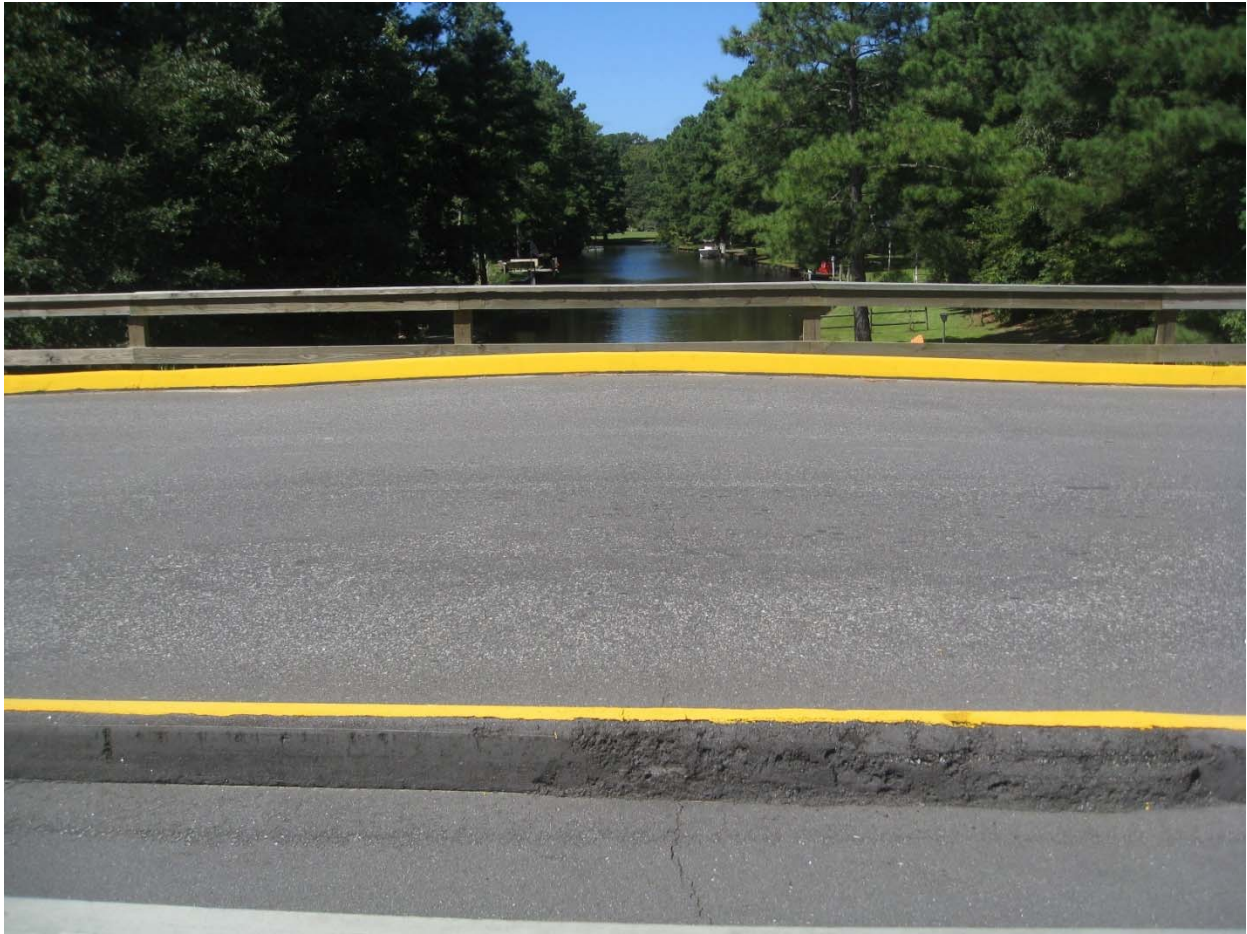
Photo 2  
Centerline of culvert looking West

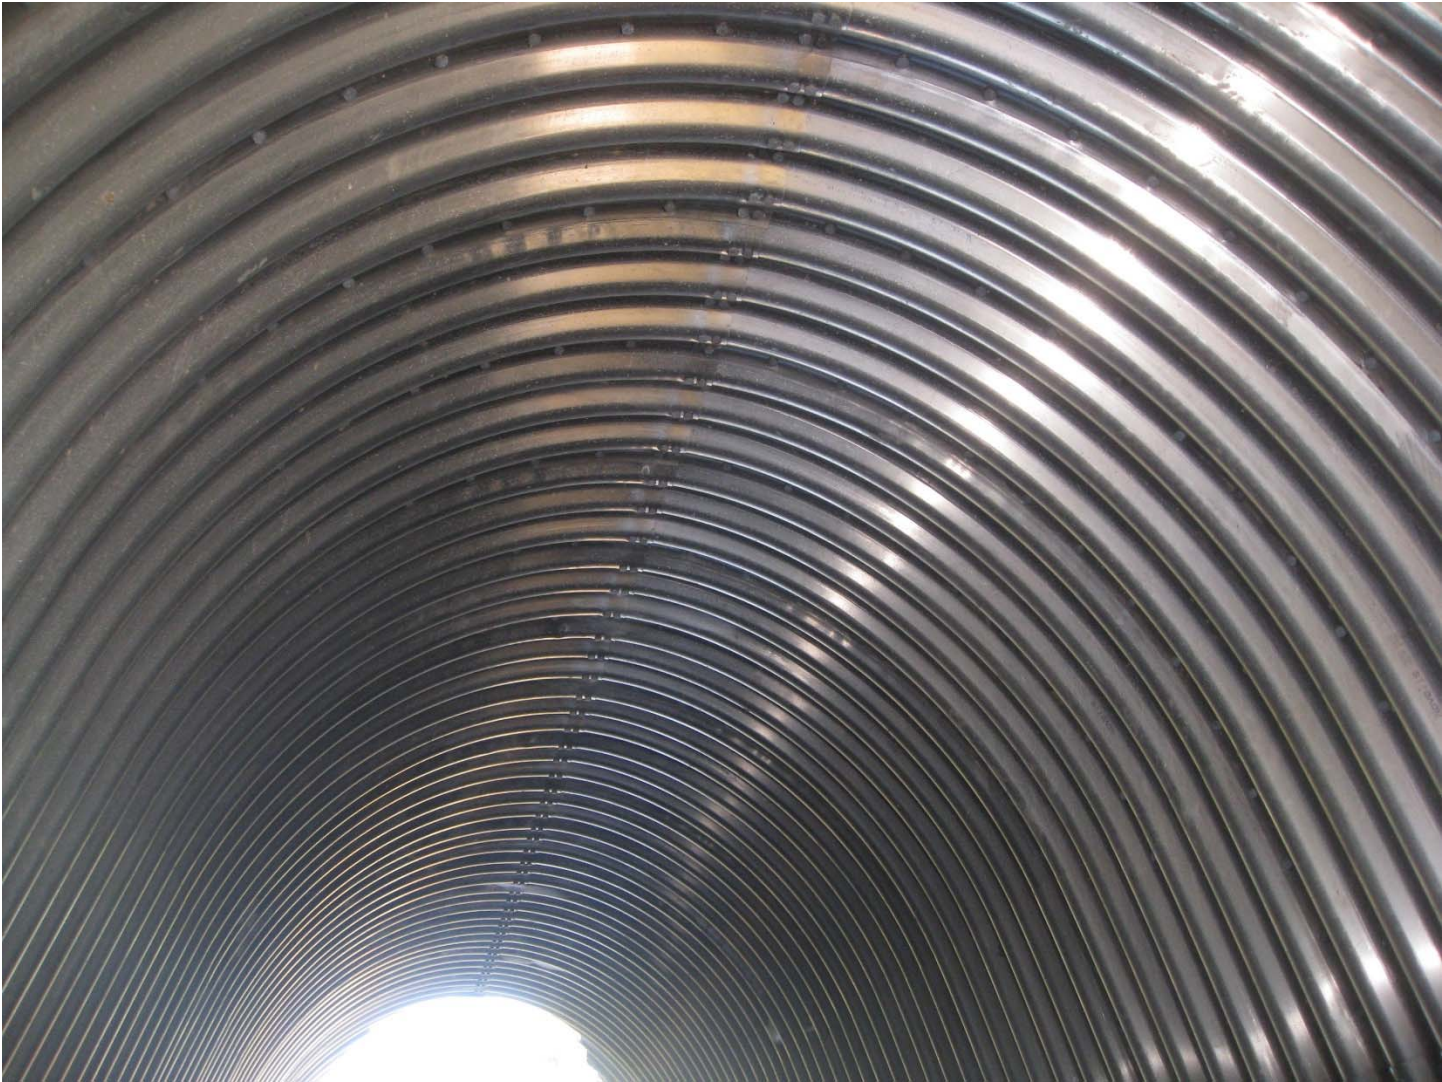
Photo 3  
Interior ceiling of the culvert looking West

No evidence was seen of erosion or soil migration from under the road bed into the canal or to the sides of the embankments. The interior of the culvert was inspected and it looked clean, no soil migration was observed anywhere around the culvert or embankments.

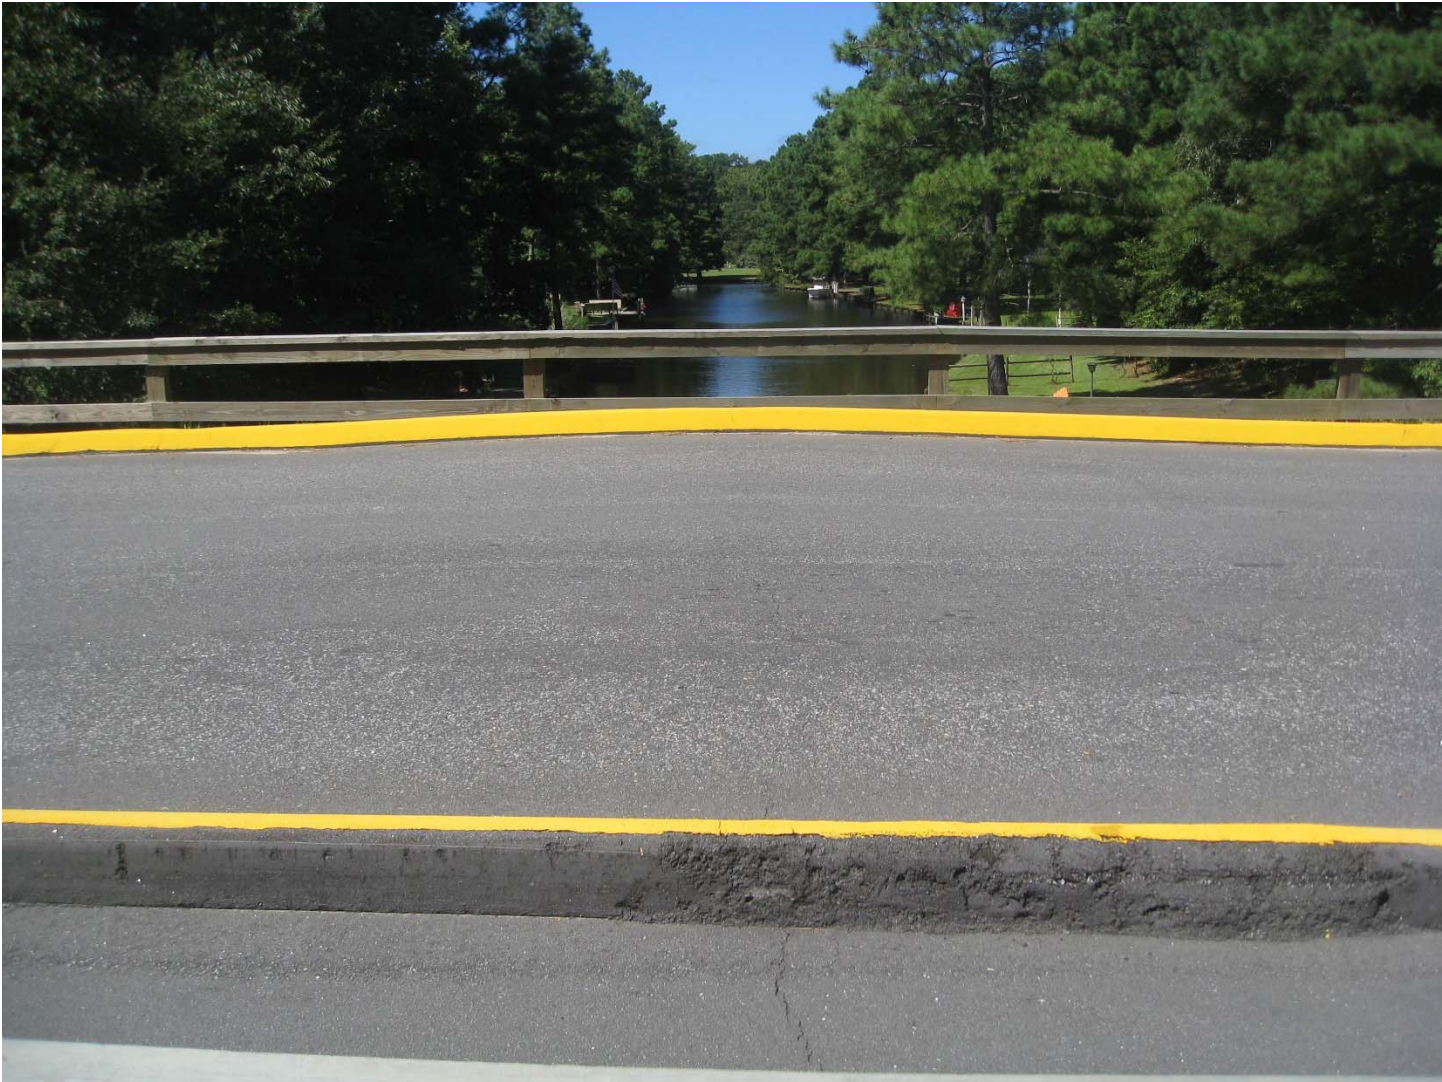
Photo 4

Centerline of culvert looking West with a stress crack visible in the center foreground from the adjacent settlement

In addition, the cracks in the roadway across the centerline of the culvert shall be sealed so as to prevent water migration from further undermining the AC foundation as shown below.

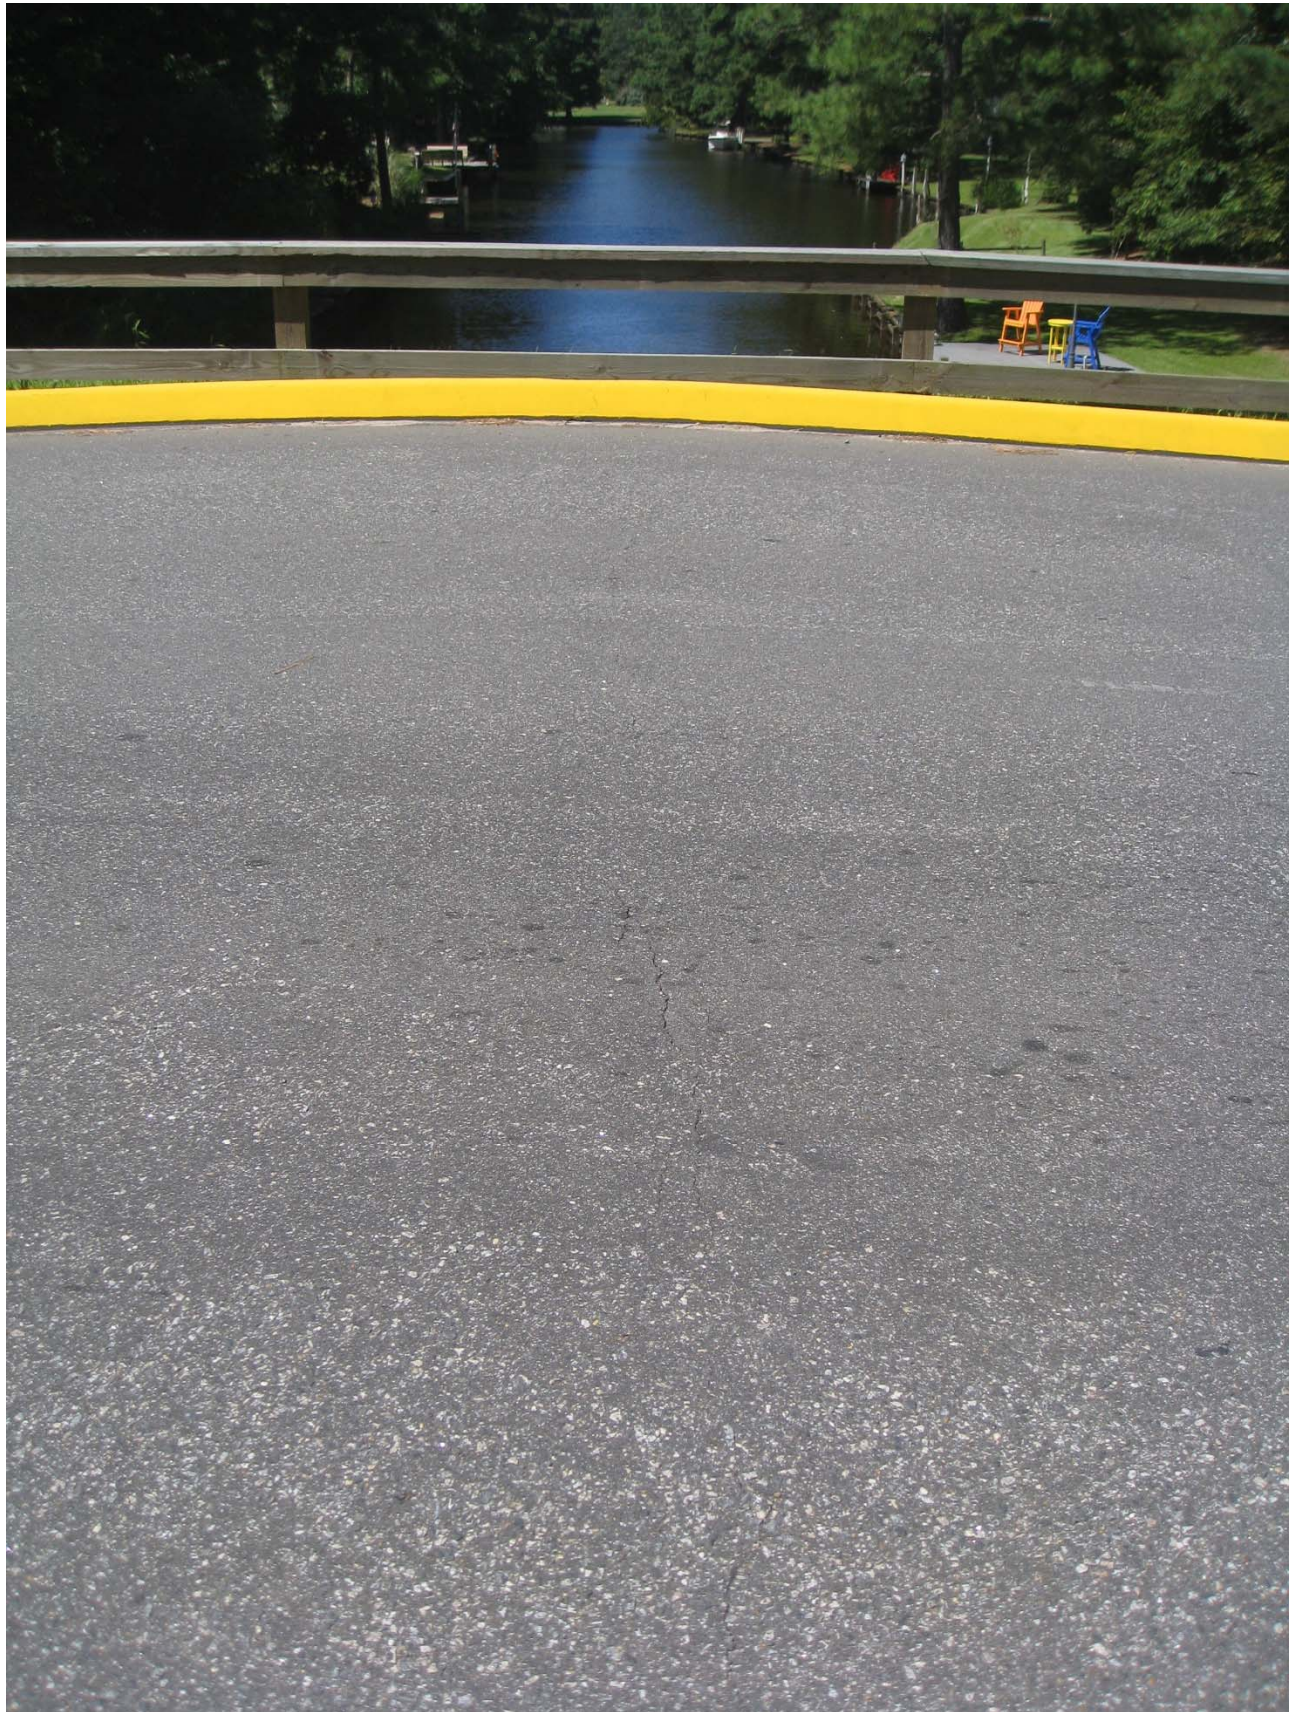
Photo 5

Continuous cracks are difficult to see in the photo above but extend the full width of the roadway at the culvert centerline as the adjacent portions of the roadway settle.

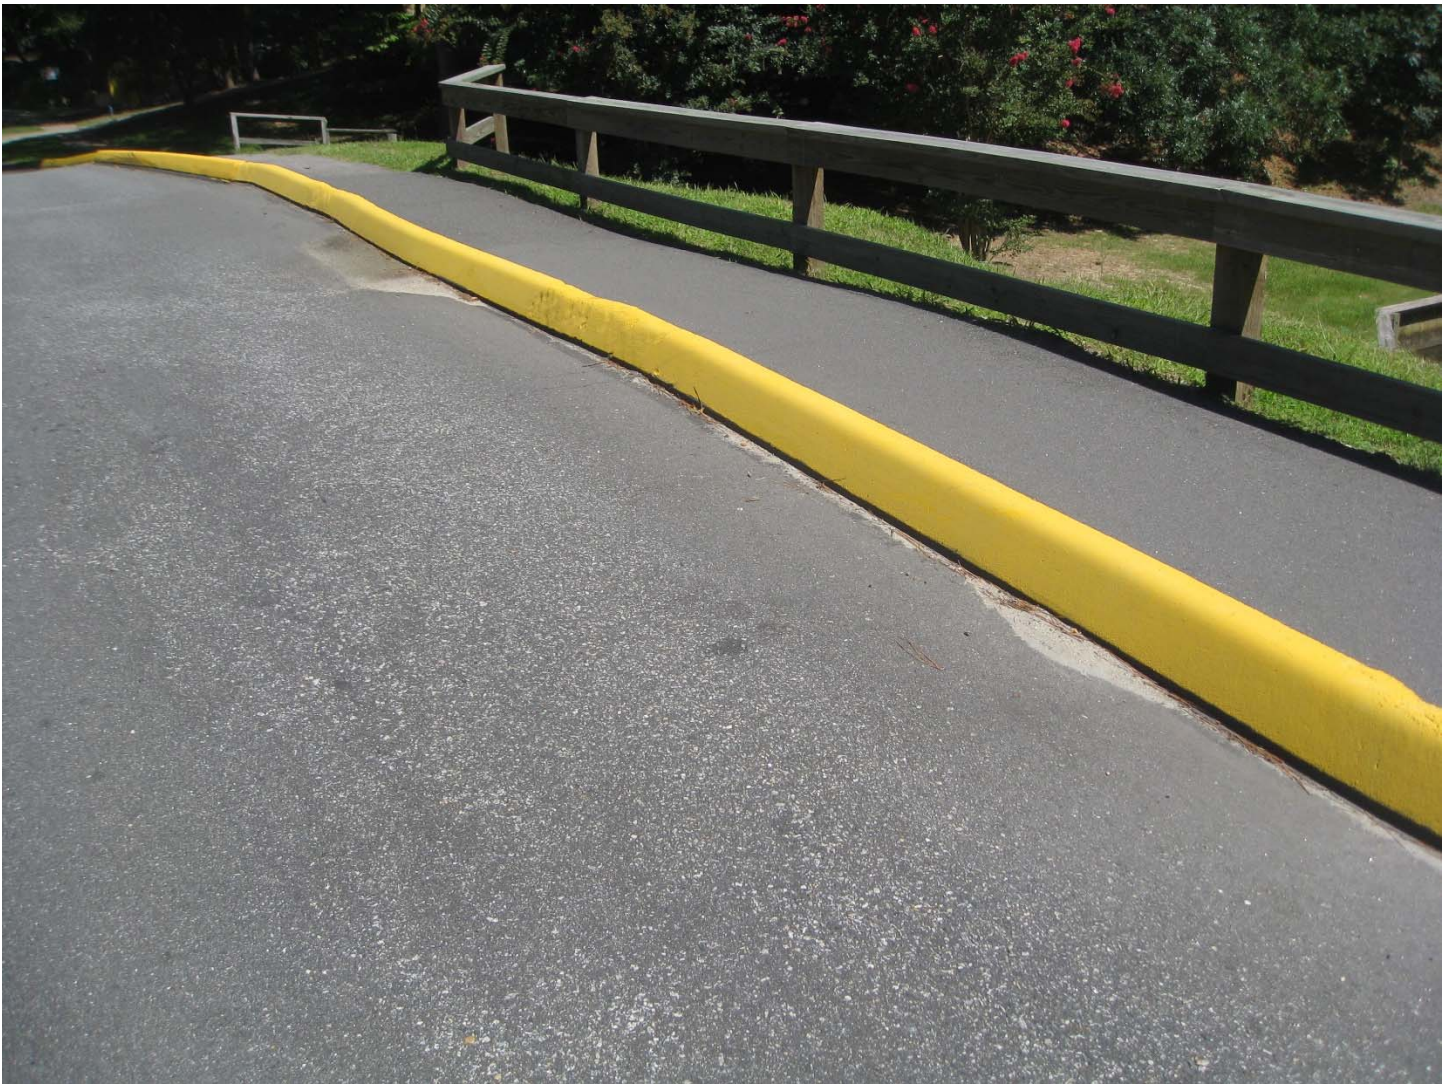
Photo 6

Evidence of ponding in the depressed areas is evident where areas of sand and sediment have accumulated and settled along the yellow curb.

The differential settlement (greater in some areas than others) has resulted in two, consecutive, significant and noticeable dips. These are present on each side of the culvert centerline and are spaced about twenty-four feet on center or about twelve feet from the culvert centerline. Consequently, a "BUMP" sign has been posted to alert motorists. There are numerous potential causes for this differential settlement including the five detailed and discussed below.

The settlement is likely due to several of the above-mentioned factors including natural settlement. While soil borings may provide some additional insight into the root causes of the settlement, a full depth repair/dig out of the existing AC and base material is the most sensible course of action to take at this time.

The material in the area needs to be repaired and removed to a depth as deep as necessary to reach firm support (by definition typically a minimum of 4 inches). This may entail removing some of the subgrade. The excavation should also extend horizontally a minimum of at least one foot into the “good” (non-depressed) pavement surrounding the area to be patched. This equates to a removal section of eight feet in length for the full width of the roadway at each recessed area. The area to be removed shall be outlined on the pavement with paint. A pavement saw shall be used to make neat rectangular cuts. The outlined area of the asphalt surfacing to be removed shall be saw cut to a depth of not less than 0.15 ft (45 mm) before removal.
