BEACH NOURISHMENT PUBLIC FORUM

TOWN OF SOUTHERN SHORES NORTH CAROLINA

Essential Data Collection Monitoring & Design Elements for Beach Maintenance & Planning

COASTAL SCIENCE & ENGINEERING

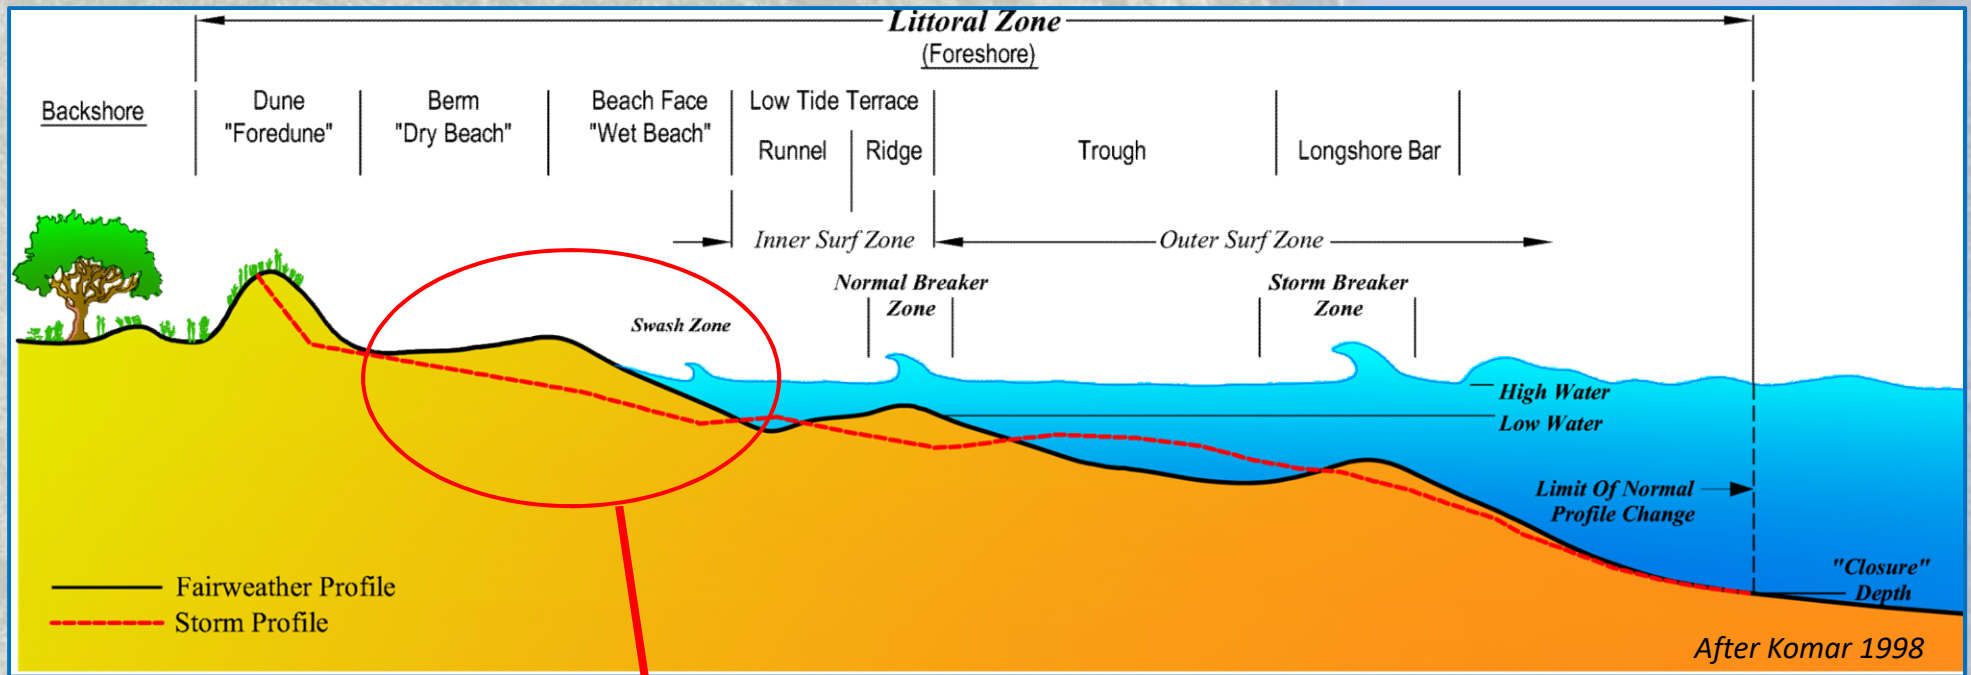
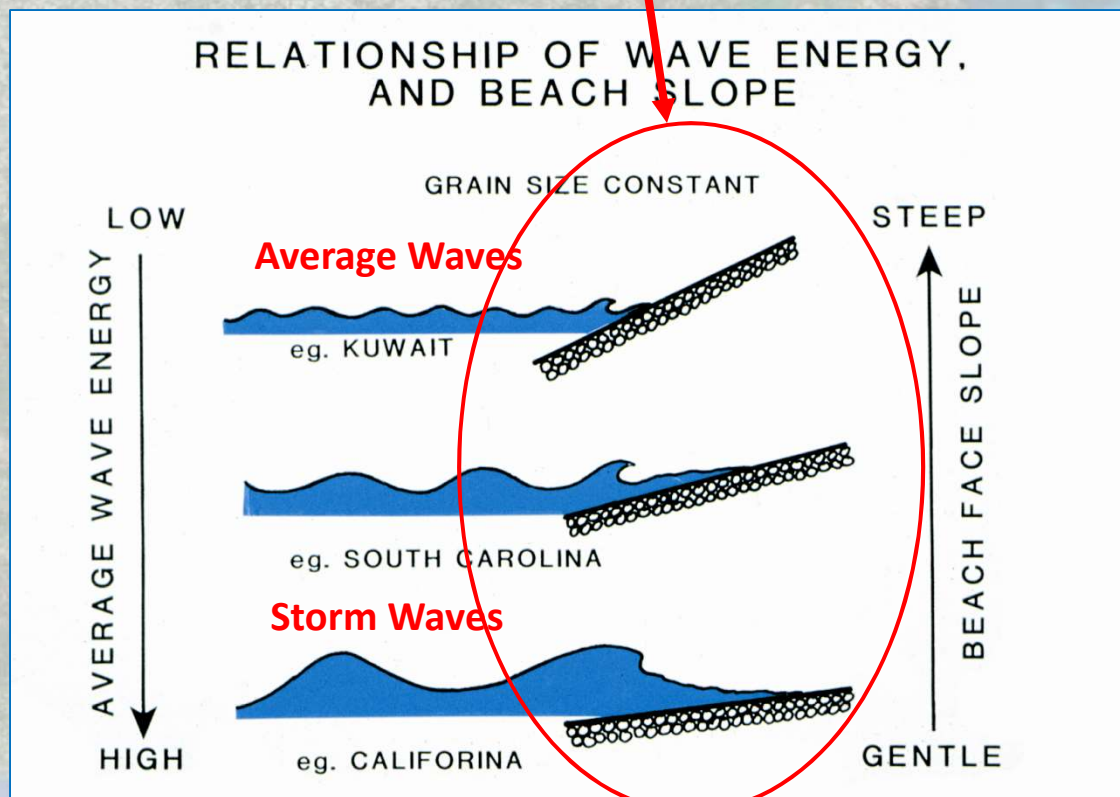
Beach Profile – The Shore Zone That Absorbs Breaking Waves

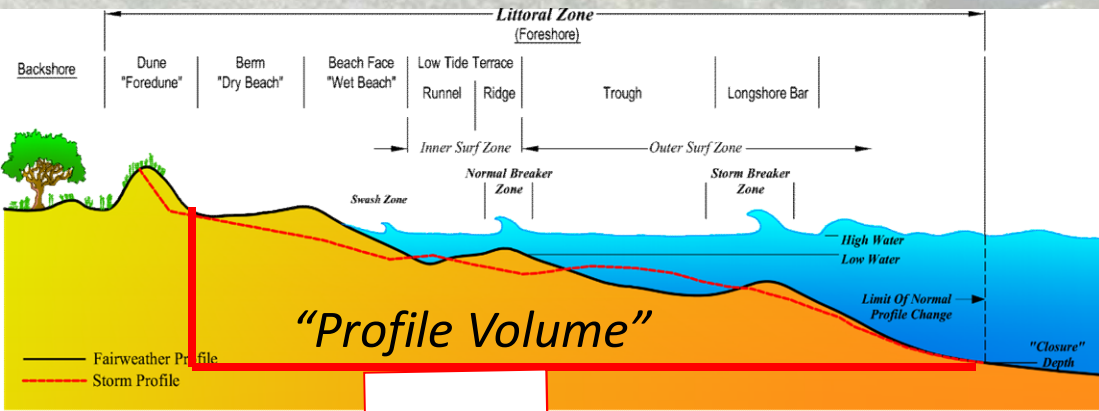
Equilibrium Profiles

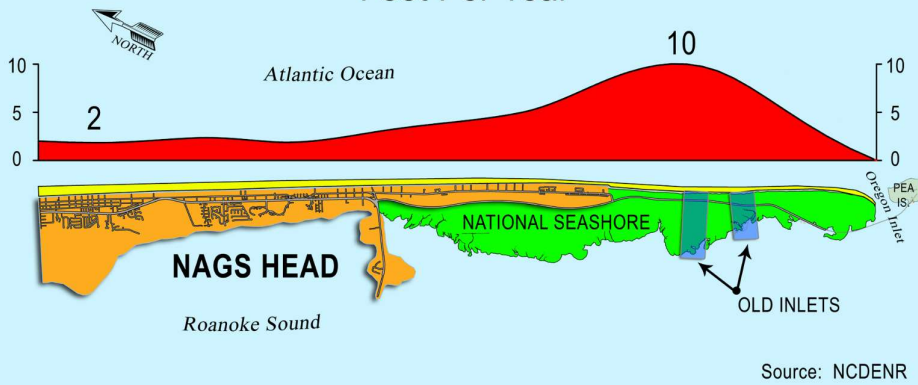
50 Year Erosion Rate Feet Per Year

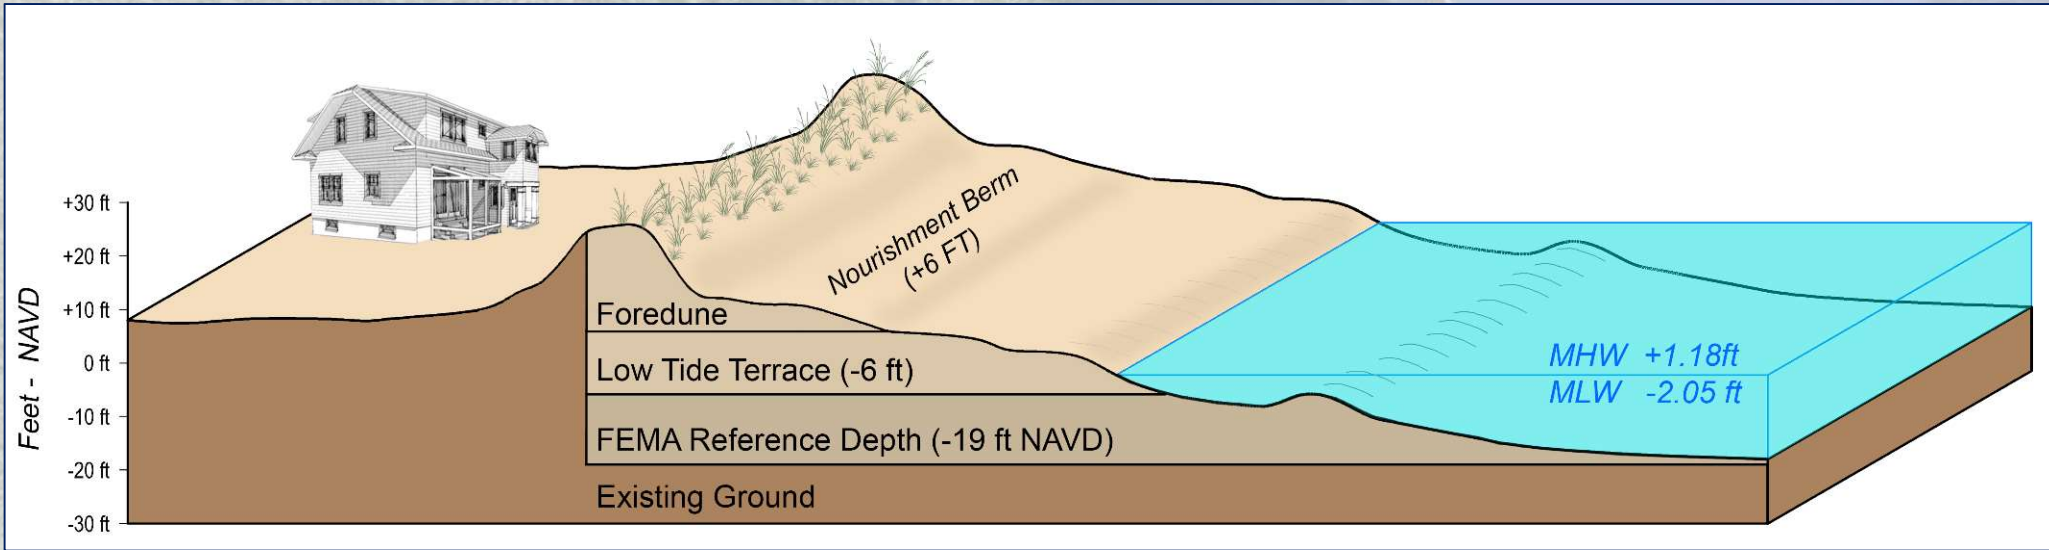
Beach Condition Analysis – “The Littoral Sand Box”

Lens 1 – *Foredune* – From the ~crest of dune to +6 ft NAVD*

Lens 2 – *Beach* – Between +6 ft and -6 ft NAVD

Lens 3 – *Underwater* – Between -6 ft and -19 ft NAVD

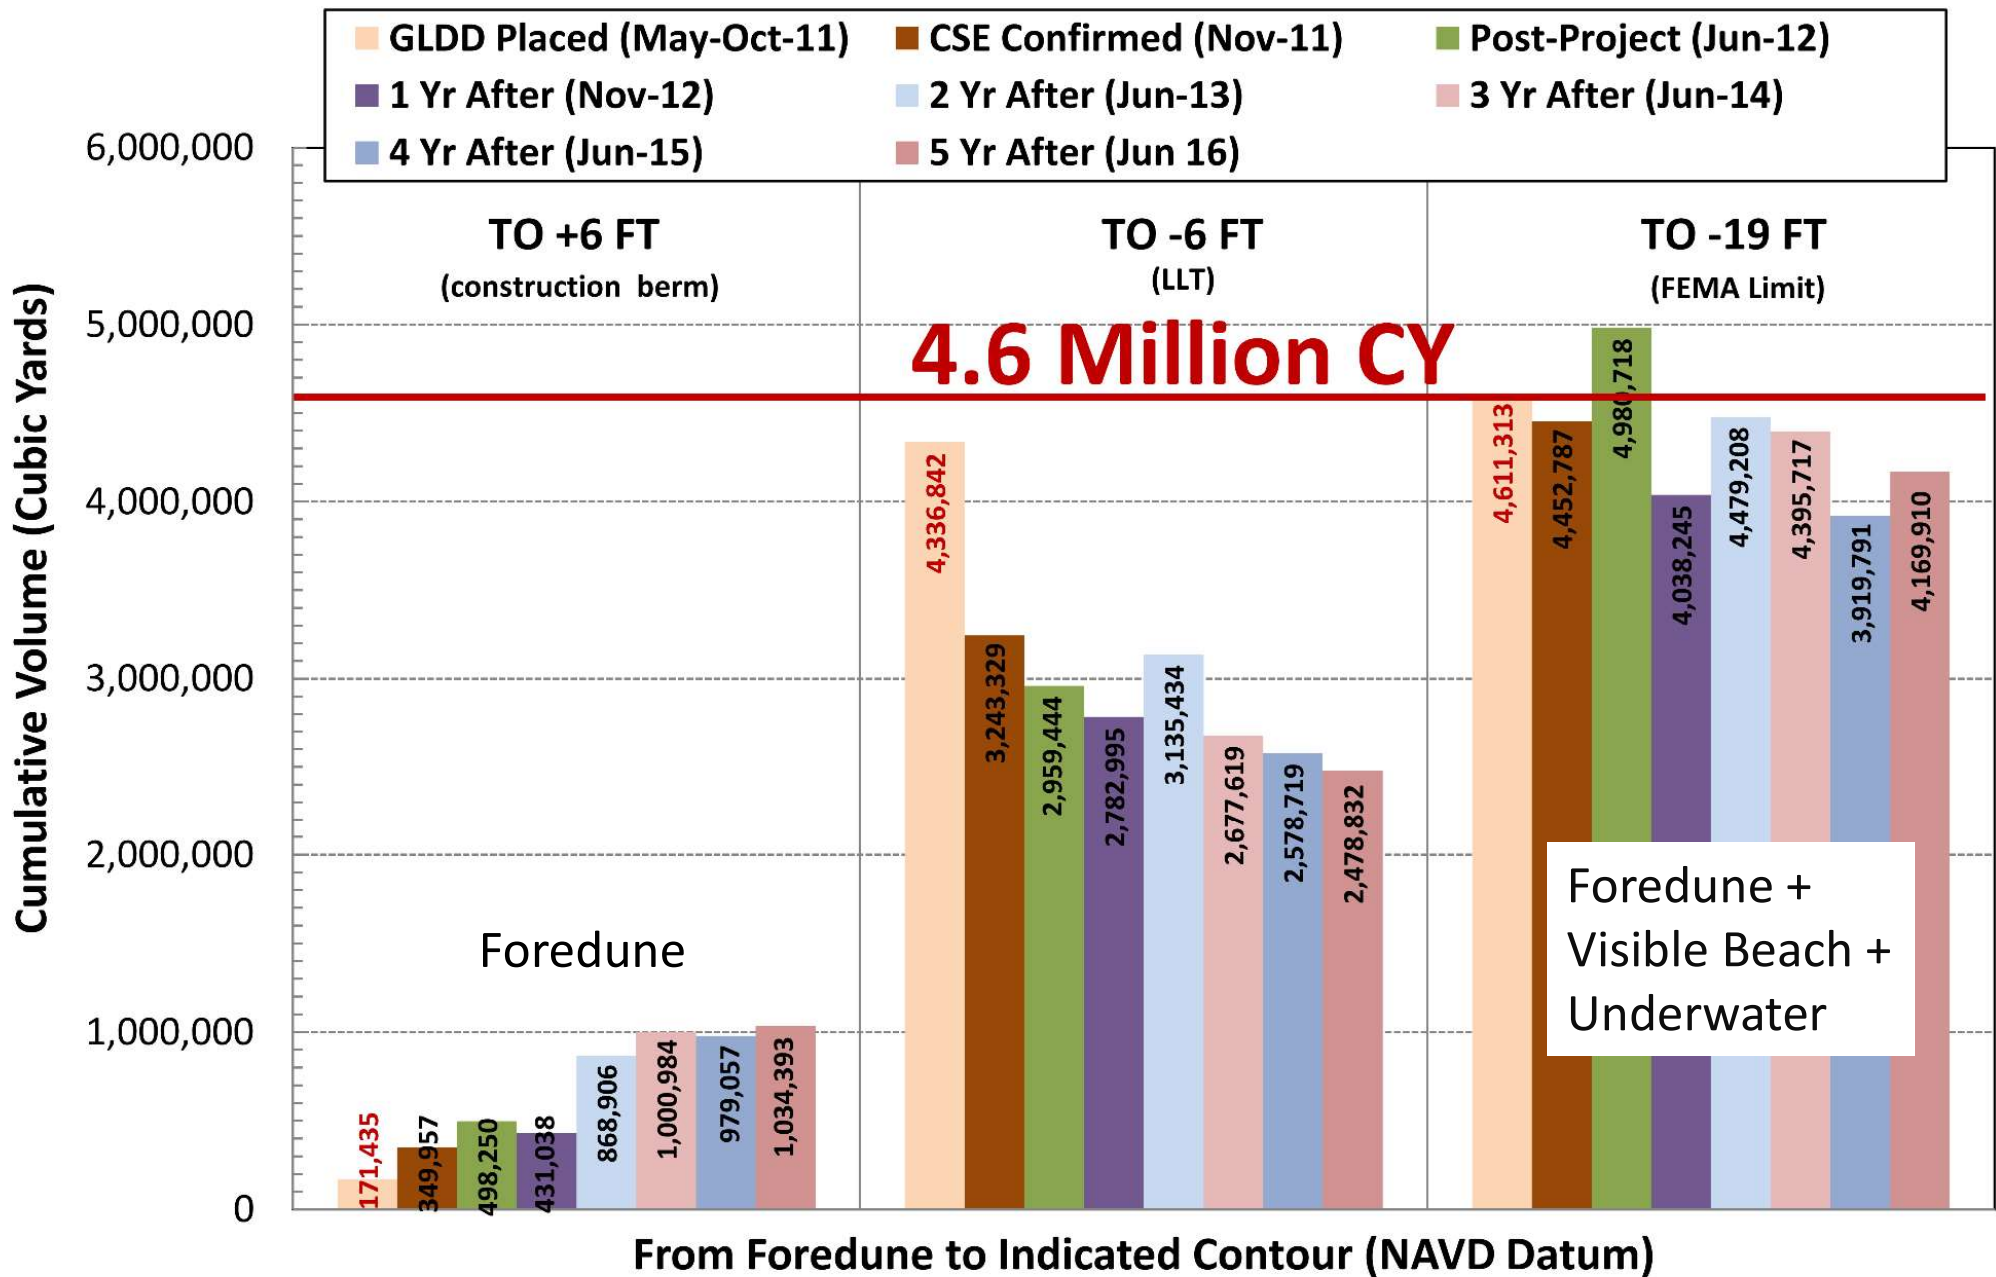
Nags Head Cumulative Beach Volume Changes (Relative To November 2010 - Pre-Project)

Net Losses

November 2011
through June 2016

~10%

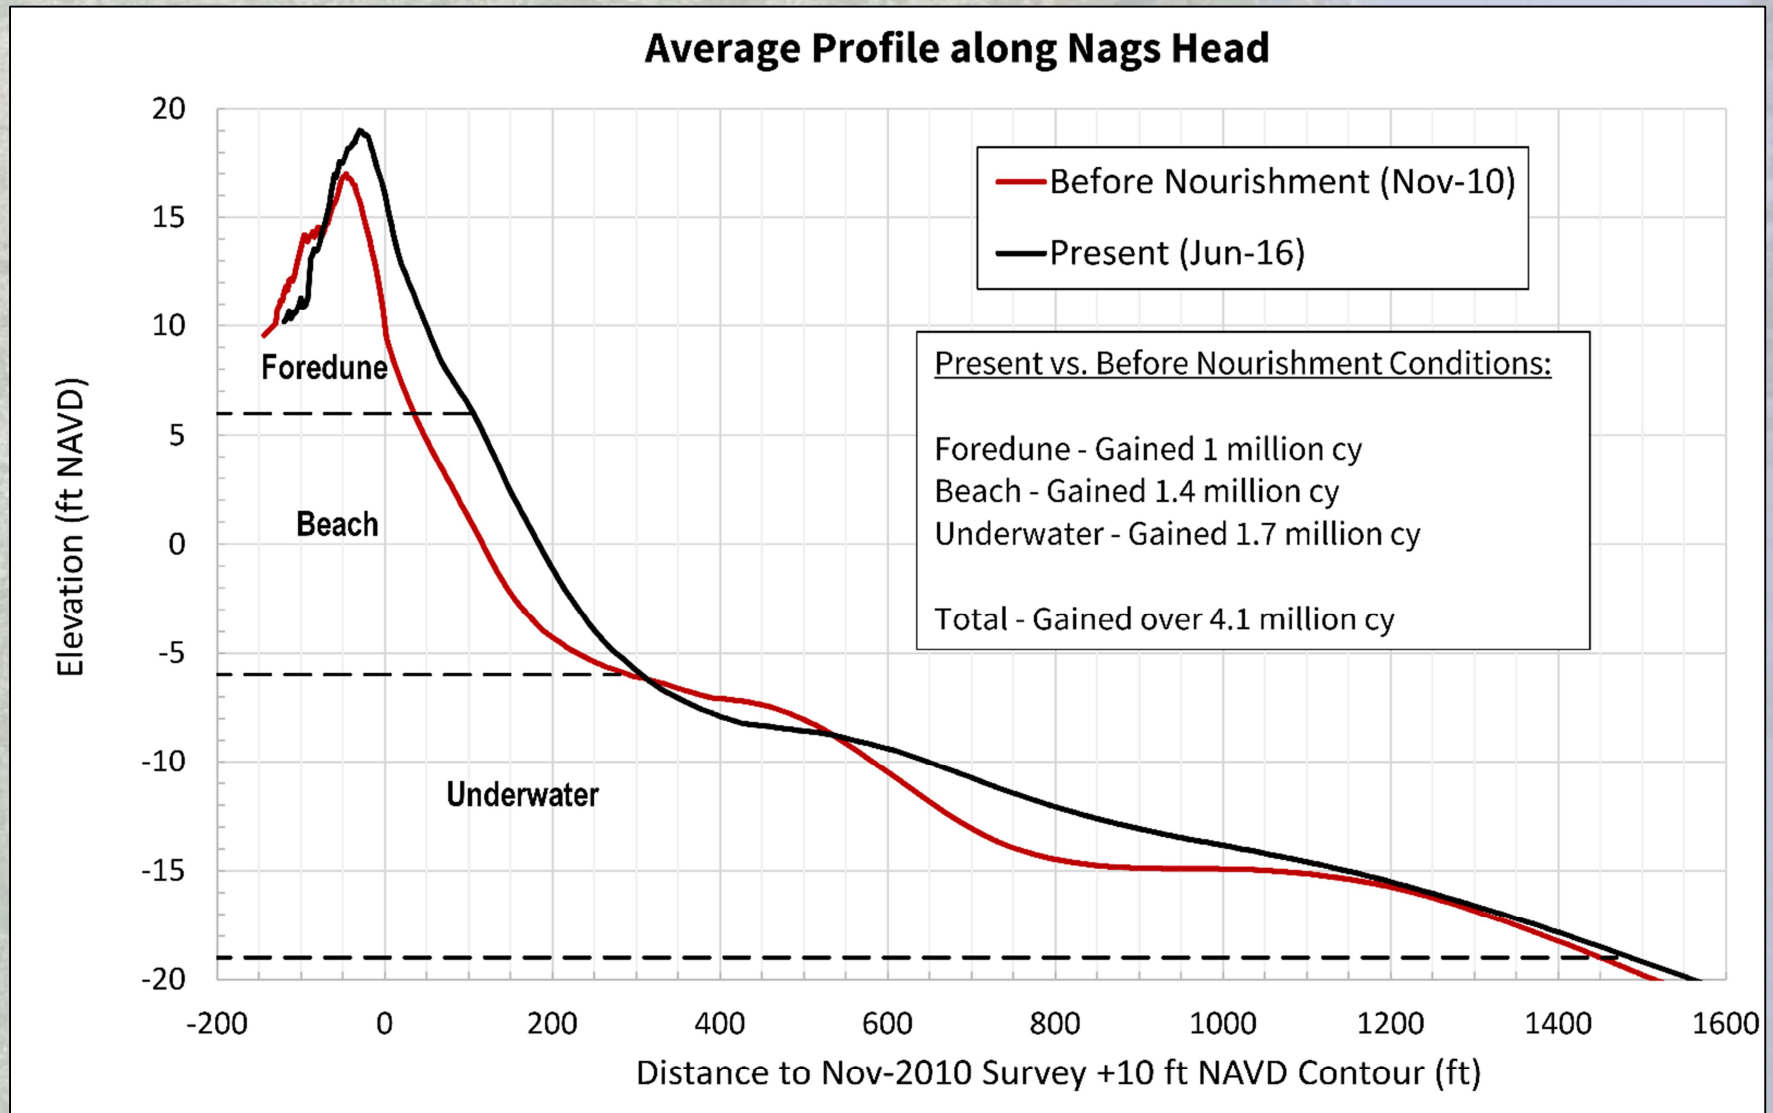
Nags Head Average* Profile Evolution

- Higher & Wider Foredune
- Greater Underwater Volume
- Similar Dry Beach Width

*Calculated from the +10 ft NAVD contour (n= 104)

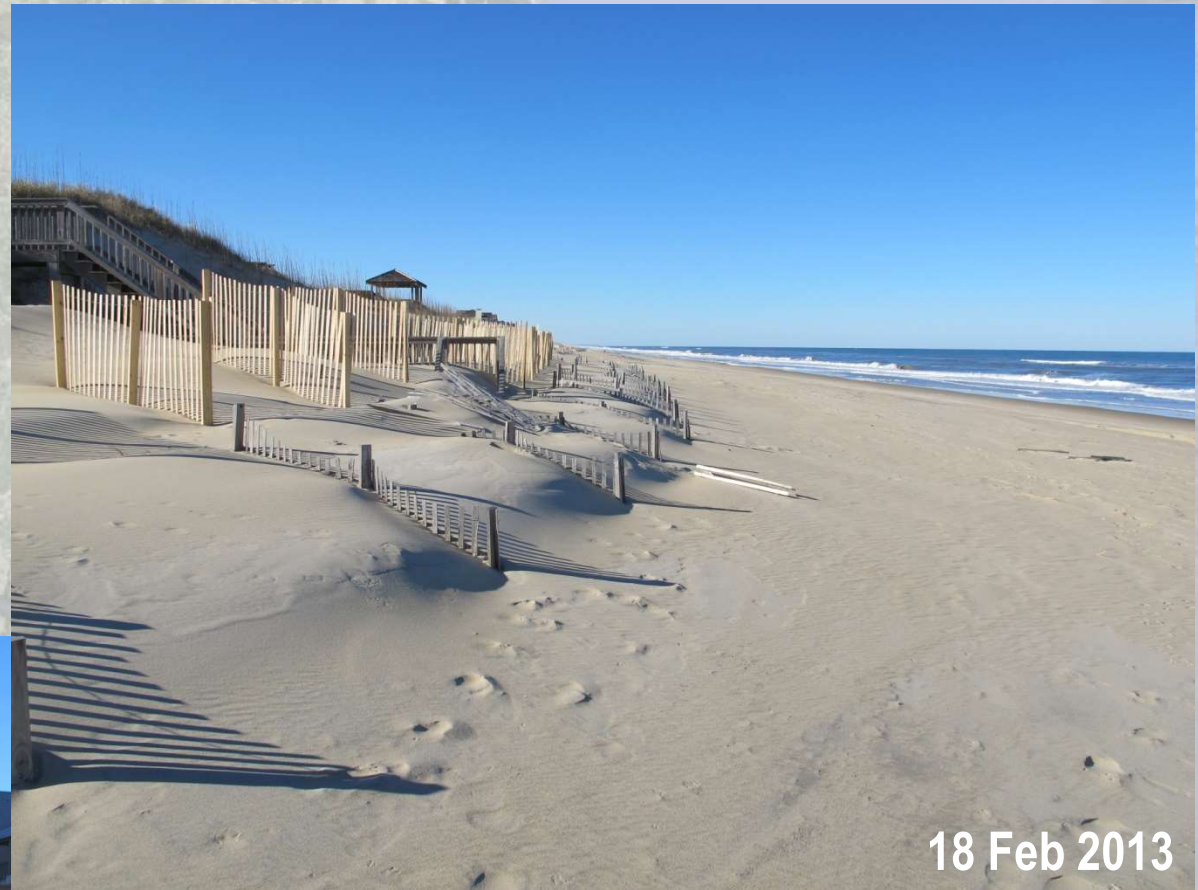
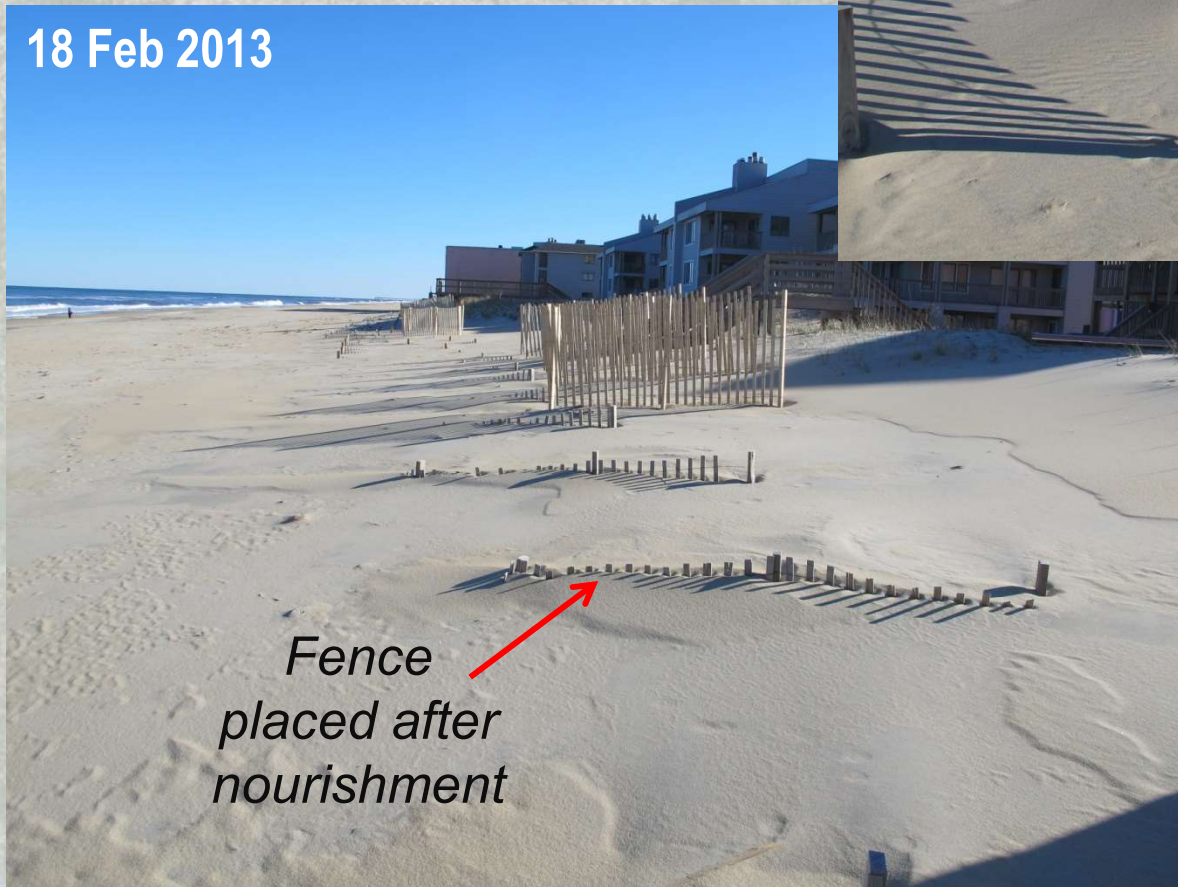
18 Feb 2013

Natural Dune Growth

After 4 years – Over twice the volume that FEMA typically approves for emergency repairs after storms

*Fence
placed after
nourishment*
