**TOWN OF SOUTHERN SHORES NORTH CAROLINA
BEACH ASSESSMENT REPORT**

APTIM COASTAL PLANNING & ENGINEERING OF NORTH CAROLINA, INC.

March 2018

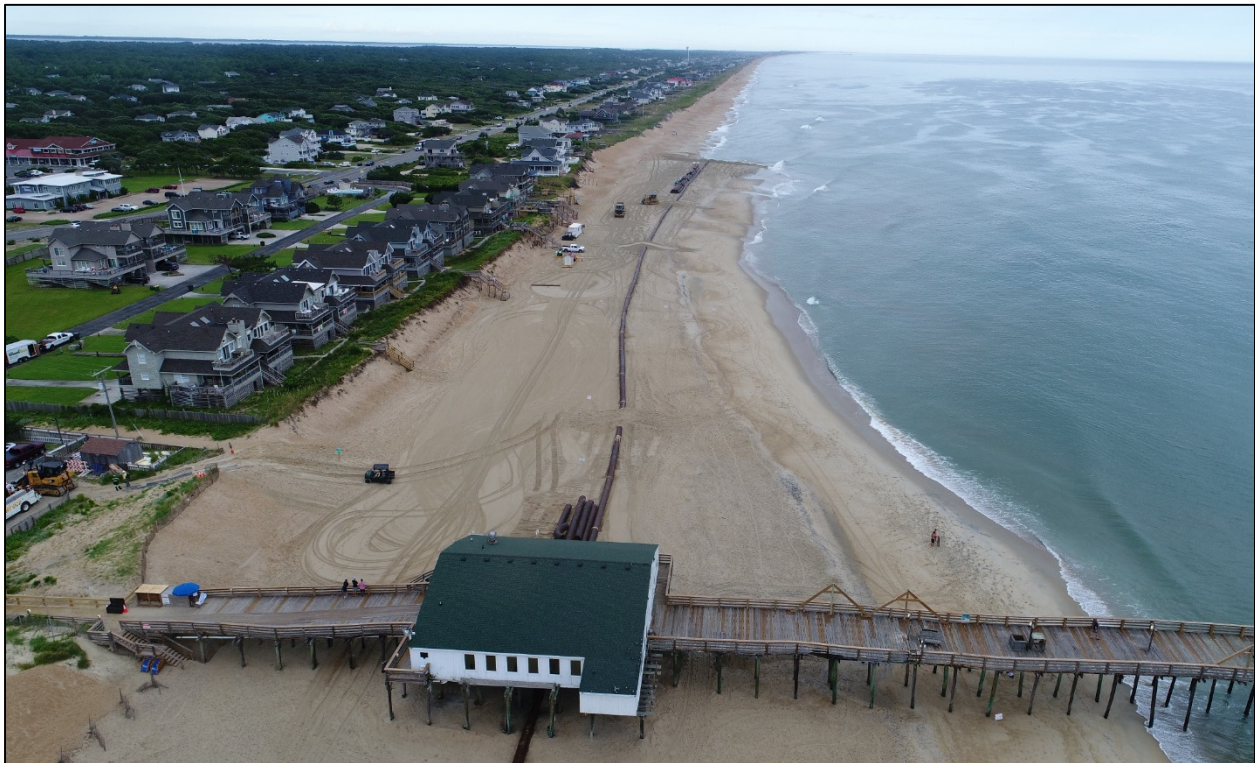
Figure 7. Aerial photo looking north along the Southern Shores Beach Nourishment project on August 4th, 2017.

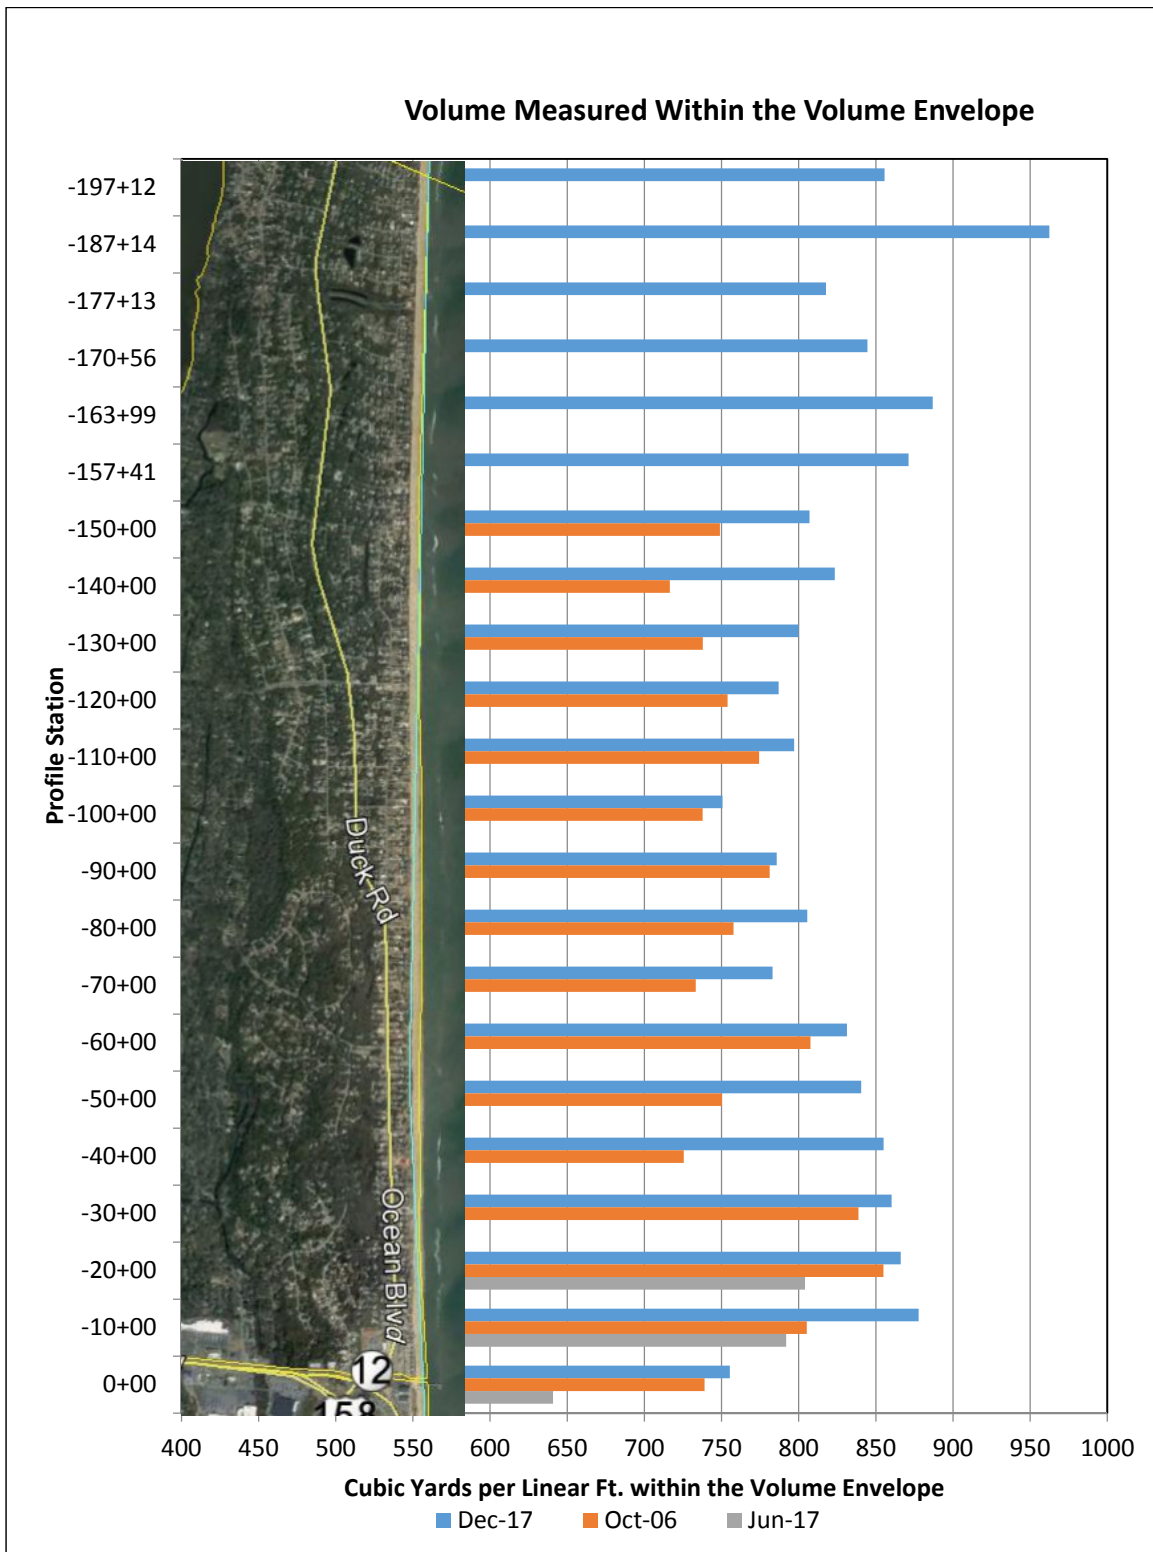
Figure 16. Beach profile cross section illustrating the volume envelope.

Figure 16 shows the volume measured within the volume envelope along each of the 22 Southern Shores profiles surveyed in December 2017. The average volume within the envelope measured along all 22 profiles in December 2017 was 830 cy/ft. The data represented in Figure 16 suggests that the area from Station -150+00 (located near 3rd Ave.) to Station -70+00 (located approximately 500 ft. south of where Ocean Blvd. and Duck Rd. meet), is relatively less than the portions of Southern Shores to the north and south of this section. The average volume within the envelope measured along the nine (9) profiles from Stations -150+00 to -70+00 is 793 cy/ft. The average volume within the volume envelope measured along the six (6) profiles to the north from Stations -197+12 to -157+41 was 873 cy/ft. and the volume measured along the seven (7) profiles to the south from Stations -60+00 to 0+00 is 841 cy/ft.

Figure 16 also shows the volume measured within the volume envelope along profiles surveyed by the USACE FRF in 2006 and along profiles surveyed by Great Lakes Dredge and Dock in June 2017. As previously mentioned, comparison of the volume present in October 2006 and the volume present in December 2017 shows all profiles had more volume within the volume envelope in December 2017 than were present at the time of the October 2006 survey. However, a comparison of the volume within the envelope in the Fill Area in June 2017 prior to the beach fill project, shows each of these three profiles had less volume than was present at the time of the October 2006 survey.

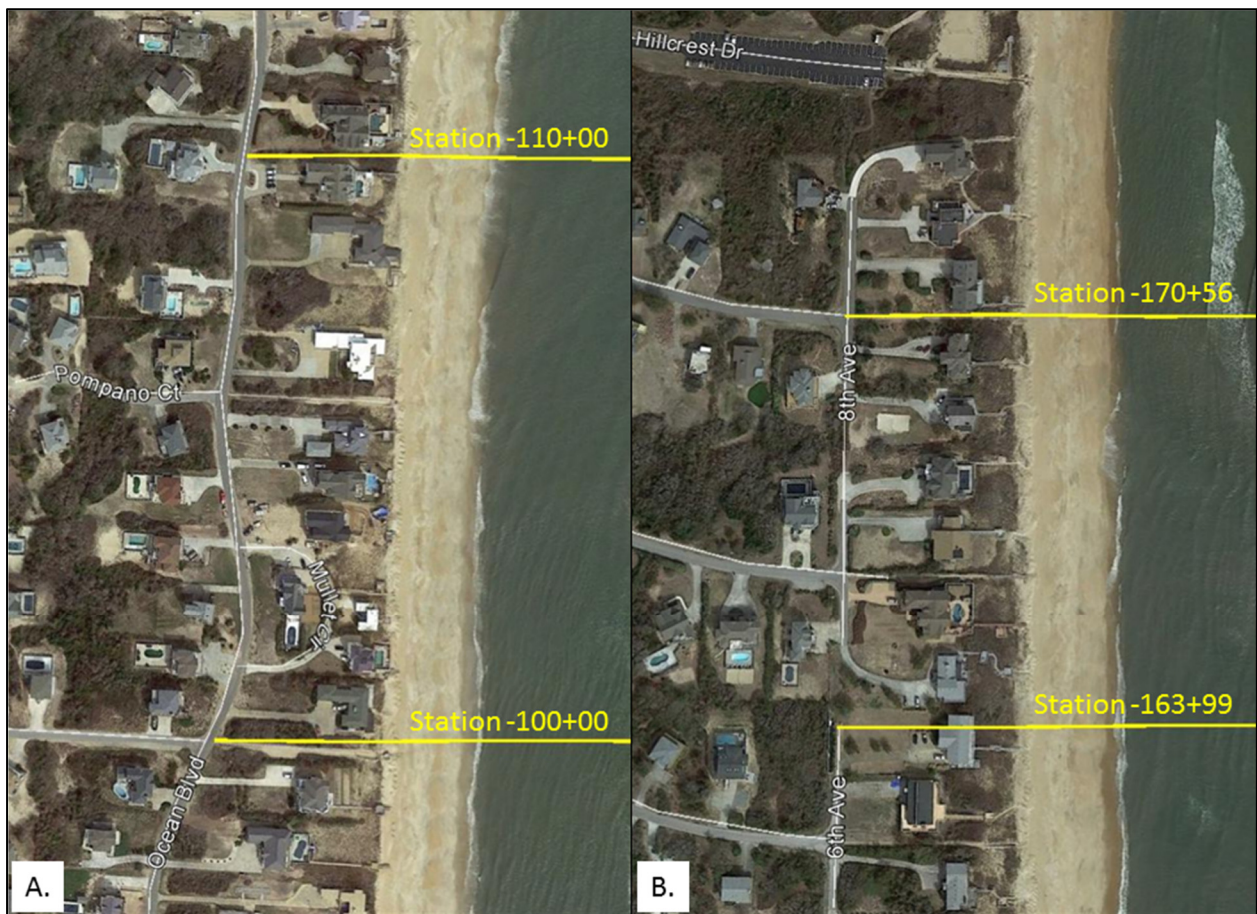
Figure 17. Google Earth Images from March 2017 showing the relatively minimal setback of structures from the vegetation between Stations -110+00 and -100+00 (A.) and the relatively greater setback of structures from the vegetation between Stations -170+56 and -163+99.

A qualitative assessment of the distance structures are set back from the vegetation line was made using publicly available satellite imagery from Google Earth. A visual examination of imagery from March 2017 shows that houses are generally situated closest to the vegetation line between Stations -140+00 and -100+00 and along the very southern part of the Town between Stations -10+00 and 0+00. Houses located between Stations -157+00 and -140+00 and Stations -100+00 to -70+00 generally appear to have a relatively moderate setback. The area north of Station -157+00 and between Stations -40+00 and -20+00 appear to have the greatest setback from the edge of vegetation. Figure 17 shows examples of the comparison of the relatively minimal setback of structures between Stations -110+00 and -100+00 and the relatively greater setback of structures between Stations -170+56 and -163+99.
