SOUTHERN SHORES VOLUNTEER FIRE STATION: EXISTING FACILITY ASSESSMENTS & PROGRAM NEEDS

South Station Located at 15 S. Dogwood Trail, Kitty Hawk, NC 27949

East Station Located at 28 E. Dogwood Trail, Kitty Hawk, NC 27949

3 Jan. 2017

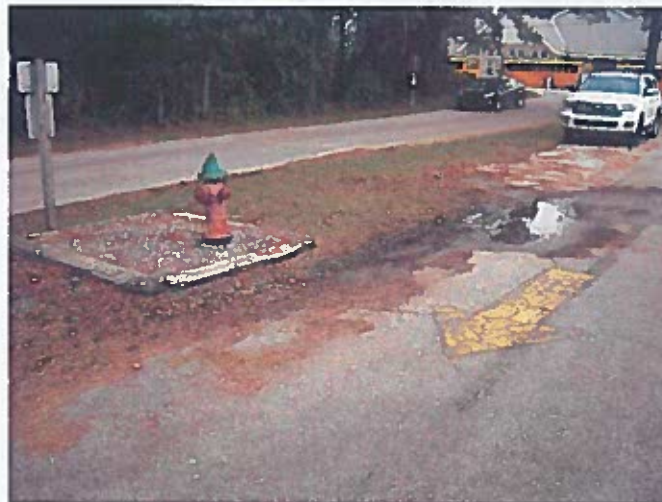
The hydrant needs a concrete pad as a working surface. Site drainage needs to be improved to eliminate ponding water.

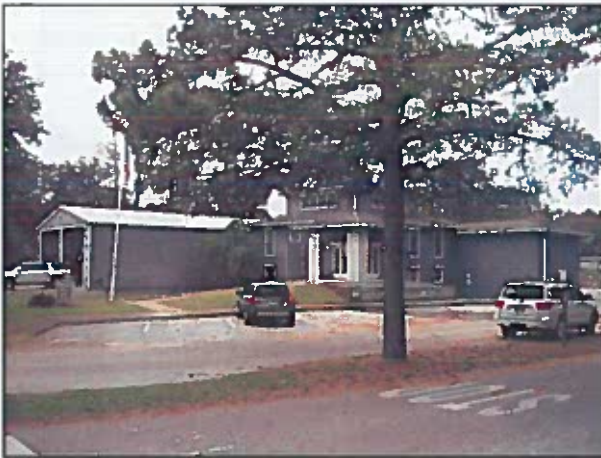
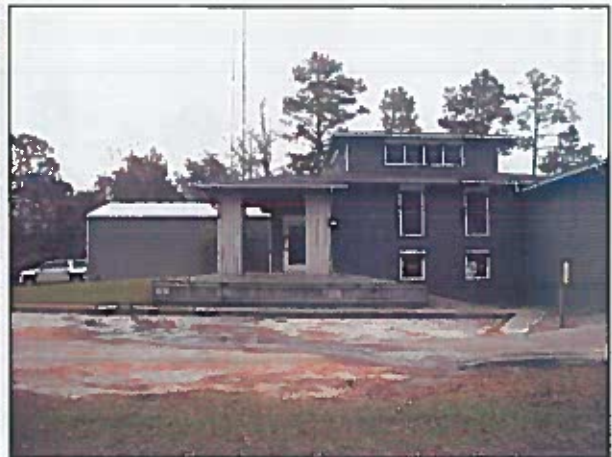
Although there is a flag pole, it is leaning at an angle.

Exterior doors and windows provide daylight and ample access to facility, but they look to be residential and not commercial quality. They have storm shutter boxes above openings due to the location along the coast. No complaints about the shutters were stated at the time of the assessment.

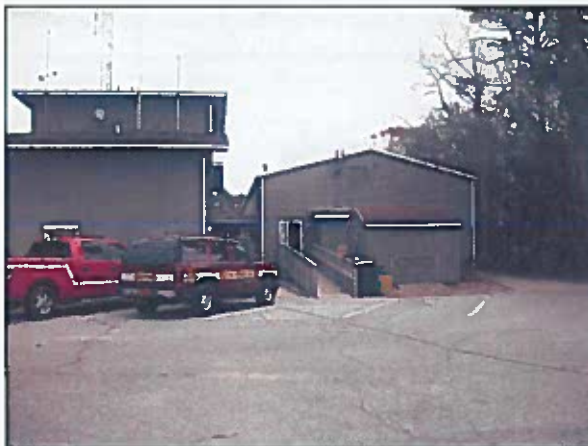
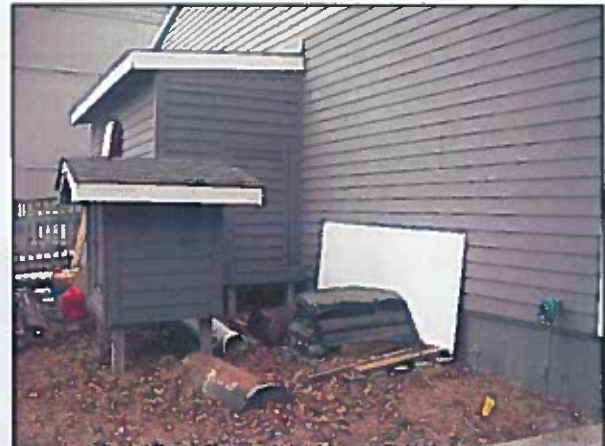
The west elevation also has the tool shed unattached to main building, next to the ADA ramp, with wood plank ramp to barn doors. Behind the tool shed is the bump out tool room accessed from inside the rear of apparatus bay. Above the tool room is the mechanical louver and exhaust chimney.

There is a lack of adequate storage, which leads to the open storage of materials and equipment on site.

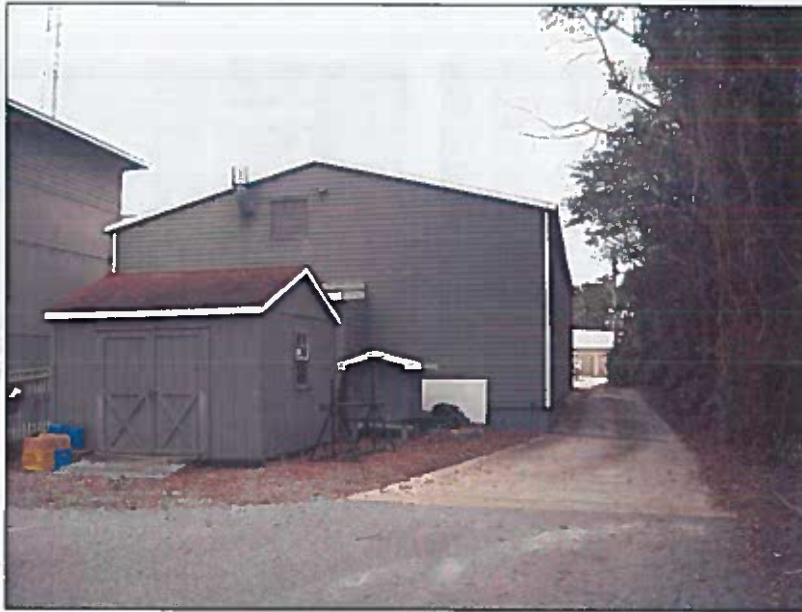
South Elevation – Along the south elevation, there are no windows or doors. A narrow vehicle access route around the southern elevation, between apparatus bay and property edge, is the only element of comment.

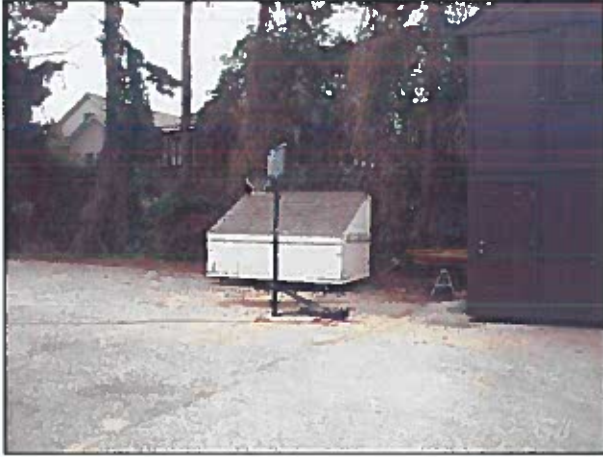
Training Props- The site currently has Fire training props that will need to be incorporated in the site design options.

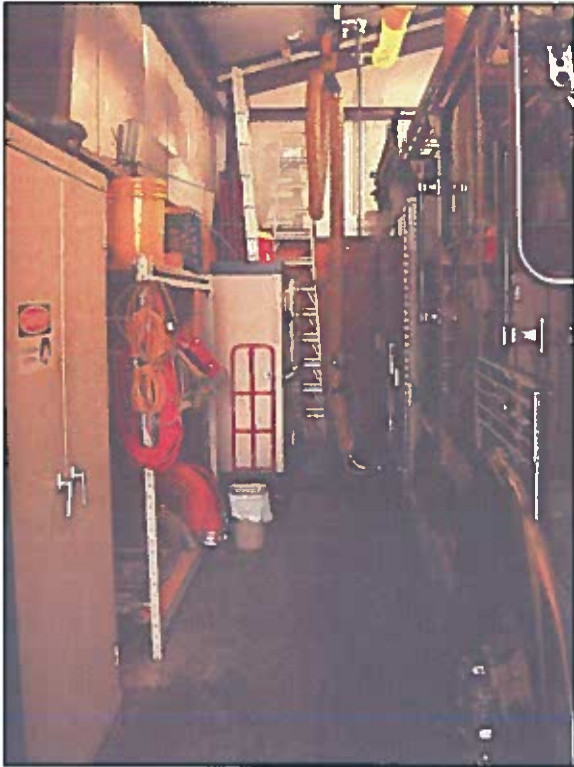
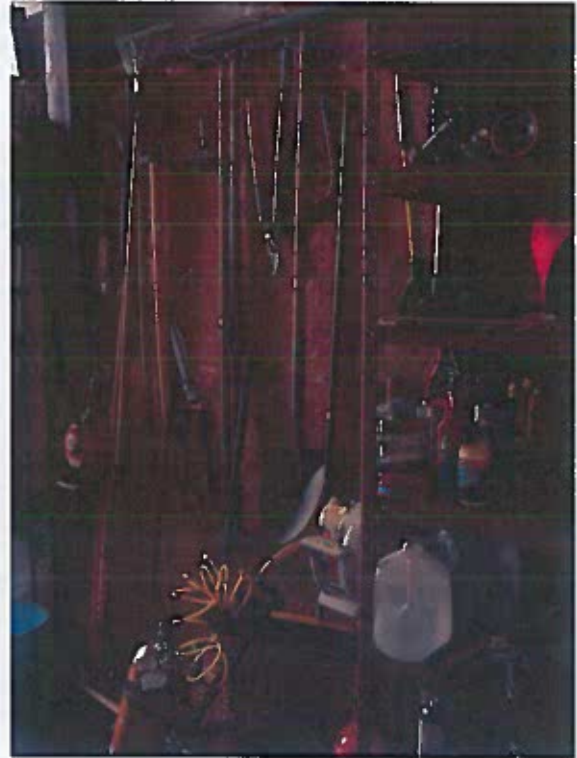
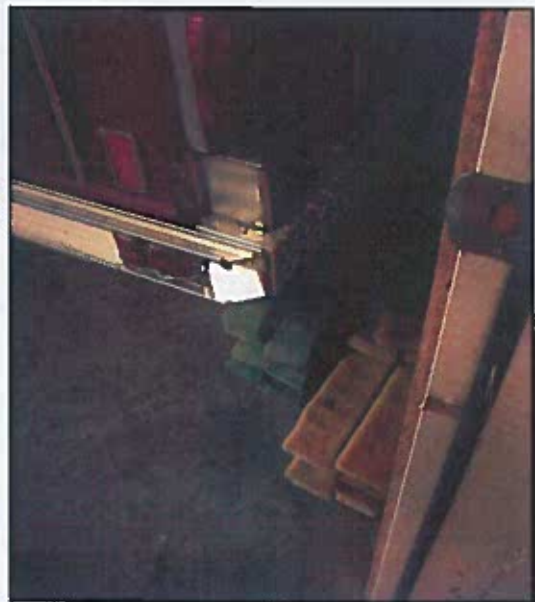
The sides of Apparatus Bays are used for storage and materials, and congest access routes.

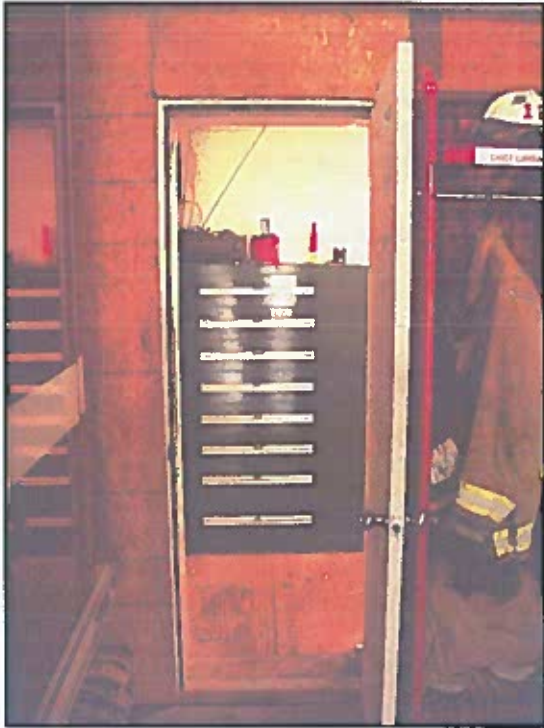
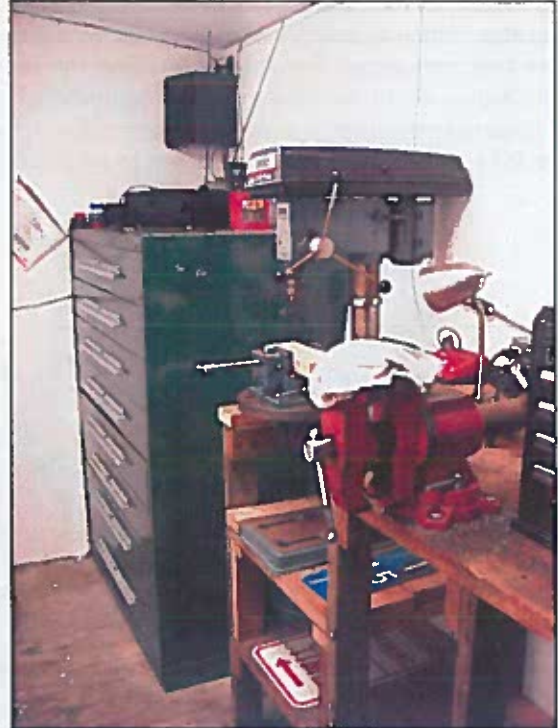
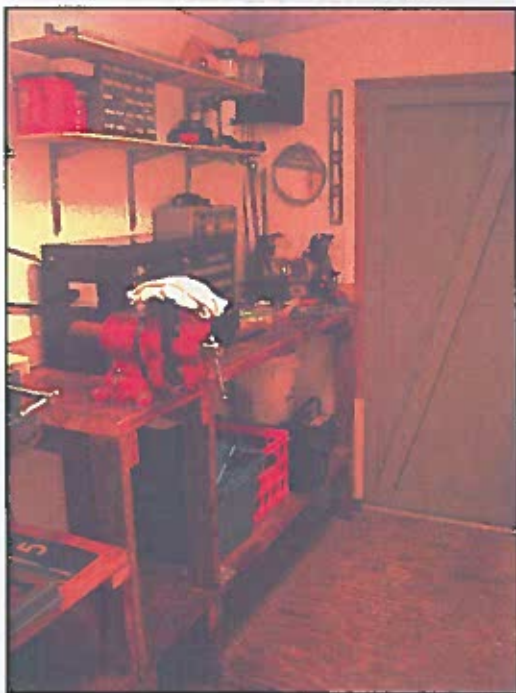
Tool Room- The Tool room is housed in the back of the Apparatus Bays, with a plywood floor and OSB covered walls on Bay side.

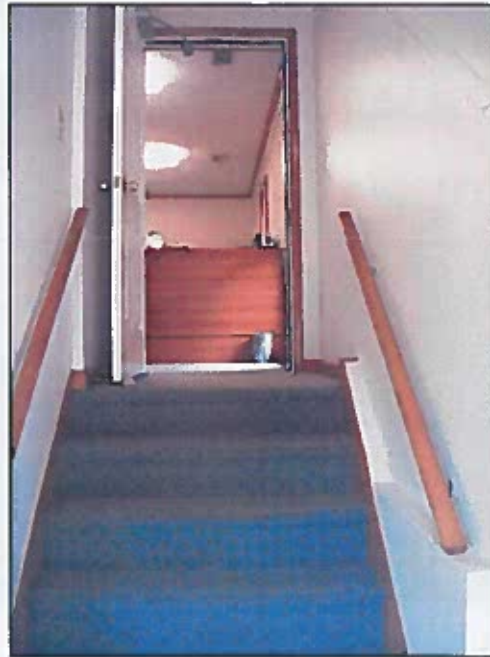
Offices-The access route to the offices is up a stairway and through a non-Accessible passageway. The clearances do not meet building codes, and the door hardware is a knob style residential type.

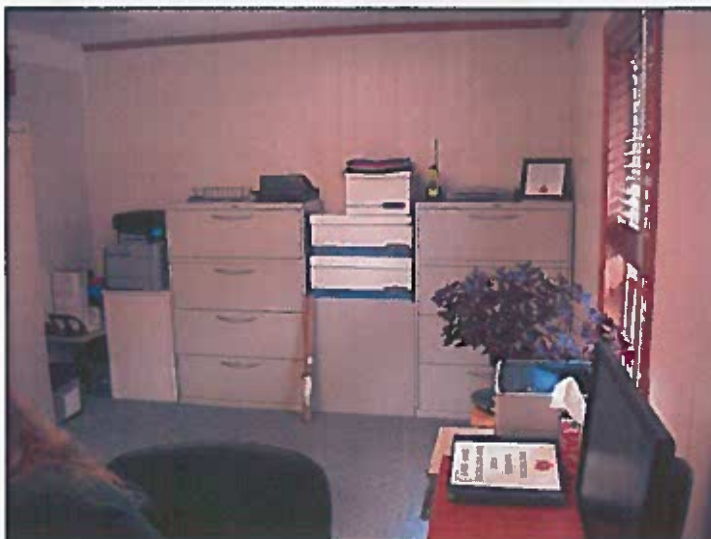
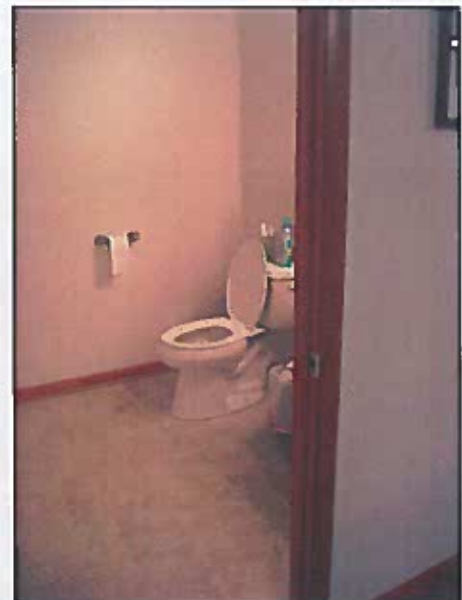
The reception office has 2 work stations with no welcome lobby. The public restroom has the needed clearances, but no grab bars or proper fixtures for the disabled.

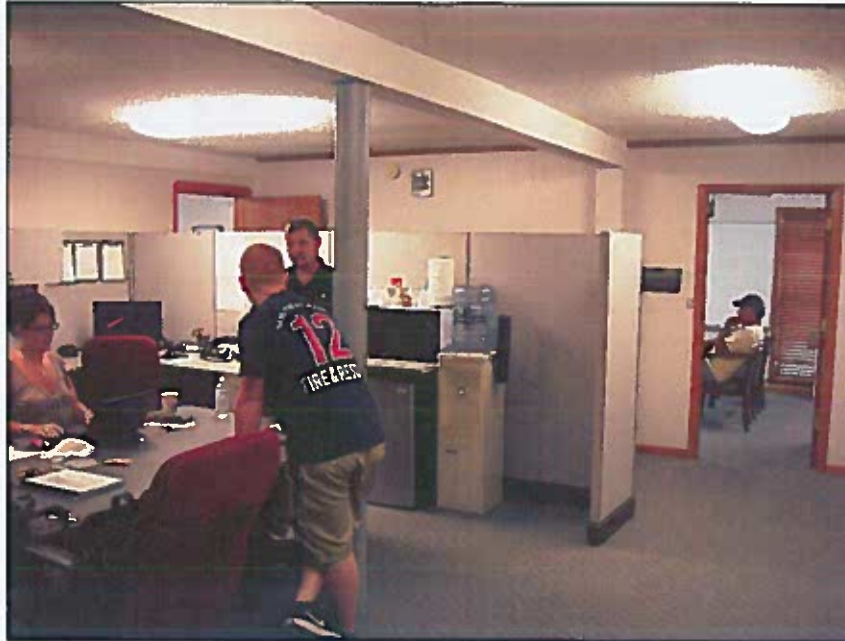
The main office are carpeted and have partitions with open workstation format.

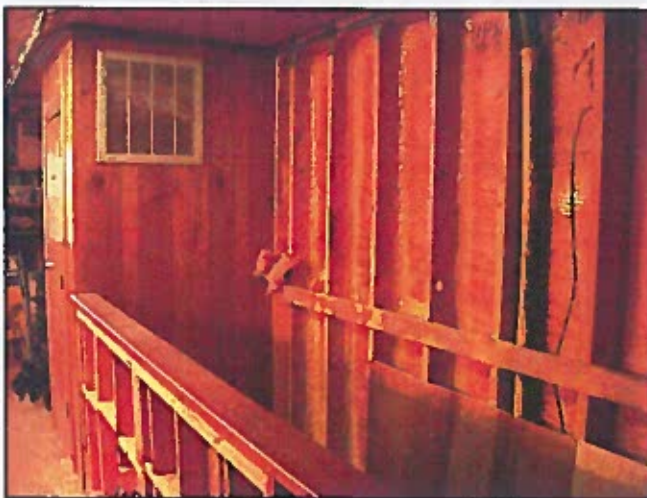
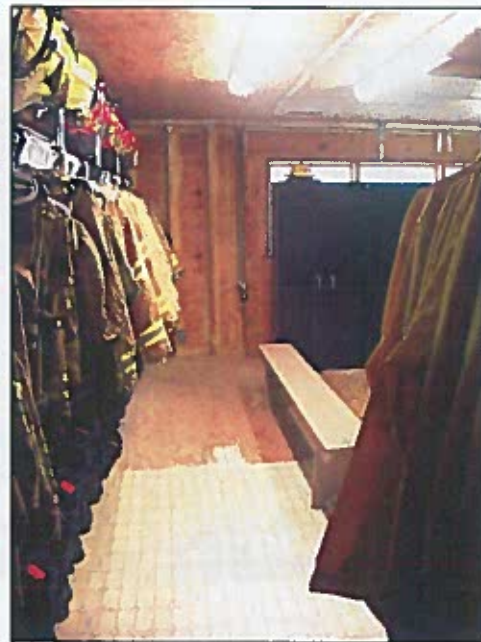
Upper Ready Room- Turn out Gear-Above the office and living space, there is a ready gear/ turn-out storage attic room. The construction is unfinished wood framed walls with no insulation or drywall, and plywood floors with vinyl flooring peeling up in some locations.

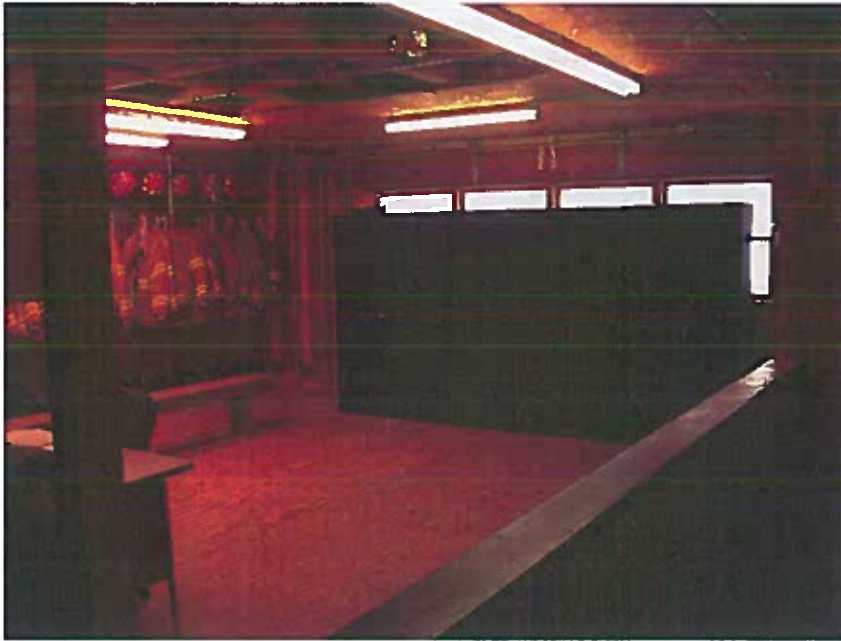
The ceiling is wood framed with partial sections covered with OSB, and the center area is exposed to the underside of wood framed roof. This does not allow for air temperature regulation, and exposed electrical wires are not to codes.

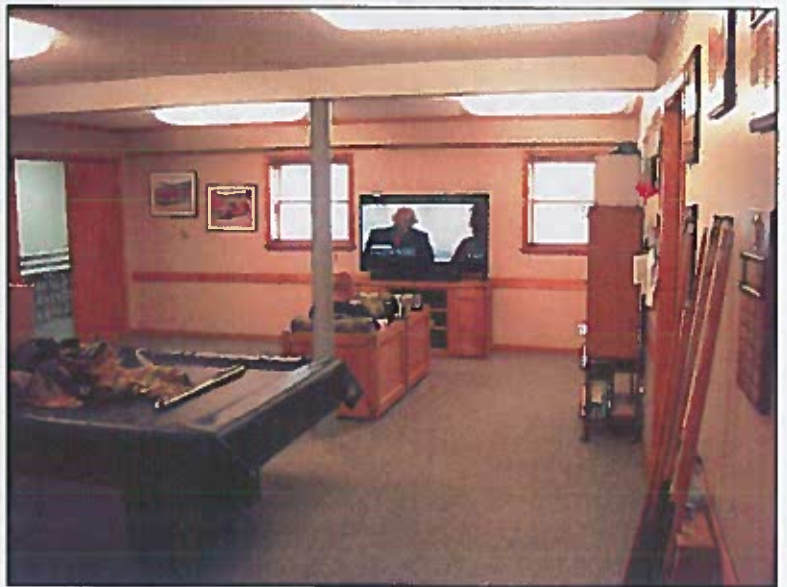
There is a small Medical Supply closet near the entrance to Day Room.

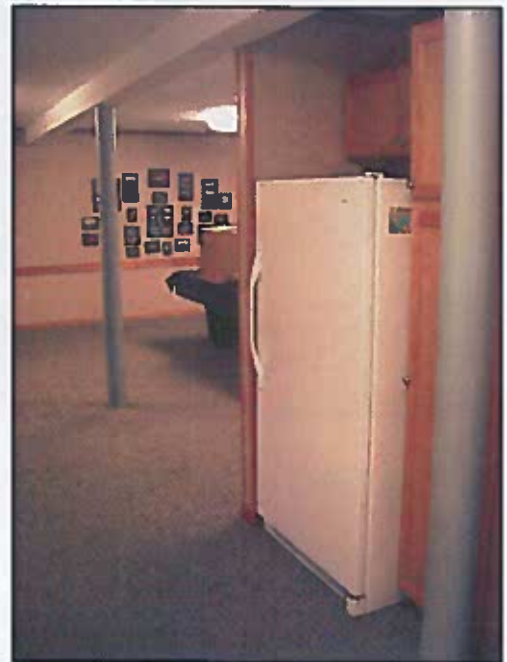
The kitchen is off of the Day Room through a carpeted passage way, which contains a refrigerator and cupboards.

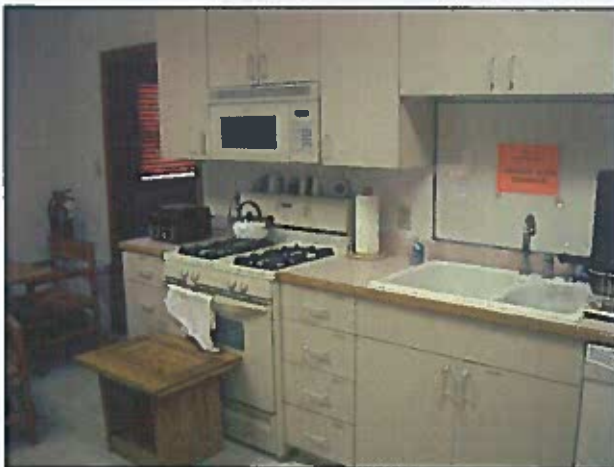
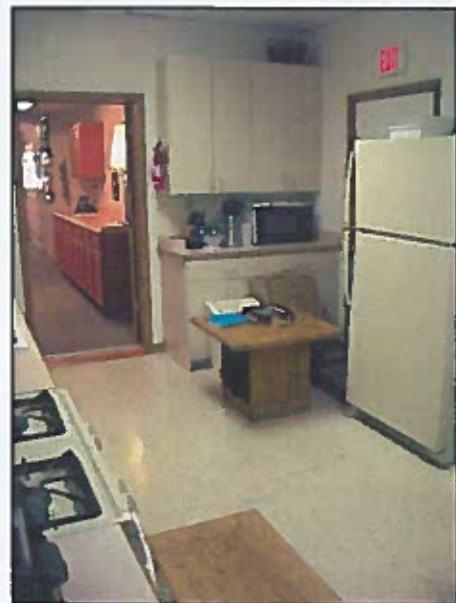
Kitchen- The kitchen for the station shows its age. The casework in the kitchen is lighter duty residential grade casework than would typically be recommended in new construction for a fire station. The kitchen sink height, hardware and base cabinet configuration will not meet current accessibility standards. The VCT flooring shows cracking. The dining area is congested around the main breaker boxes & ATS, and blocks access to the Fire Extinguisher.

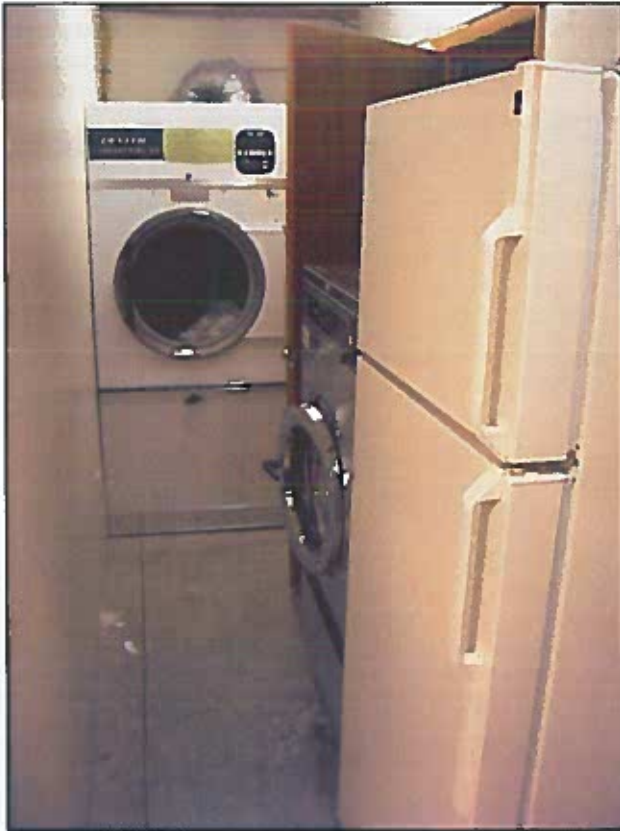
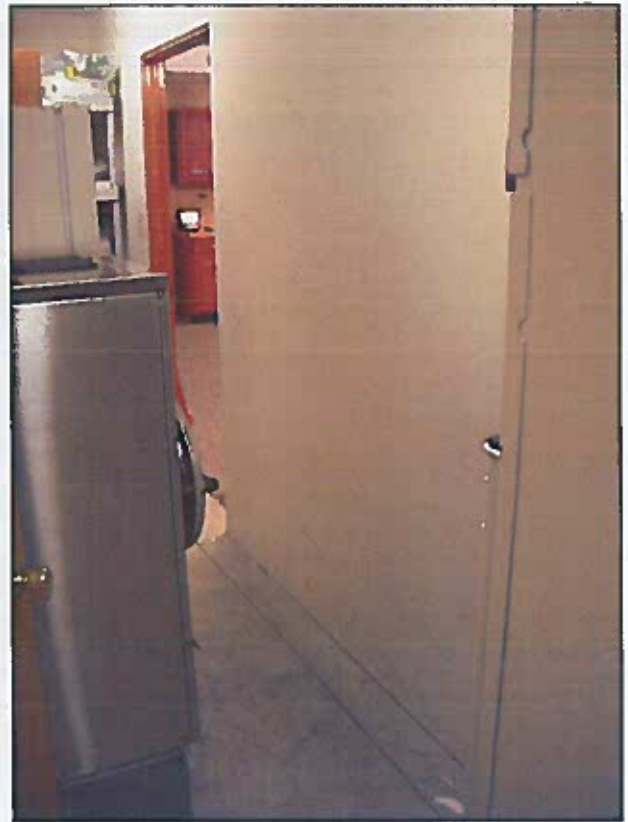
Laundry Room- The main industrial quality Washer/ Dryer machines and restroom are off of the Day Room, and through a very narrow non-accessible hallway, adjacent to a refrigerator. The access to this area is nonconductive for doing large loads of laundry. Dirty PPE often carry known carcinogens. Contaminated PPE should not be brought from the "hot-zone" of the Apparatus support areas into the "clean" portions of the station.

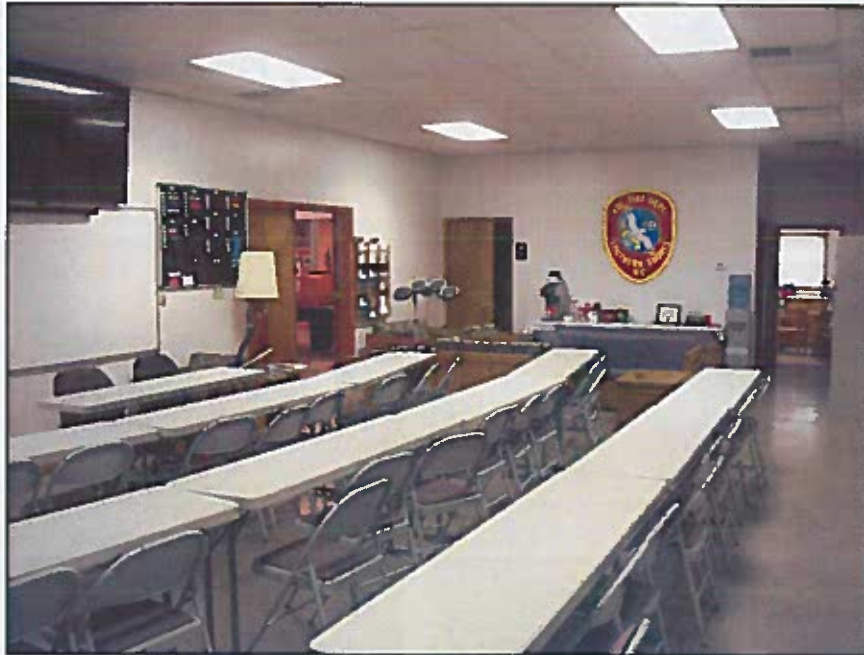
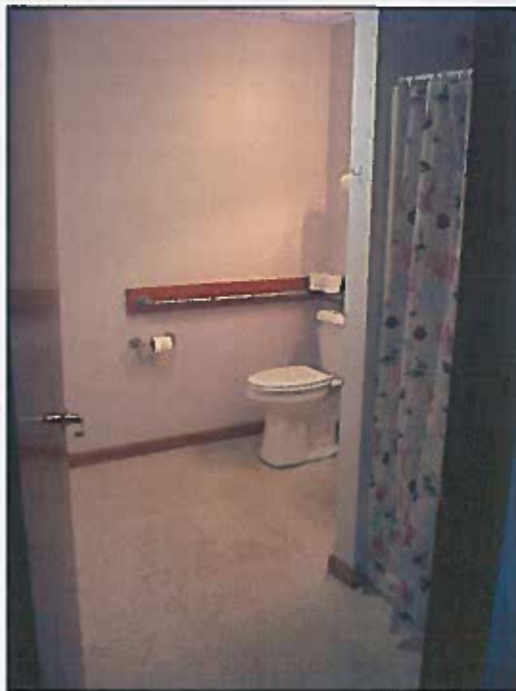
Training Room- The Training Room is between the Kitchen and Day Room, and has mostly Accessible Restroom with shower.

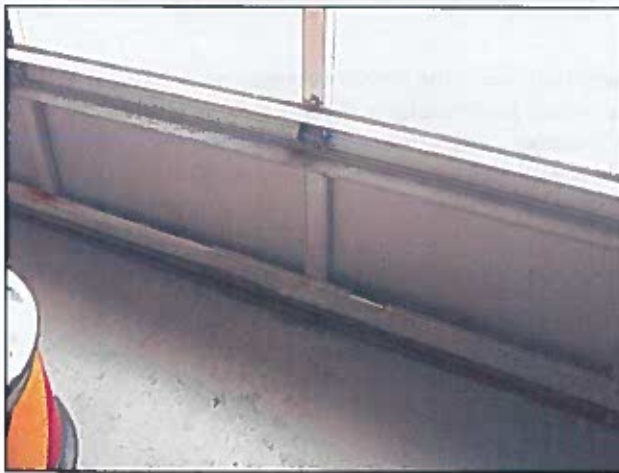
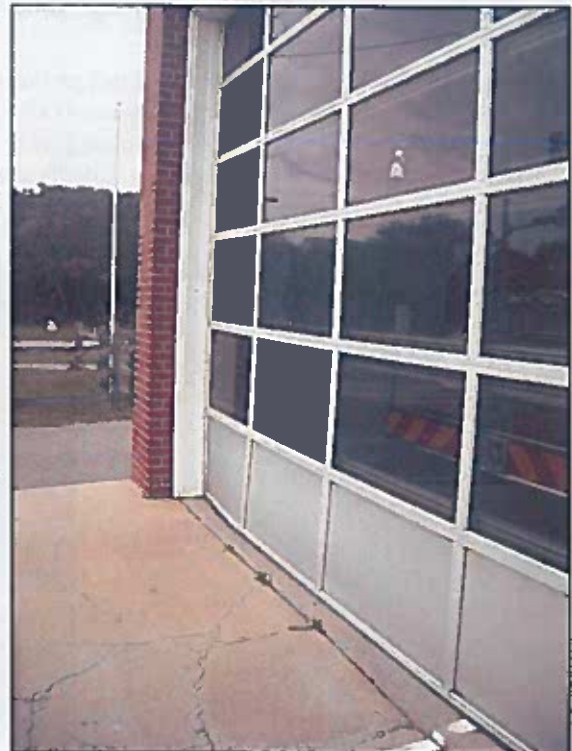
The main Engine overhead door is damaged and should be replaced with a proper insulated door.

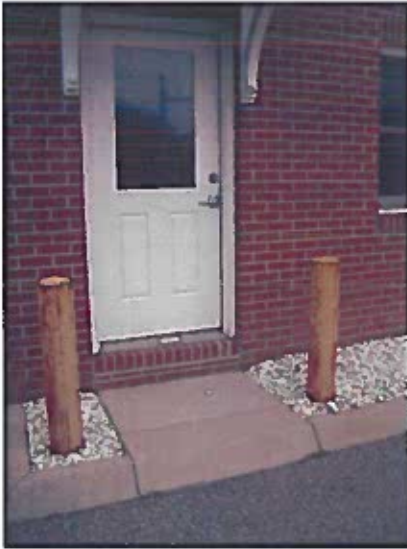
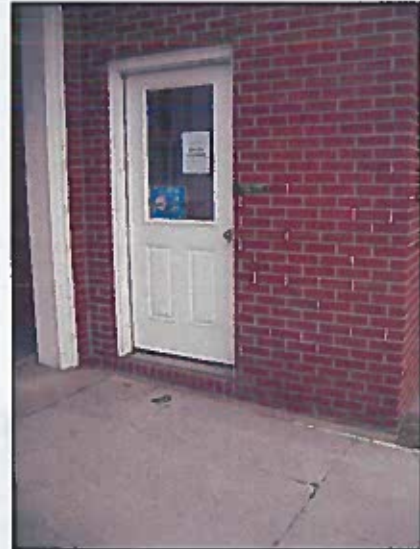
The main public doors on the west and south elevations, are not ADA accessible due to the step, and the door handle on the EMS entry not being a lever mechanism.

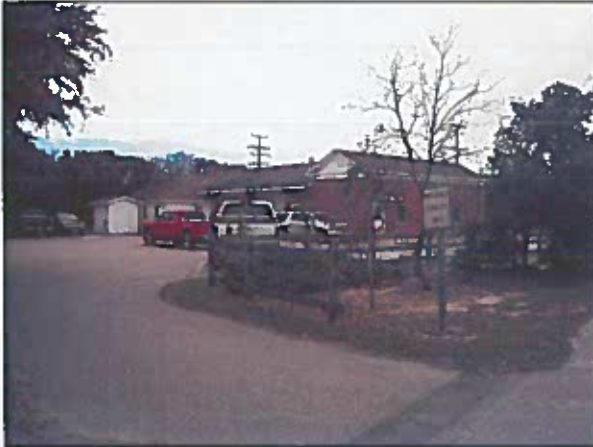
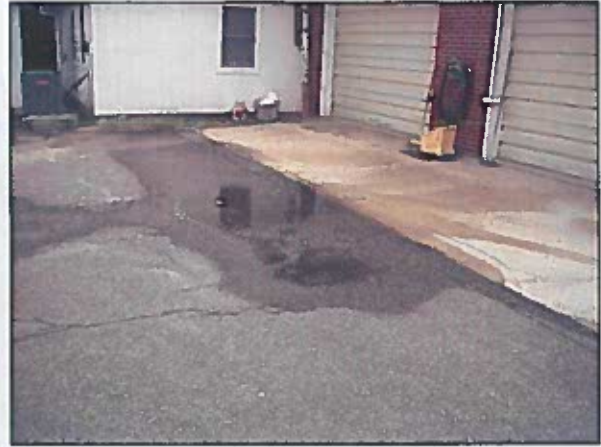
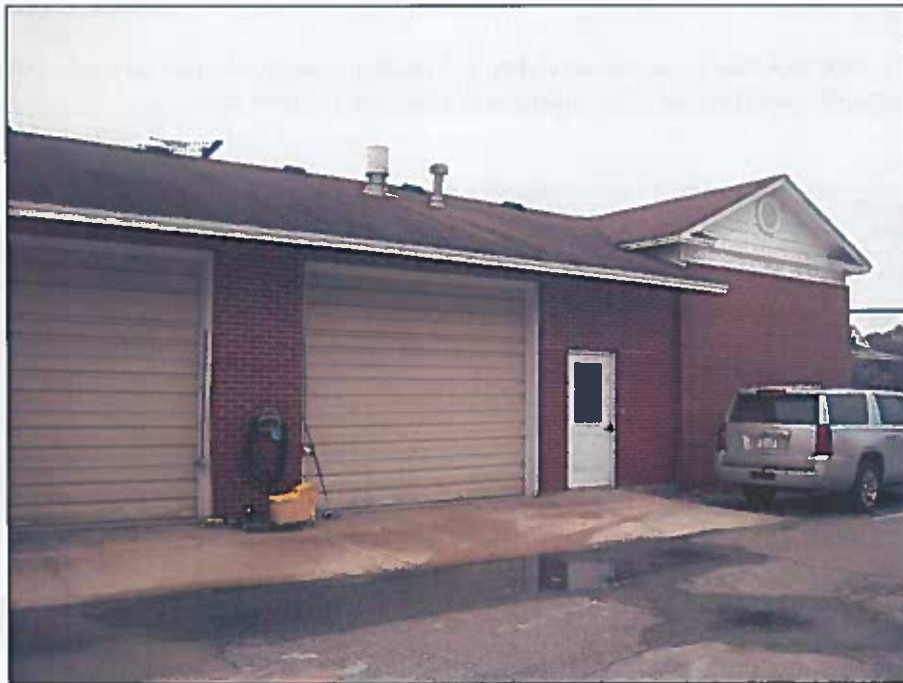
North elevation- The northern elevation houses the living, cleaning and parking areas for the facility. 2 overhead doors to the bays can be seen here, as well as a man-door.

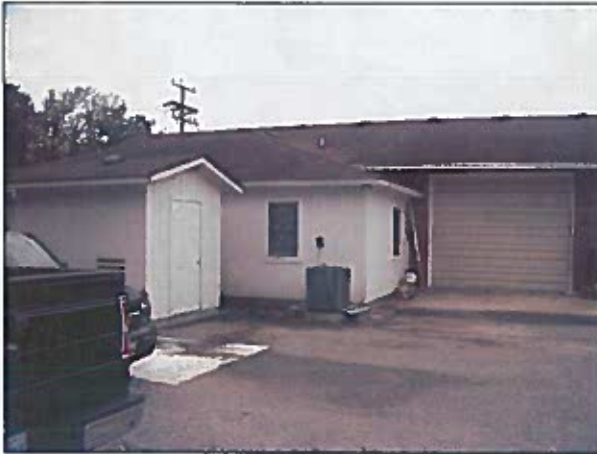
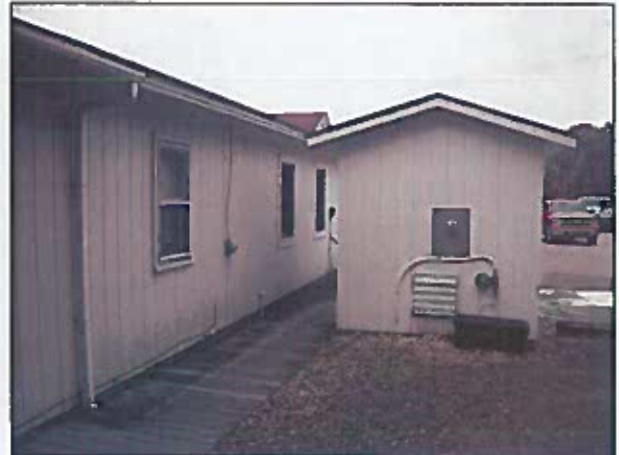
There is also a smaller shed that houses the generator next to the living quarters of the facility on the northern elevation, between station and parking area. The main facility lacks gutters at several locations.

Since there is no proper drainage, pooling effect occurs at the valley between asphalt and concrete apron.

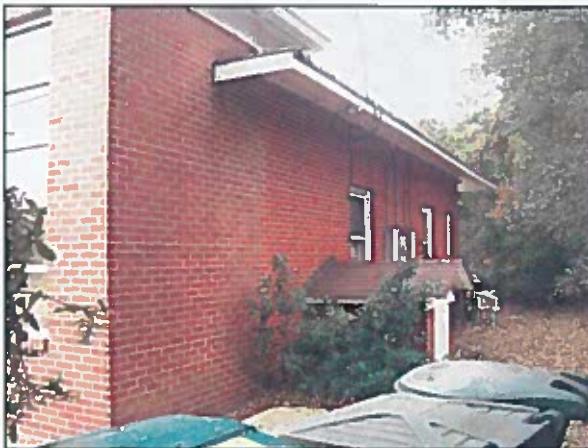
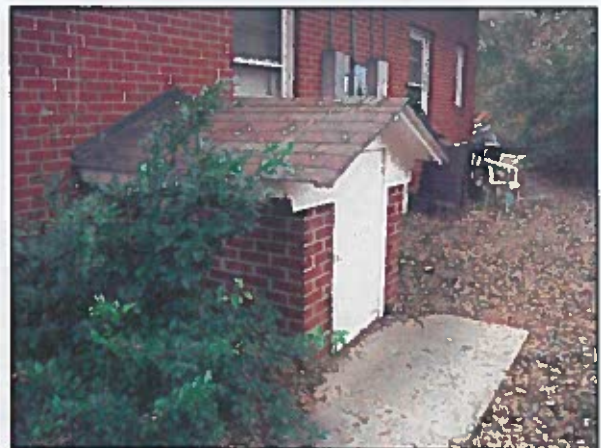
East elevation- The east elevation shows the vegetation and addition of small structure for housing the gas BBQ. The main breakers are located here, as is the underground cable box and trash cans.

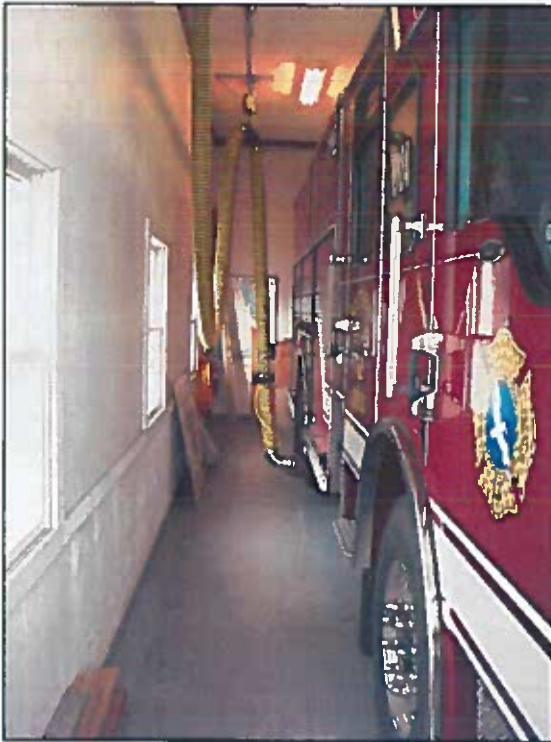
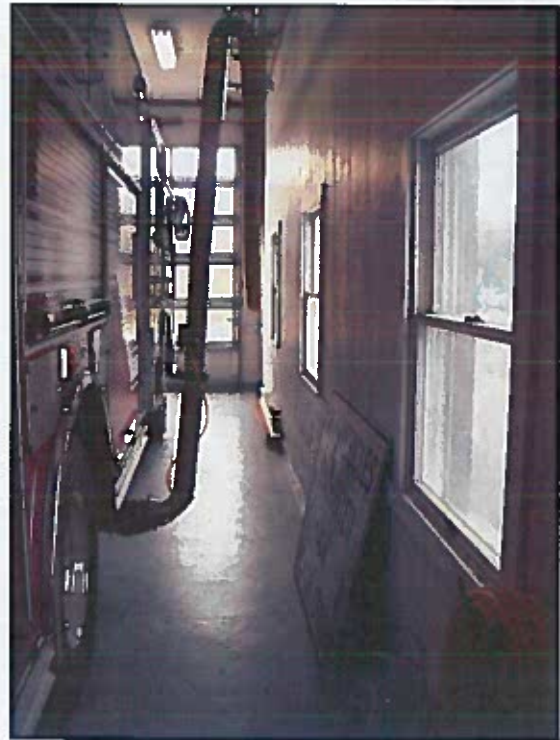
In an already confined space, necessary exhaust system hoses take up precious real-estate.

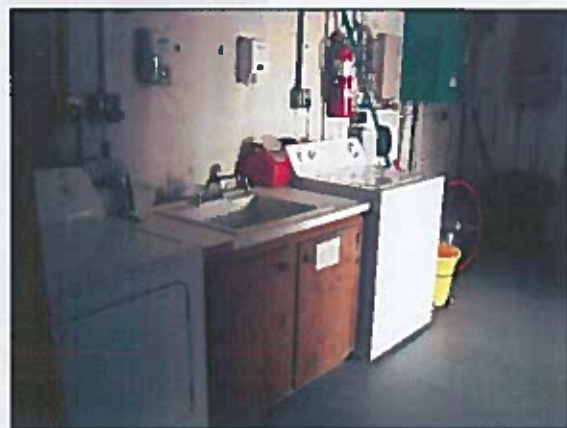
Residential Washer and Dryer are located in rear of EMS bays. There is a small decontamination area in-between washer and dryer. The typical standard in a new construction is to have a separate decontamination room where this equipment can be housed out of the bay area. Typical new construction would also have a large decontamination sink with sideboards for washdown of larger items in addition to an emergency shower/eyewash station for safety.

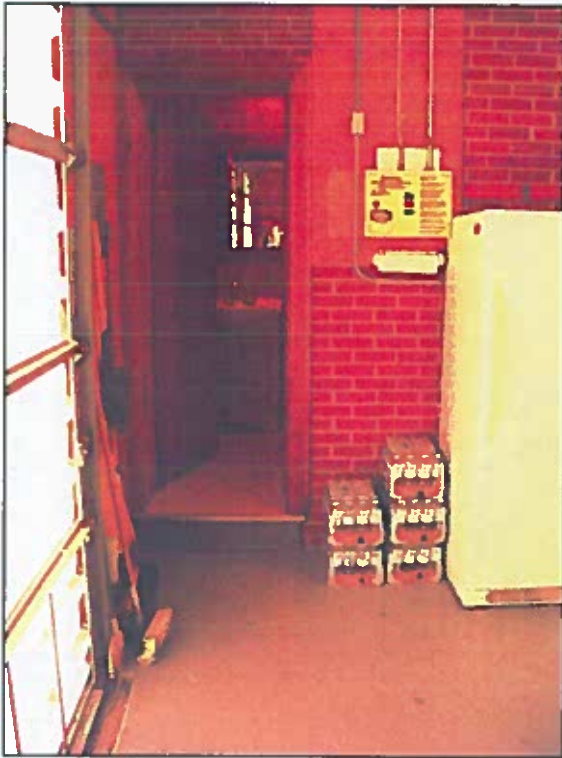
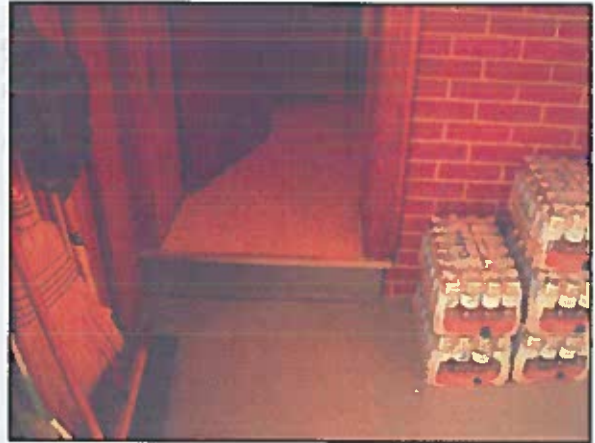
The Apparatus Bay Restroom is not accessible due to a step up, knob handle, and the accessible route clearances are encroached upon by equipment and water bottles.

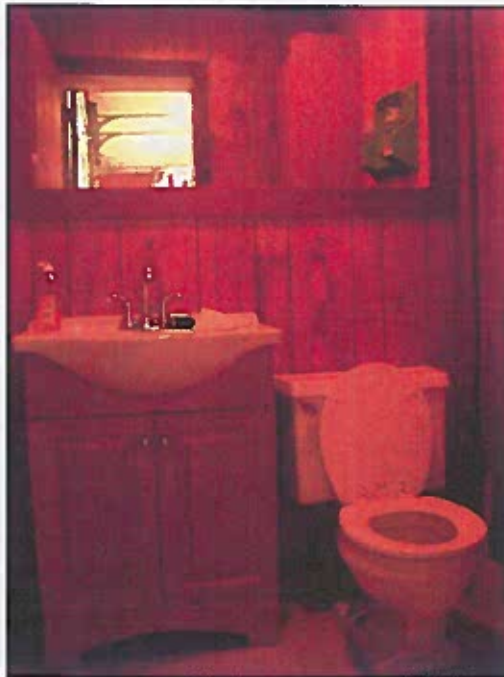
The sink is a standard residential grade standalone sink with no ADA clearances underneath, and no grab bars in Restroom.

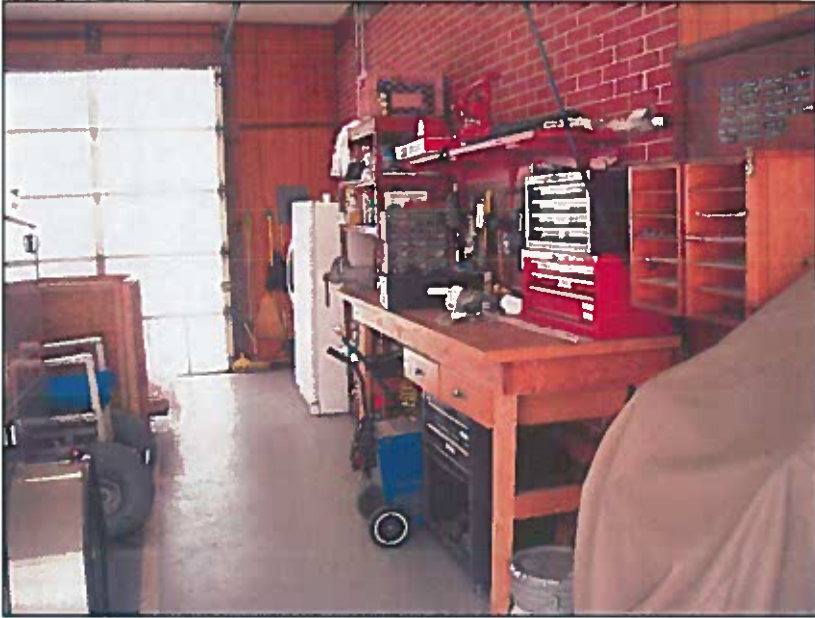
The Tool Shop is sharing the space in bay with storage along the wall.

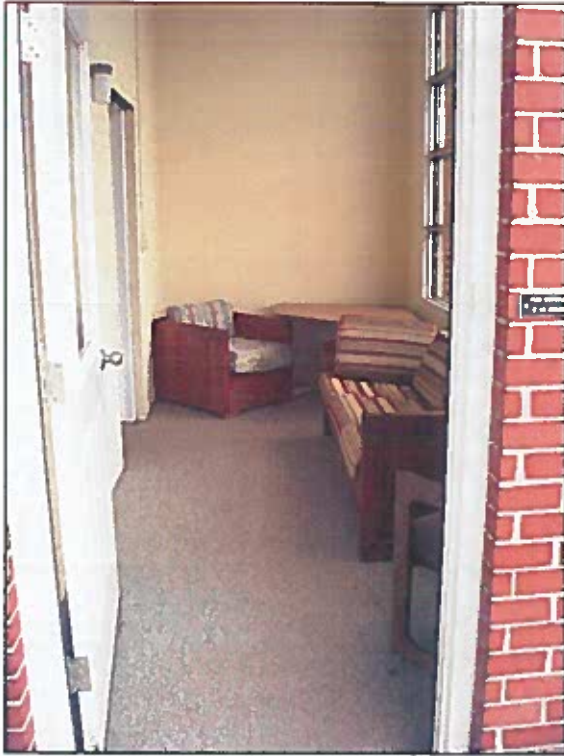
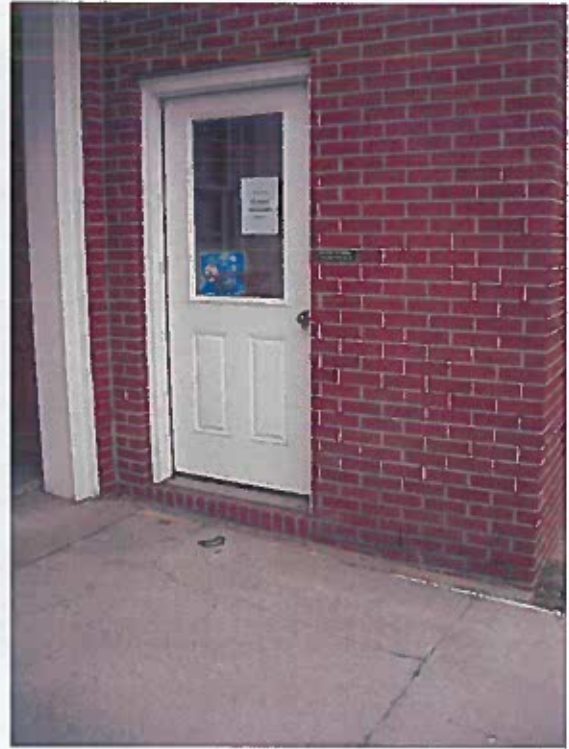
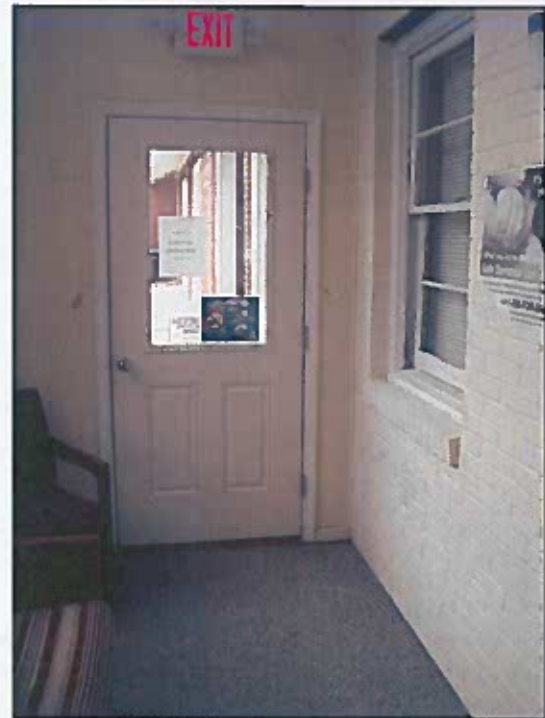
Public Entrance- The main entry is a step up due to flooding threat for the area, and the door handle is not a Lever type, which is required for this entrance.

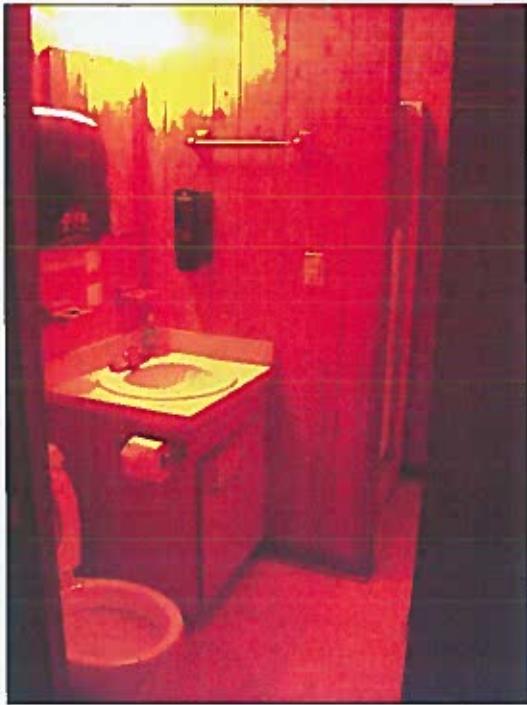
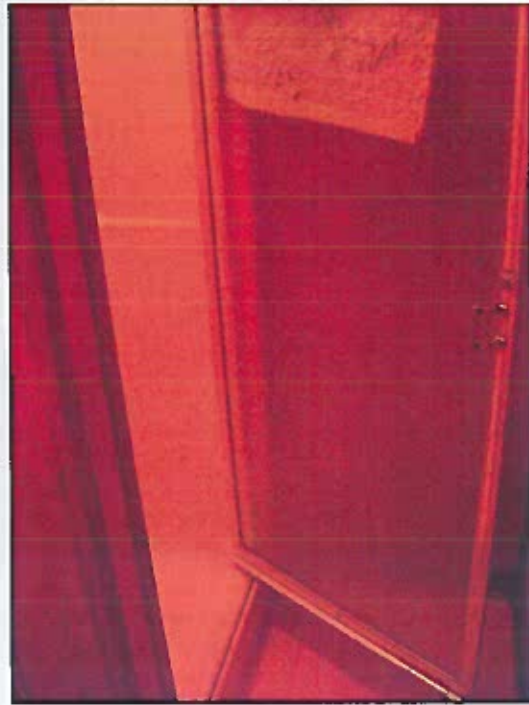
Restroom/ Shower- The current fixture arrangement will not meet accessibility standards. . The shower is not handicap accessible, and the sink and toilet do not have ADA approved hardware, and clearances are not met.

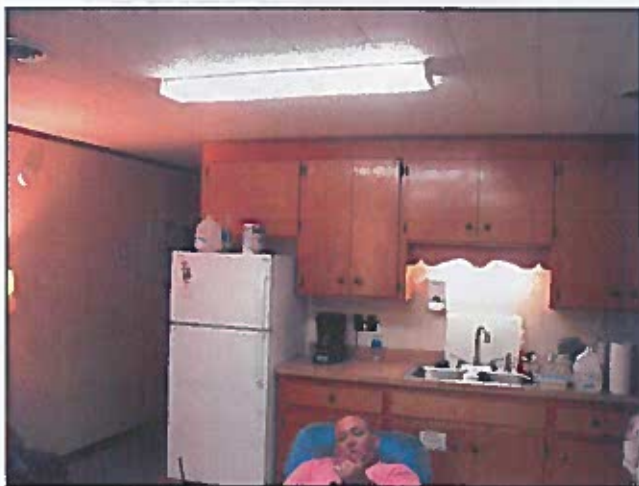
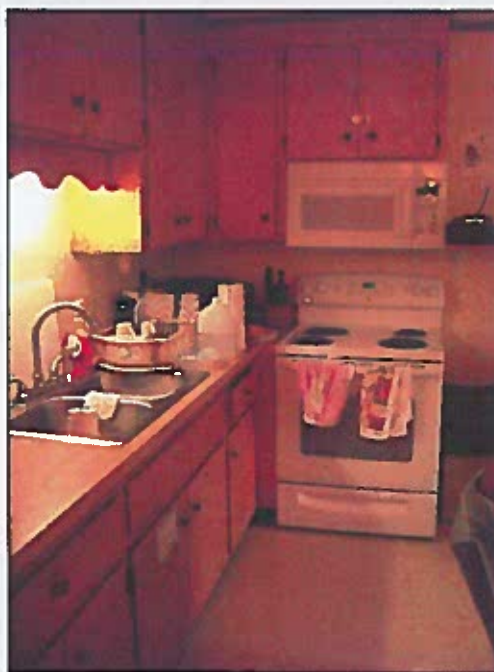
Day Room/ Kitchen- The dayroom is an open plan configuration containing the areas for seating and dining with the kitchen. The Kitchen has Plastic Laminate counter tops, and residential style fixtures.

The casework in the kitchen is light duty residential grade and would not be recommended in new construction for a fire station. The kitchen sink height and base cabinet configuration will not meet current accessibility standards.

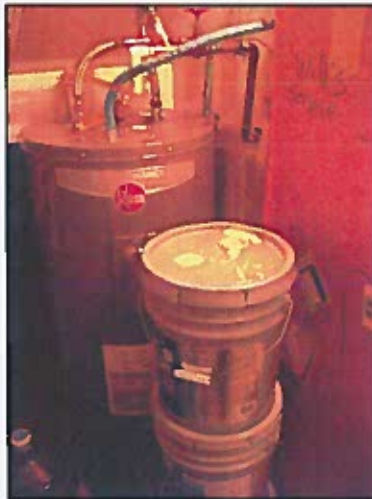
1. Cold and hot water piping is copper at connections to fixtures, therefore it is logical to assume water piping is copper throughout the building. Did not observe any insulation on water piping.

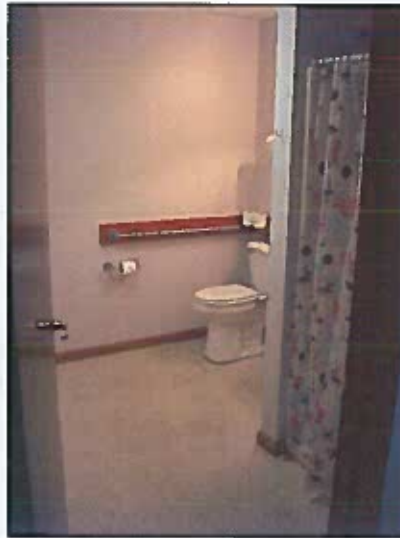
8. While some water closets had grab bars and one shower had a hand-held sprayer for accessibility, compliance with ADA requirements including mounting heights was not confirmed. Drain and water piping under lavatories is not insulated.

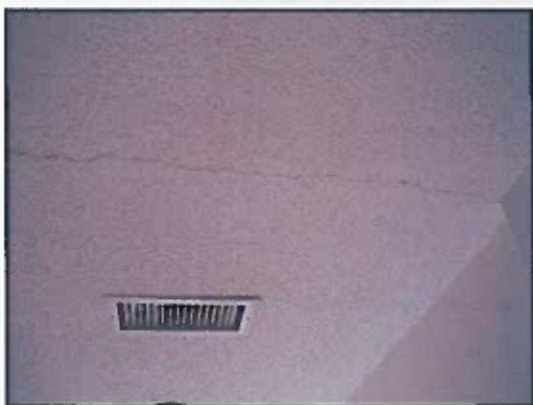
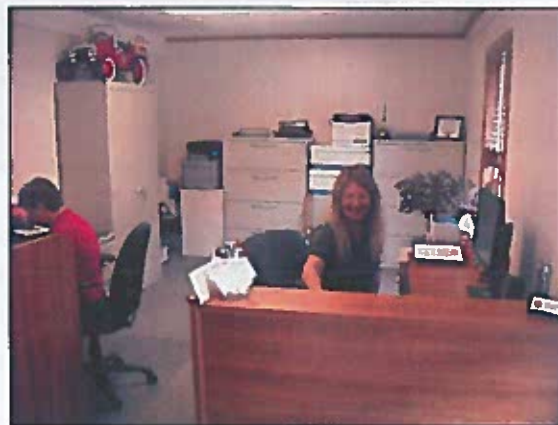
5. Insulation on all exterior refrigerant piping requires replacement due to deterioration from exposure to UV rays.
6. Office area's HVAC is reported to be problematic for temperature control. The thermostat for this HVAC unit is located in the office area, but the return air grilles for this unit are located in the reception area. When the door between these two areas is closed, temperature control and comfort is sacrificed.

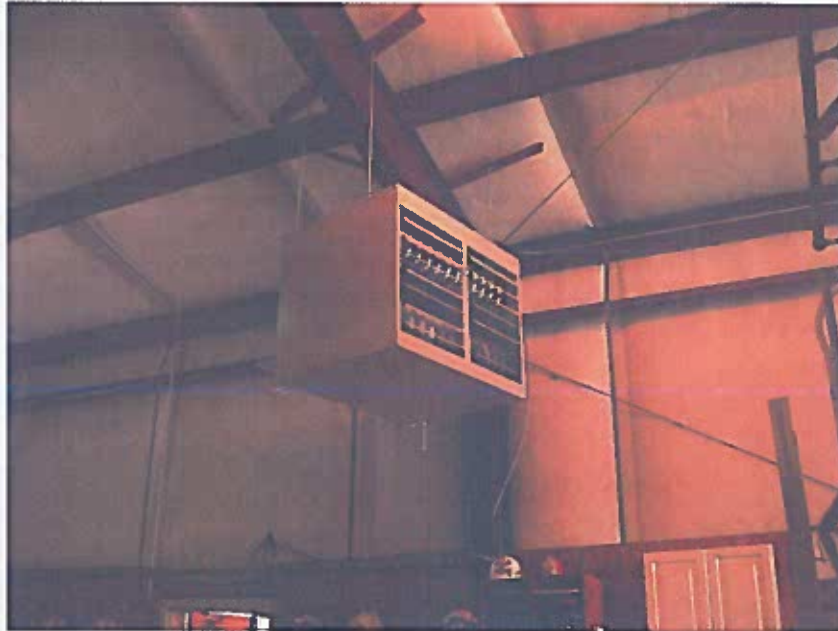
10. Apparatus Bay:
 - a. Two LP gas fired unit heaters. Even though only one heater is functional, heating in the Bay is reported to be sufficient. Heater on south side is not functional.
