SOUTHERN SHORES VOLUNTEER FIRE STATION: EXISTING FACILITY ASSESSMENTS & PROGRAM NEEDS

South Station Located at 15 S. Dogwood Trail, Kitty Hawk, NC 27949

East Station Located at 28 E. Dogwood Trail, Kitty Hawk, NC 27949

3 Jan. 2017

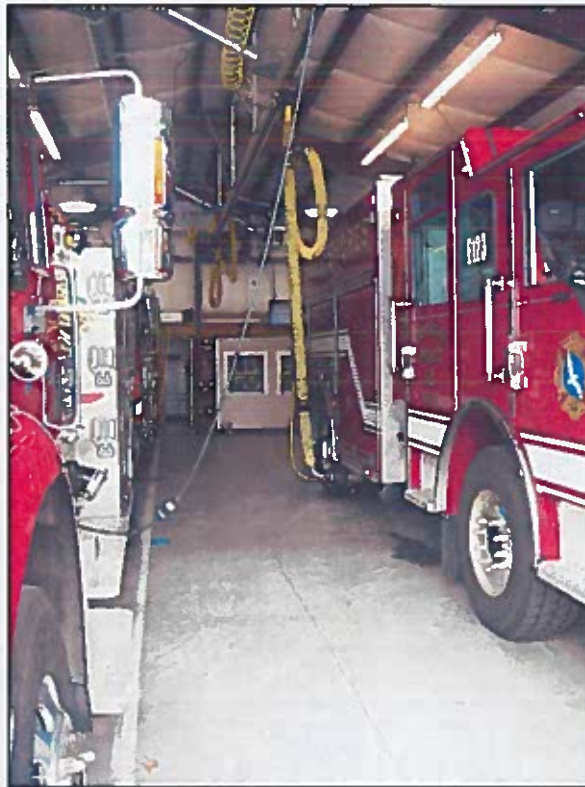
- d. Plymovent brand system is installed to provide source exhaust from vehicles in the Bay. All three vehicles had their exhaust outlets connected to the system. System is reported to be ten years old and works acceptably.
- 18. Tool/Work Room in back of Apparatus Bay does not have any heat or ventilation.

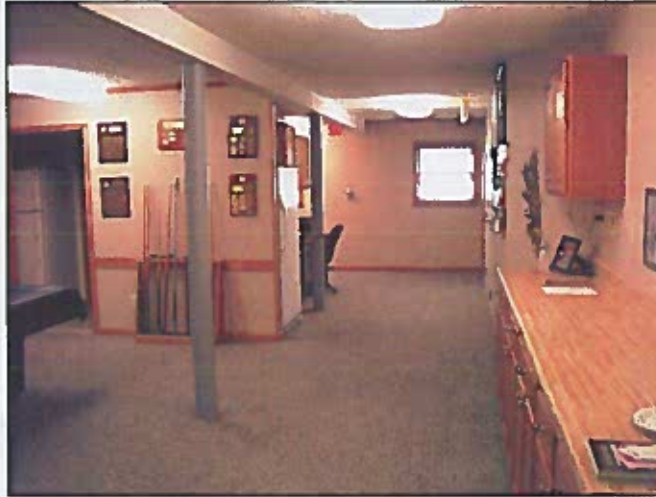
- Interior lighting is provided by a mixture of surface mounted incandescent fixtures, recessed linear fluorescent fixtures, surface linear fluorescent fixtures, suspended linear fluorescent fixtures. Linear fluorescent lamps appear to primarily be T12. Where specific room comments regarding lighting follow, the comments are intended to point out observations that are out of the ordinary.

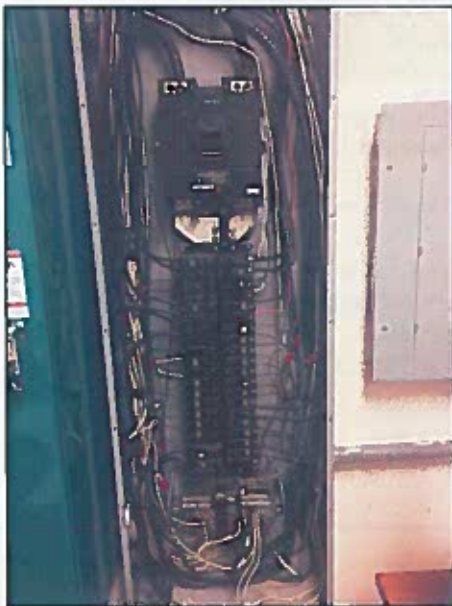
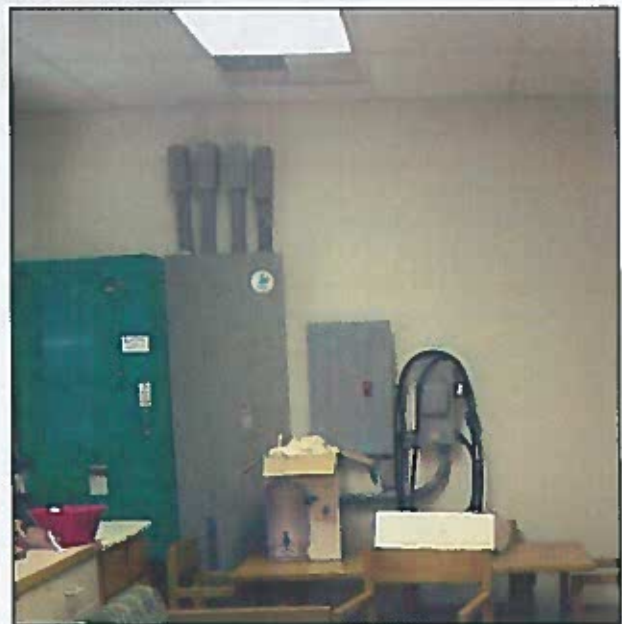
- Lighted exit signs are located at exterior egress doors. No specific fixtures for emergency egress lighting were observed, as the intent appears to be for the generator to serve as a suitable backup power source.
- Exterior lighting is provided by a mixture of flood lights with double ended halogen lamps, halogen PAR type lamps, wall mounted incandescent fixtures, and LED wall sconce fixtures.
- The NEC requires all panels to have locking covers. The panel in the kitchen next to the generator automatic transfer switch did have a cover during our assessment, but it currently does not. It will need to be replaced to meet codes.

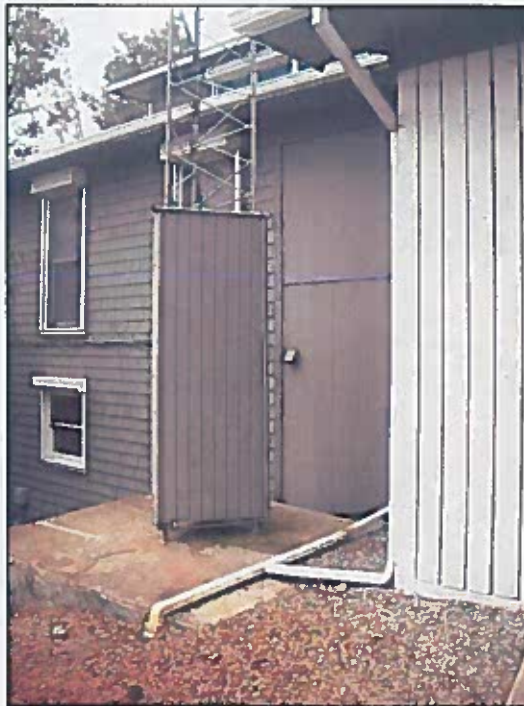
27. Exterior South Side: Telephone service entry is located near the generator.

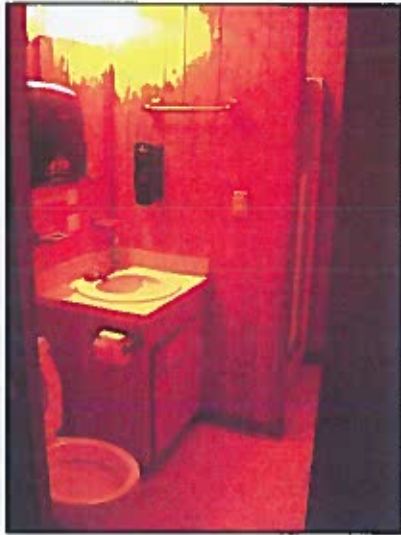
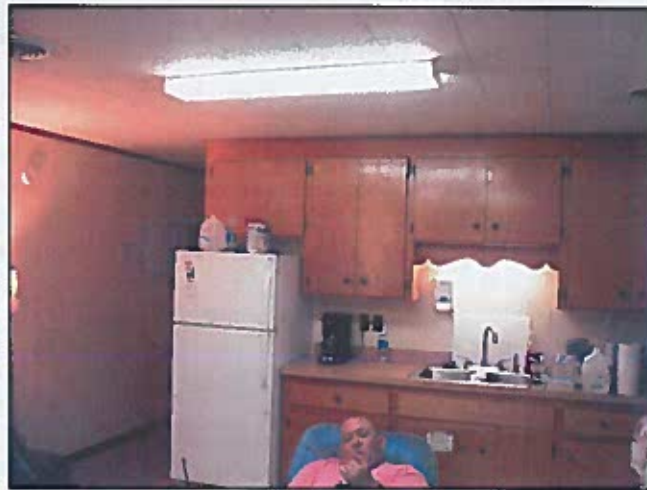
1. Cold and hot water piping is copper at connections to fixtures, therefore it is logical to assume water piping is copper throughout the building. Did not observe any insulation on water piping.
2. Waste piping is PVC.

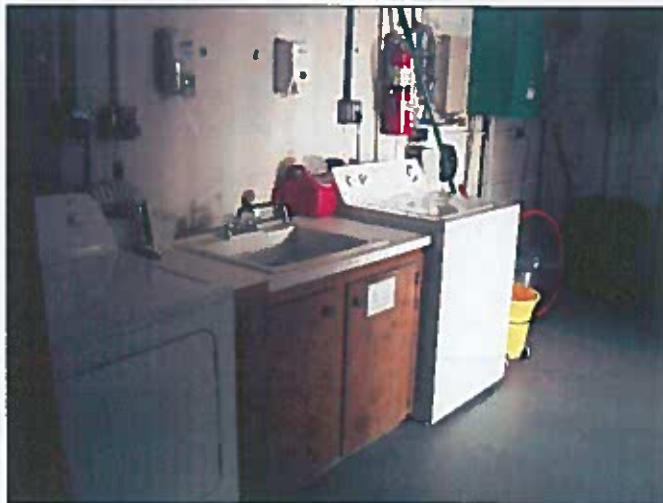
3. Plumbing fixtures are a mixture of residential types with tank type water closets and manual type faucets on lavatories and sinks.
4. Hot water for building is provided by a single electric storage type heater.
5. Washer and dryer are residential type. Dryer is electric.
6. Although there is some water stained ceiling areas in the building, no water leaks were observed.
7. Truck bays have three floor drains. The floor drains do not appear to have any sand or oil intercepting capabilities.

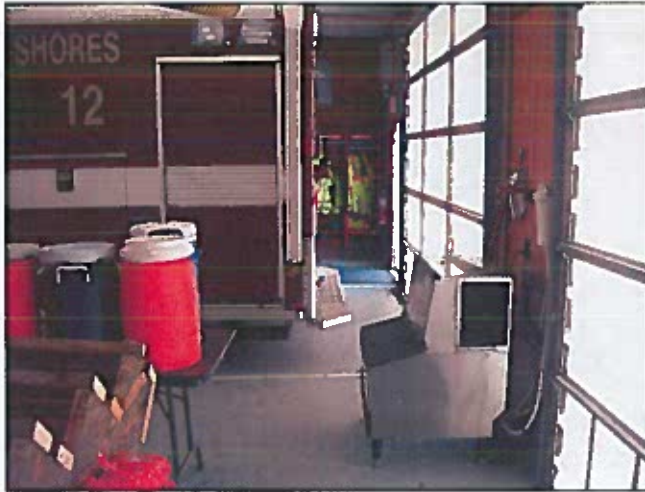
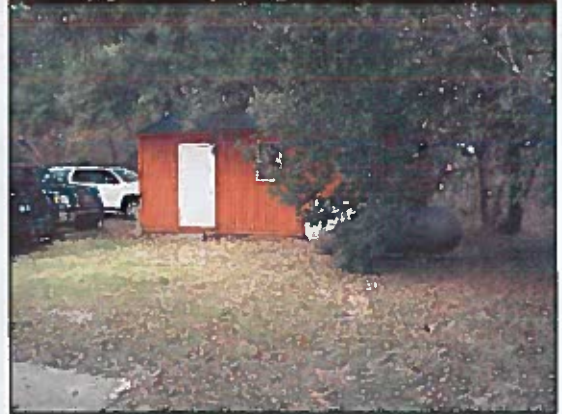
8. Ice machine in Fire Department truck bay drains to exterior grade.
9. In either the Fire Department or EMS truck bays, there are no emergency eyewash/shower station for personnel decontamination. The only decon apparatus is manual squeeze bottles for eyewash at the lavatory in the Fire Department truck bay restroom and an eyewash on the faucet of the utility sink in the EMS truck bay area.
10. Fire Department truck bay has one air compressor for general duty.
11. Water for the building is provided by the Town's system. Sewer is to an onsite septic tank and field.
12. Gas for building generator and Fire Department truck bay heater is LP from onsite aboveground storage tank located in north corner of the site, next to the newest facility on site.

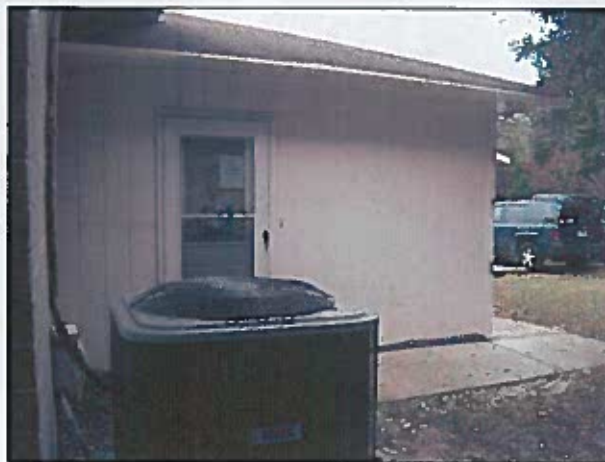
1. EMS area of the building is conditioned by two split system heat pumps:
 - a. Heil 2-1/2 ton system manufactured in 2016 serves the front living space. System's refrigerant is R-410a. Outdoor condensing unit is constructed especially for coastal environments.
 - b. Goodman 1-1/2 ton system with unknown manufacture date serves the back sleeping areas. System's refrigerant is R-22.

2. The Heil 2-1/2 ton heat pump system is new and should last many years.

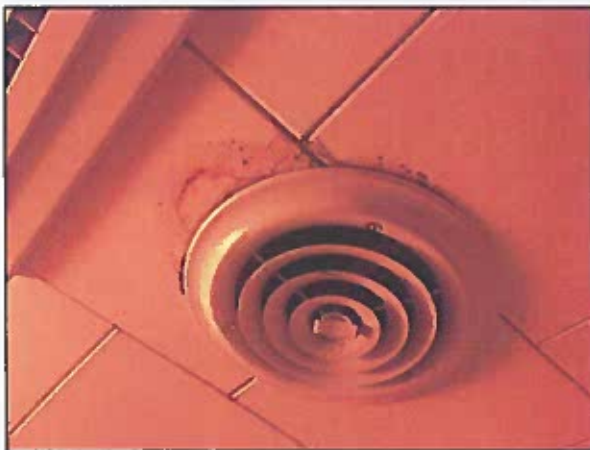
Restroom

3. The Goodman 1-1/2 ton heat pump system should be replaced due to its service life and that it uses phased out R-22 refrigerant.
4. Split systems' indoor air handling unit sections are not in locations conducive to maintenance, they are located above a ceiling and in a closet.
5. Two ceiling diffusers have residue which could be dirt or mold. Without being sampled and tested by a certified industrial hygienist, we would be speculating what it is.

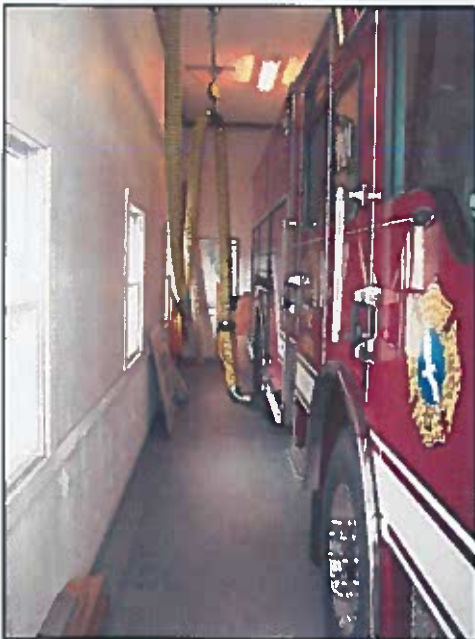
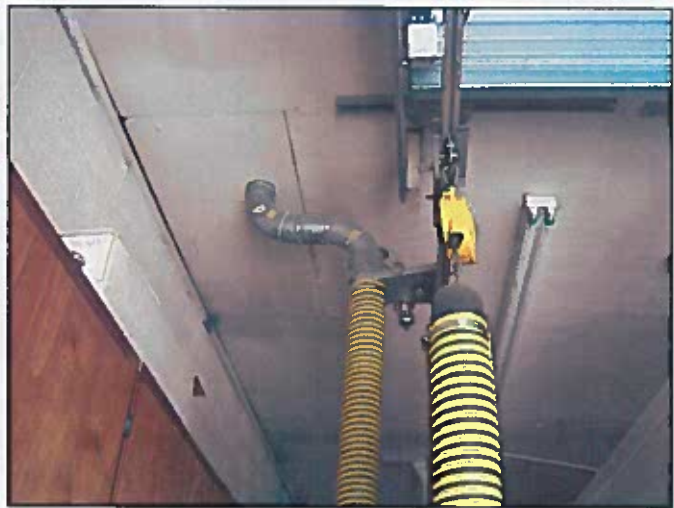
13. Plymovent brand system is installed to provide source exhaust from vehicles in both the Fire Department and EMS truck bays. All vehicles in the Fire Department truck bay had their exhaust outlets connected to the system. The two EMS vehicles were not connected to the system. Plymovent system control panel is located in the Fire Department truck bay. Exhaust fan is located in the attic space.

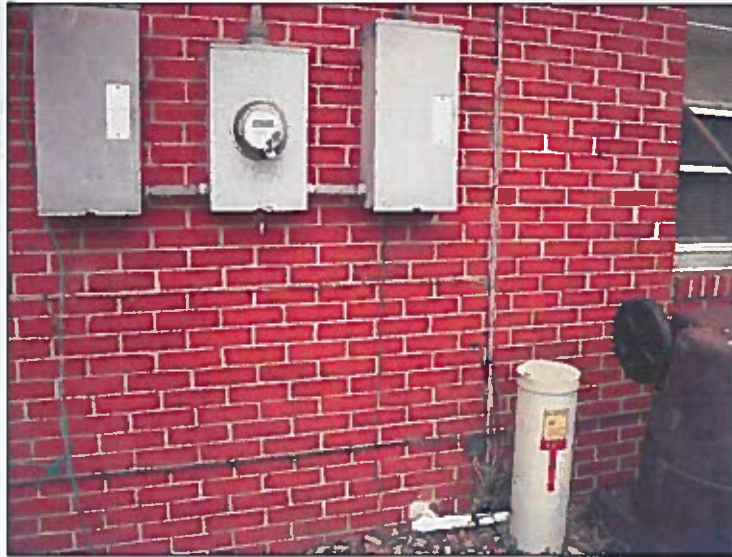
1. The electrical service is provided by the utility company, overhead to a meter base located on the exterior East wall of the facility. This service configuration is 120/240 Volts, single phase, 3 wire. The service drop from the utility pole to the building is routed through tree branches and it is visibly under pressure from those branches.

2. The utility service cable is attached to the building and then installed surface mounted to the meter base. This exposed cable surface mounted to the building is not well protected and is subject to physical damage.

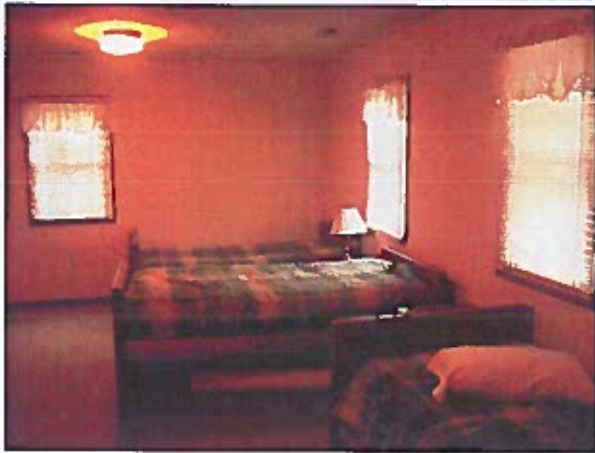
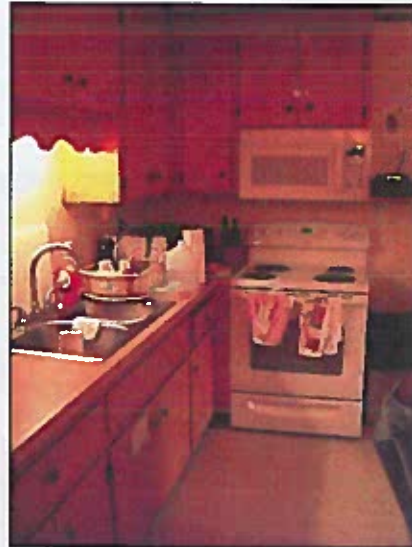
10. A portion of the building is occupied by an EMS department. The bedrooms and day room of that space has residential type smoke detectors installed. There is no detector in the corridor space adjacent to bedrooms.

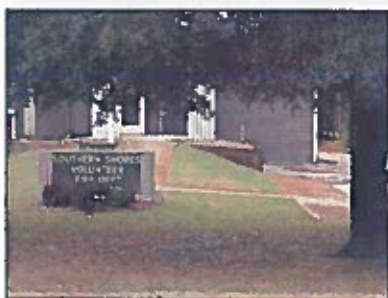
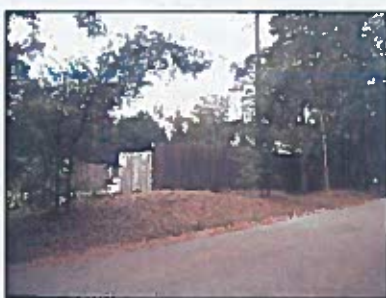
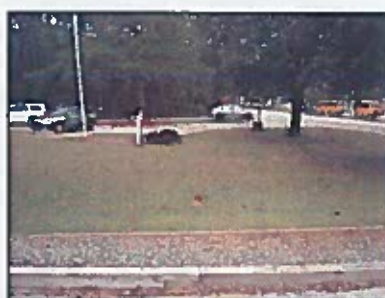
Existing Pavement – asphalt and concrete drive and parking area, and concrete apron for apparatus', with noticeable cracks and pooling where there is no drainage on lower part of site.

Storm-water/Site Drainage – Water for the building is provided by the Town's system. Two sump pumps located in front of building must remain operational to keep groundwater/rain water out of the main building's lowest level.

If this station is to remain in service for many more years, it will require many upgrades, such as installing concrete bollards at bay doors, patching drive apron at bay doors, offering adequate parking spaces including Handicap stalls and loading zones, LED light fixture retrofit, HVAC overhaul and replacement/ installation of new equipment and supply lines, installation of proper ADA ramps, provide grab bars and upgrade hardware and restroom fixtures, significant site drainage modifications, and consideration given to an updated electrical system.

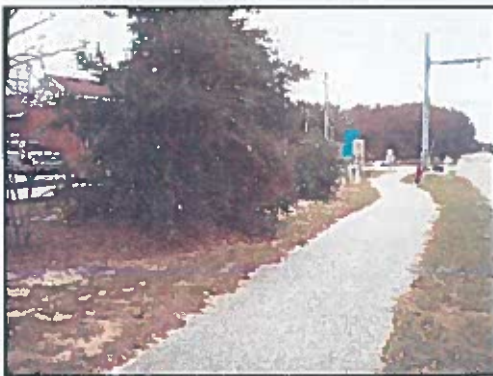
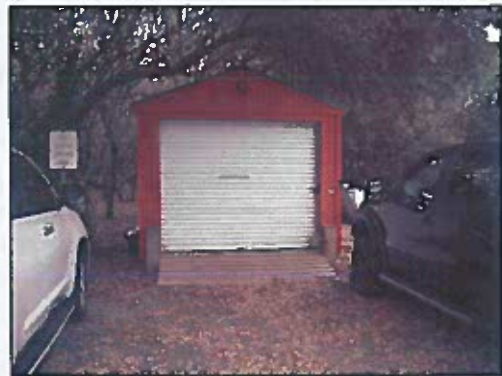
Existing Pavement – Existing concrete pavement is in poor condition. Severe cracks are on the apparatus apron on front of station, and joints have moss growth within cracks. Asphalt pavement is in fair condition for parking area.

Storm-water/Site Drainage – Water for the building is provided by the Town's system. Drainage on the north side where parking meets the building apron pools.

The apparatus bay, concrete apron, and asphalt drive durability is a significant point of concern for the facility. The concrete slabs have already exhibited significant cracking and failure in some areas. Consideration of replacing the concrete slabs and subbase is our recommendation.
