# Structure Safety Report

## 2 Year Complete Topside and Underwater Element Inspection

DIVISION: 1 COUNTY: DARE STRUCTURE NUMBER: 270051 FREQUENCY: 24 MONTHS

SUPERSTRUCTURE: SINGLE 25'X11' ALUM. BOX CULVERT; 41'-6" ALONG CENTERLINE OF CULVERT

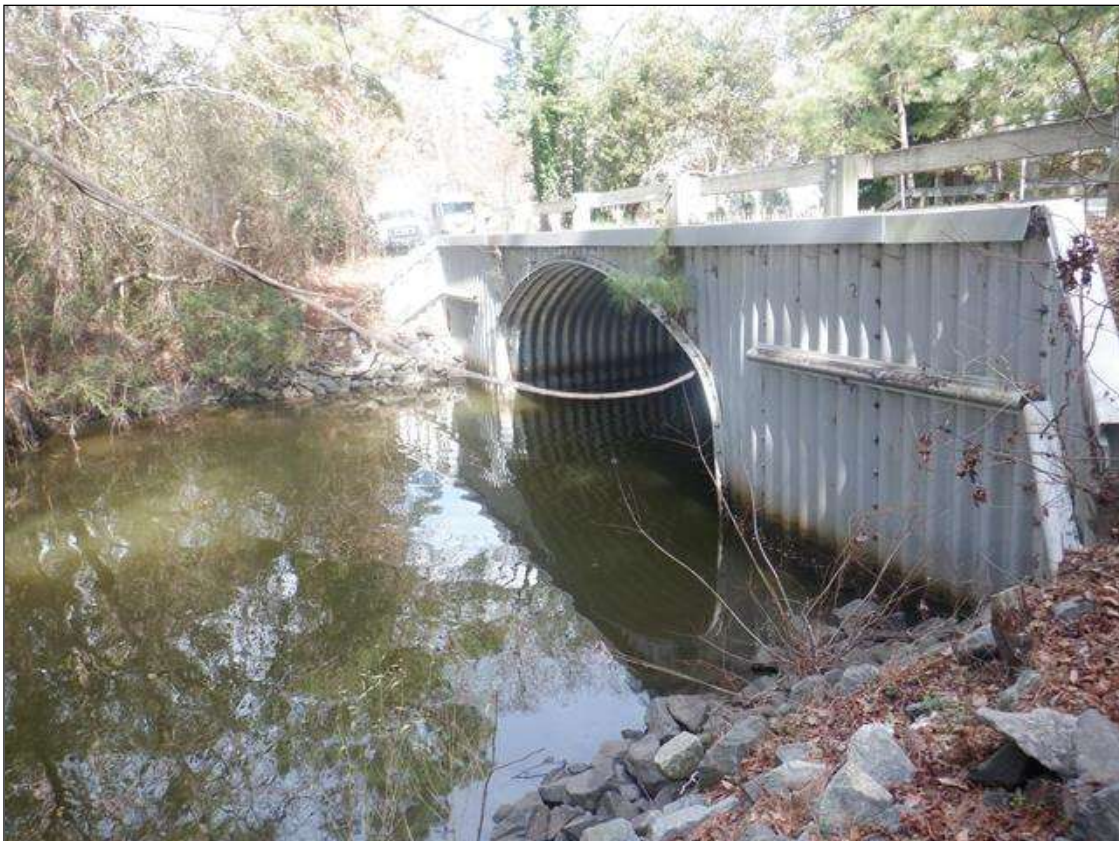
WEST PROFILE

Priority Level	Defect Type	Quantity	Defect Description
2	Scour	1	Span 1 Culvert Section 1: PRIORITY ACTION REQUESTED - 2' VERTICAL EXPOSURE OF TOEWALL ON WEST END

3370	Maintenance and Repair of NBIS Pipes and Culverts	LF	1	Span 1 Culvert Section 1: PRIORITY ACTION REQUESTED - 2' VERTICAL EXPOSURE OF TOEWALL ON WEST END
